External Road Dilapidation Report – Existing Condition

Uungula Wind Farm

Prepared for: Uungula Wind Farm Pty Ltd

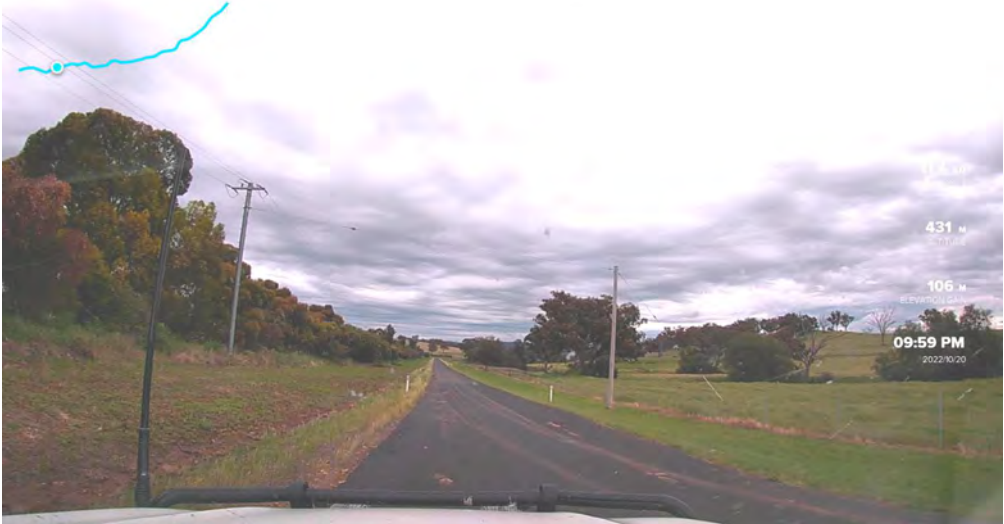
Defect ID	Start Ch	End Ch	Defect Type (and side of road)	Image
7.0 (Image looking west)	2000	2600	Edge break (BS) Ravelling/Fretting (BS) Pothole (RHS) Pothole (CR) Pothole Patched (BS)

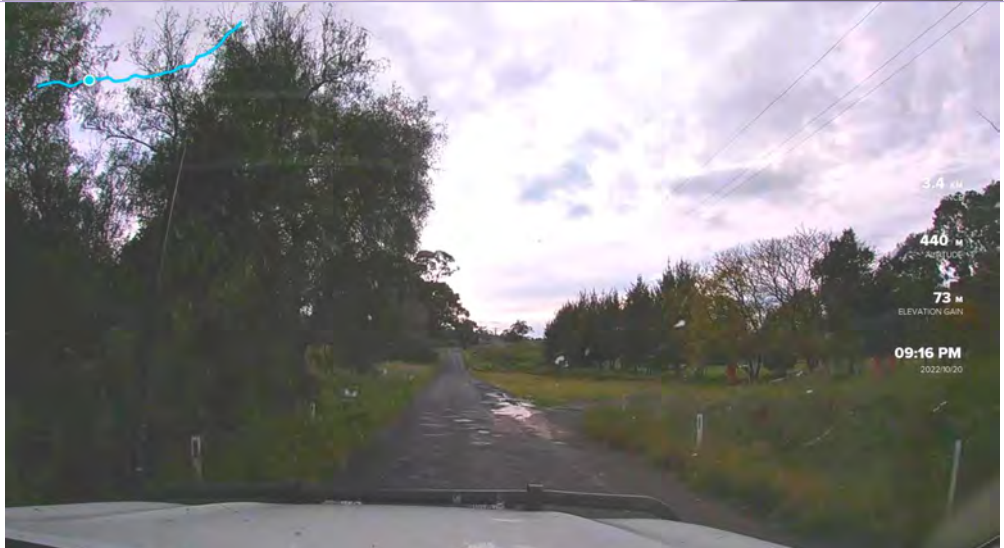
8.0	2600	3400	Pothole (RHS) Ravelling/Fretting (RHS) Stripping (RHS) Delamination (CR) Ponding issues

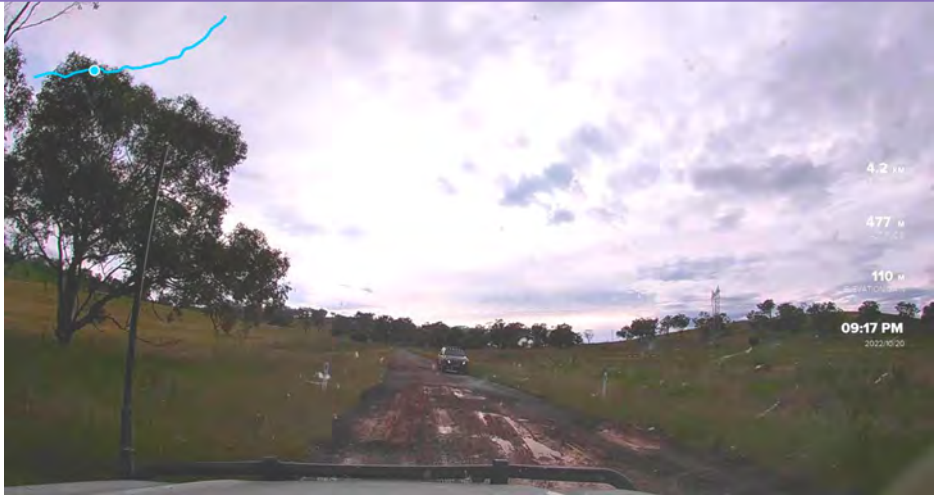
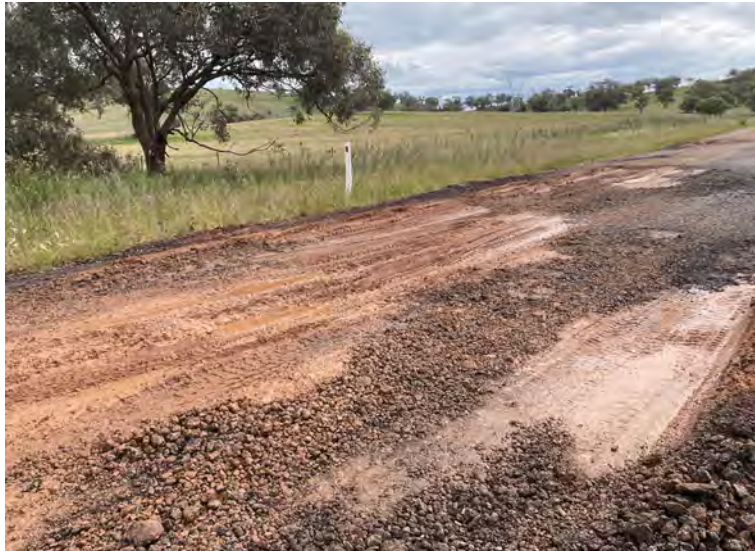
Defect ID	Start Ch	End Ch	Defect Type (and side of road)	Image
9.0	3400	4200	Ravelling/Fretting (BS) Delamination (RHS) Pothole (LHS) Depression (CR) Ponding issue Crocodile Cracking (LHS)

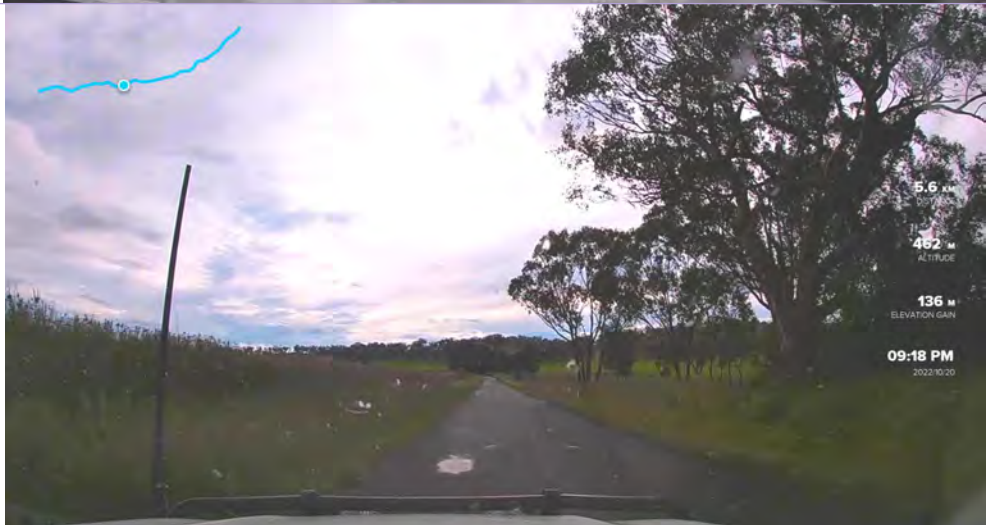
Defect ID	Start Ch	End Ch	Defect Type (and side of road)	Image
10.0	4200	4800	Ravelling/Fretting patched (LHS) Depression (RHS) Stripping (RHS)	 
11.0	4800	5200	Pothole (BS) Stripping (RHS)

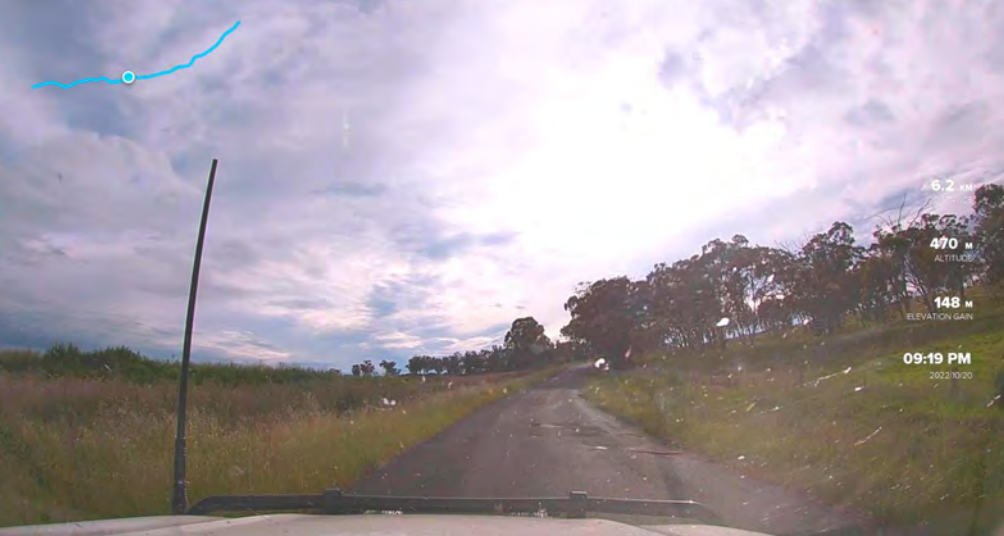
Defect ID	Start Ch	End Ch	Defect Type (and side of road)	Image
14.0 (Image looking west)	5500	5600	Pothole (CR) Ravelling/Fretting (CR)	 
15.0	5700	6400	Ravelling/Fretting (RHS) Pothole (CR) Delamination (CR) Edge break (RHS) Stripping (LHS)

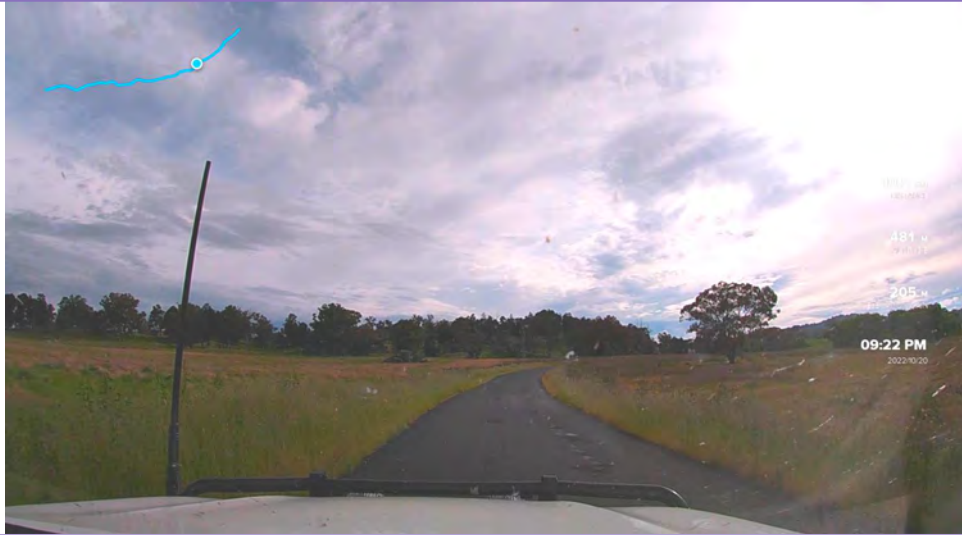
Defect ID	Start Ch	End Ch	Defect Type (and side of road)	Image
24.0	9900	10400	Ravelling/Fretting Patched (RHS) Longitudinal Cracking (RHS) Longitudinal Cracking (CR)

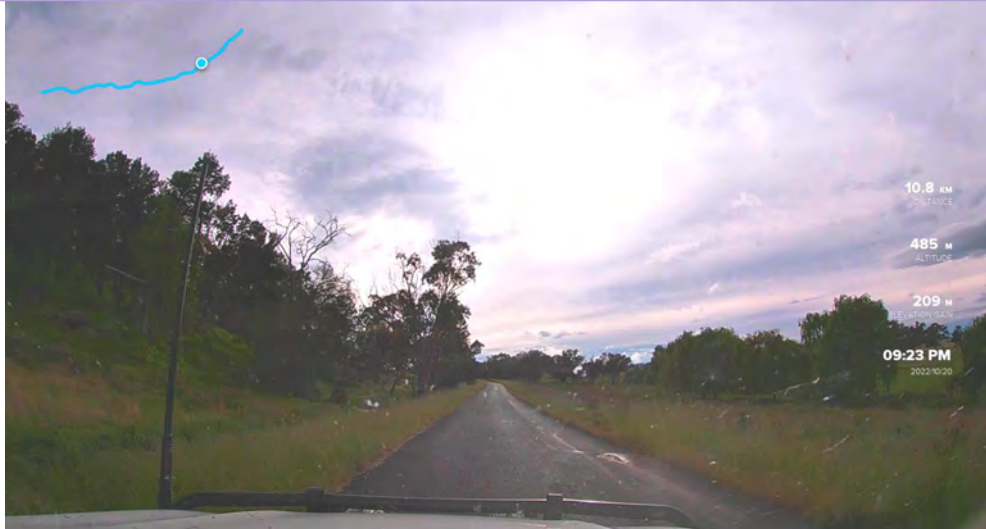
25.0	10400	10600	Ravelling/Fretting Patched (RHS) Ravelling/Fretting Patched (CR) Pothole (RHS)

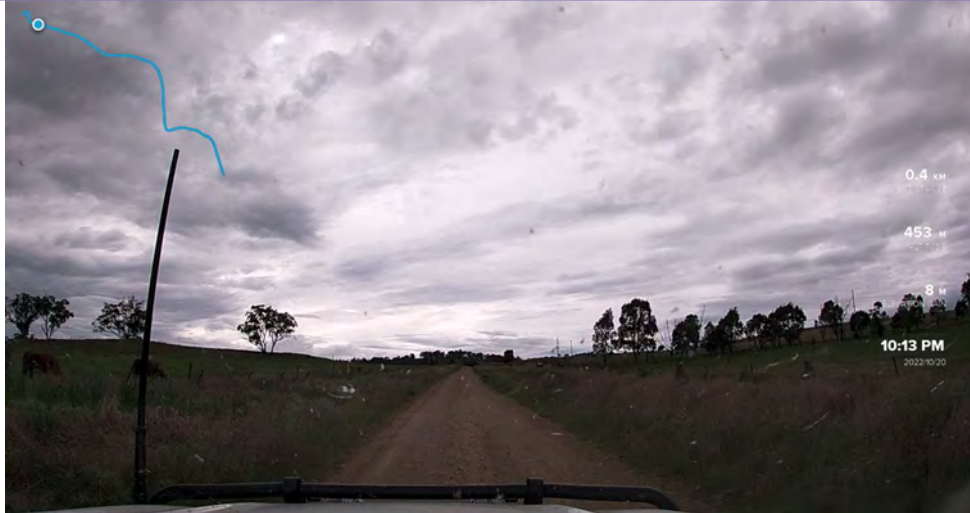
Defect ID	Start Ch	End Ch	Defect Type (and side of road)	Image
1.0	0	500	Minor Defects

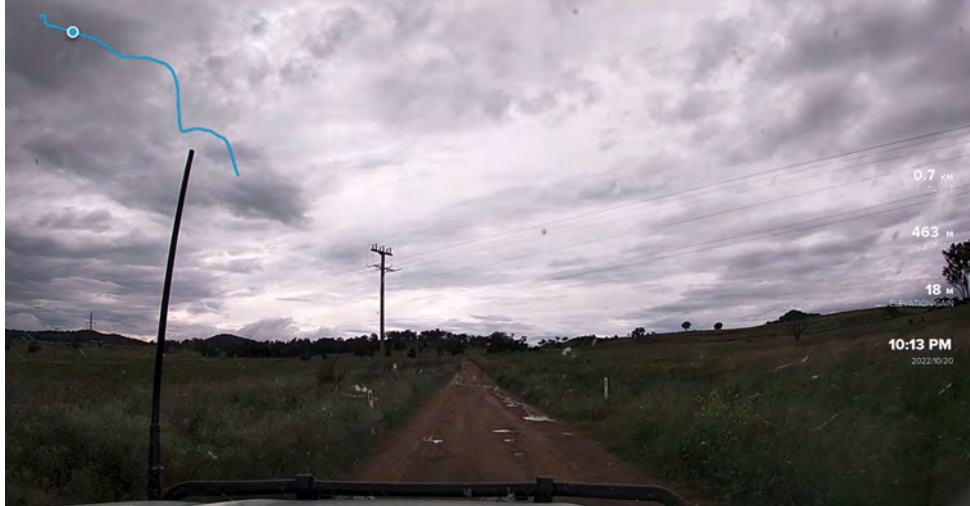
2.0	500	700	Surface Scour (BS) Potholes (BS) Rutting (RHS) Drainage Issue

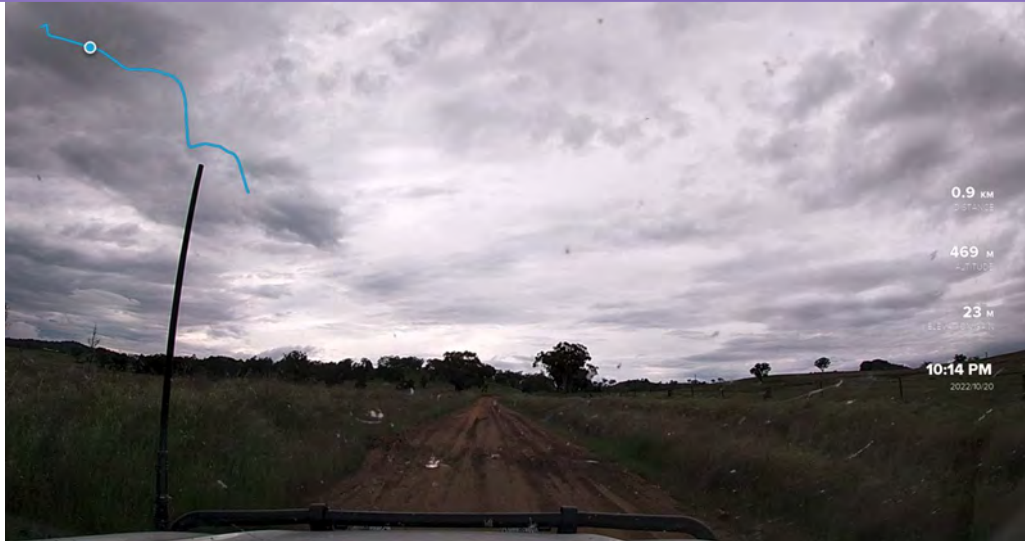
Defect ID	Start Ch	End Ch	Defect Type (and side of road)	Image
3.0	700	800	Rutting (BS) Soft Surface (BS)

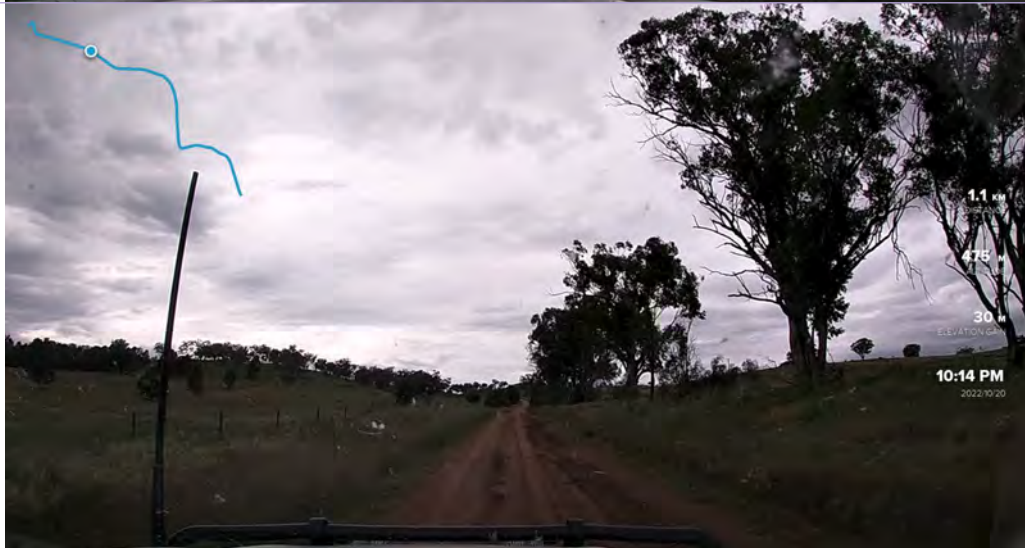
4.0	800	1000	Loss of material (RHS)

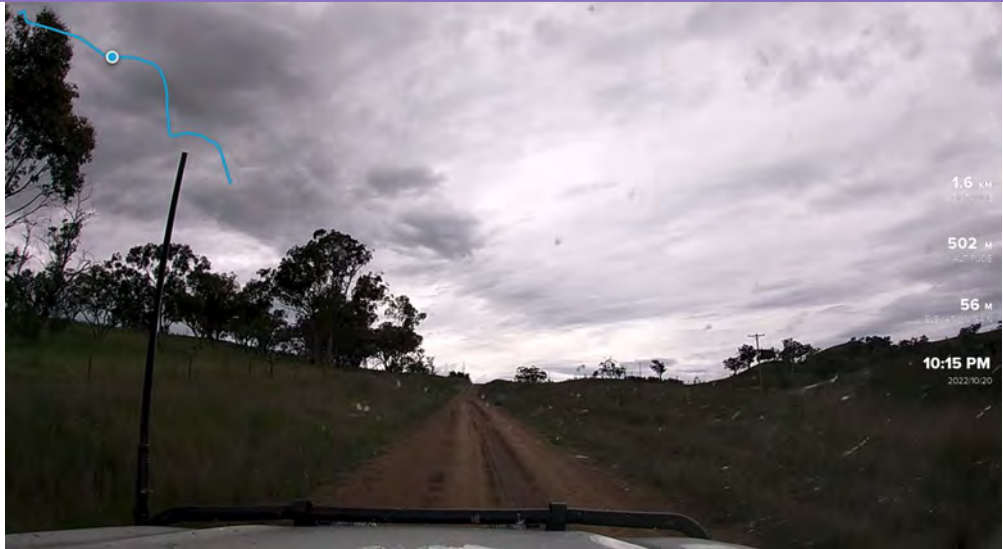
Defect ID	Start Ch	End Ch	Defect Type (and side of road)	Image
7.0	1400	1900	Rutting (CR) Rutting (BS) Loose material

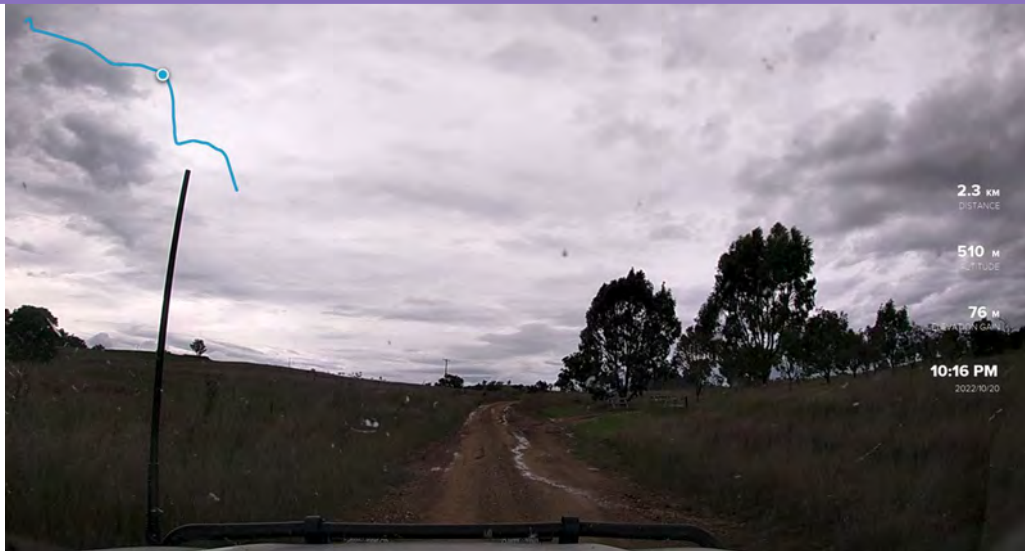
Defect ID	Start Ch	End Ch	Defect Type (and side of road)	Image
9.0	2100	2200	Surface Scour (RHS) Rutting (RHS) Drainage issue

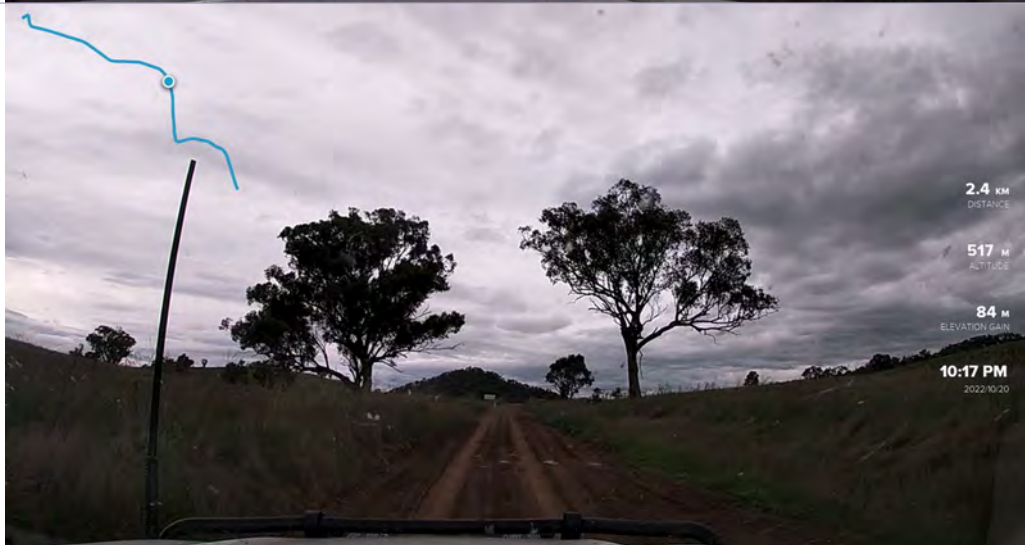
10.0	2200	2400	Potholes (CR) Loose material (BS) Loose material (CR)

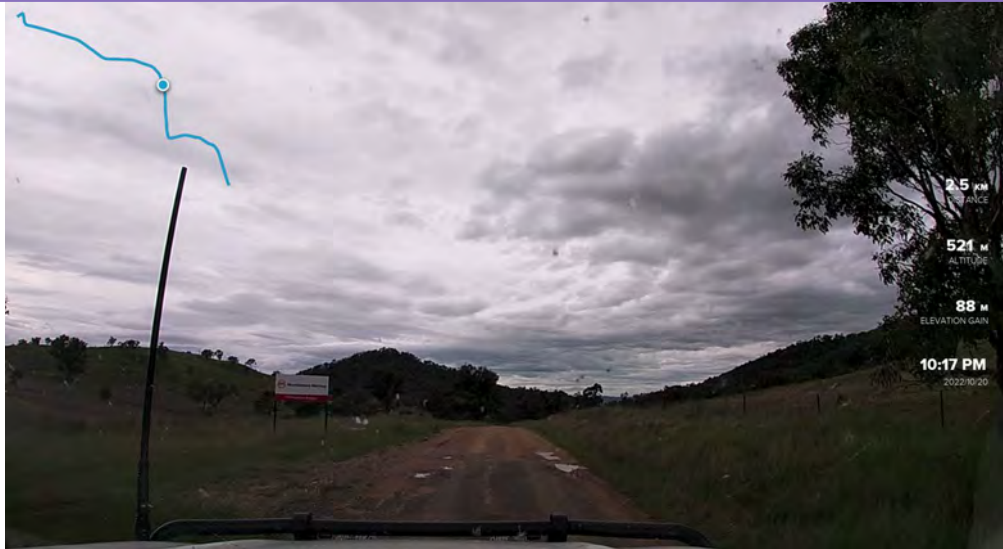
Defect ID	Start Ch	End Ch	Defect Type (and side of road)	Image
11.0	2400	2500	Potholes (BS) Settlement (LHS) Drainage issue at sealed/unsealed interface.

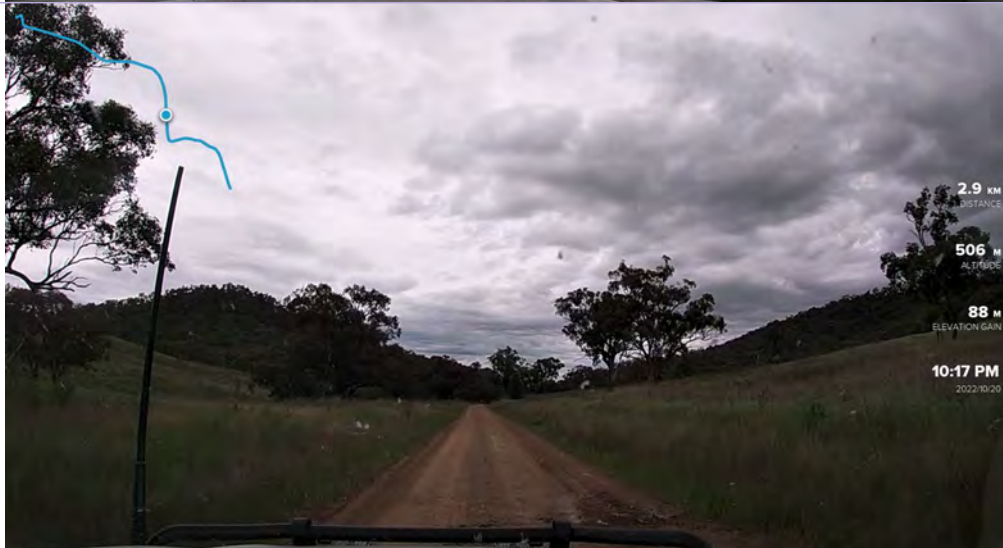
12.0	2500	3100	Rutting (RHS) Rough Surface Loose Material

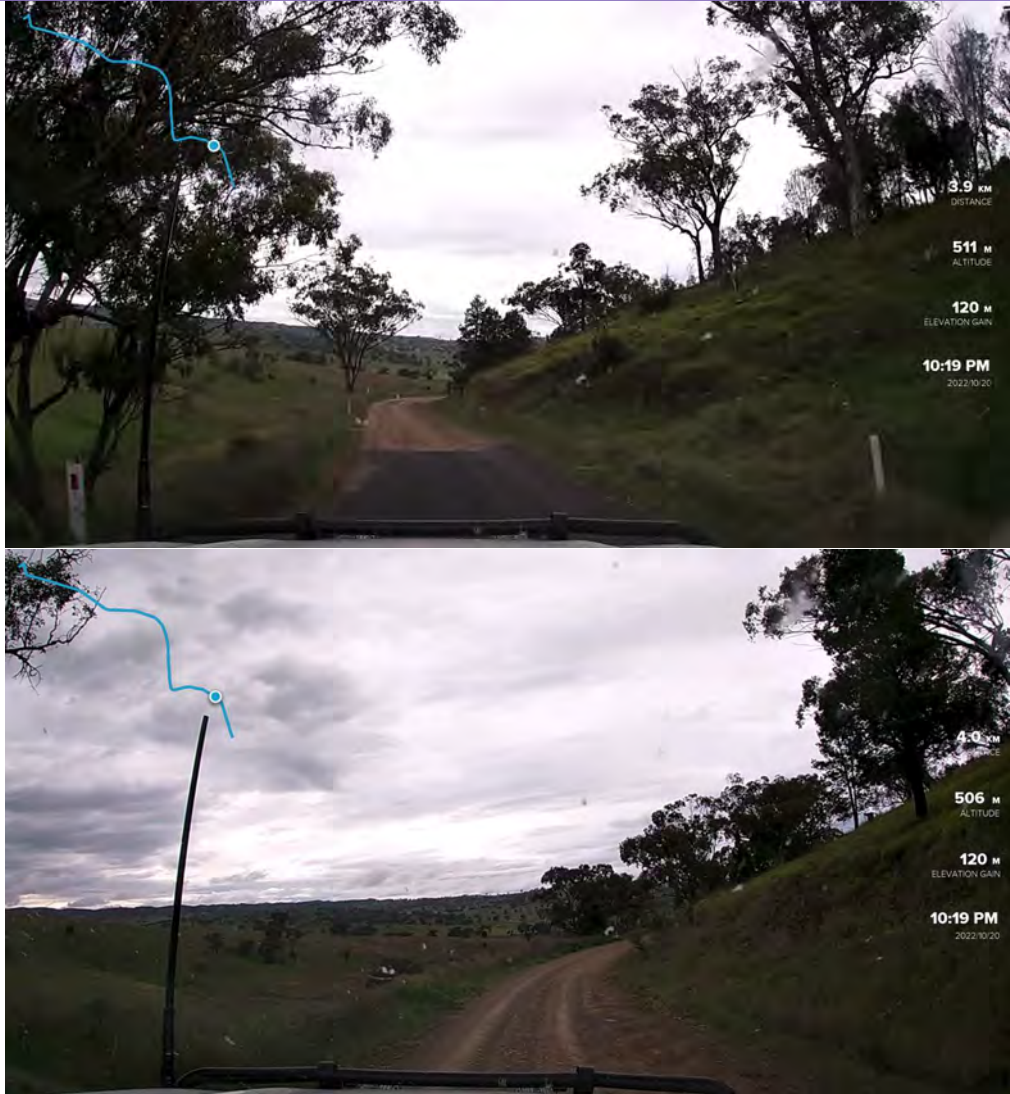
Defect ID	Start Ch	End Ch	Defect Type (and side of road)	Image
16.0	3800	4300	Sealed to unsealed pavement Edge break (LHS) Corrugation (RHS) Surface Scour (RHS) Loose material (RHS)

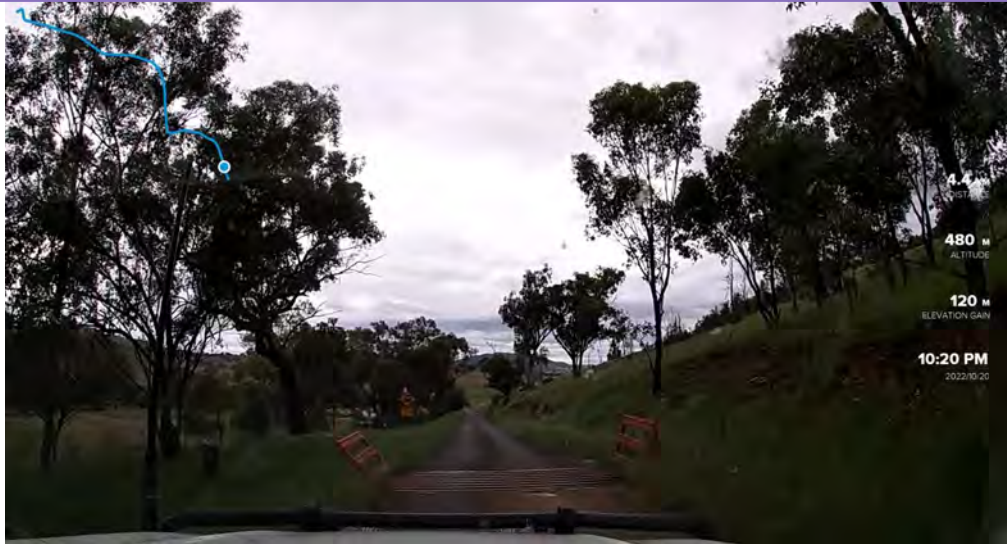
Defect ID	Start Ch	End Ch	Defect Type (and side of road)	Image
17.0	4300	4800	Unsealed to sealed road. Cattle grid at transition. Pothole (RHS) Edge break (RHS)

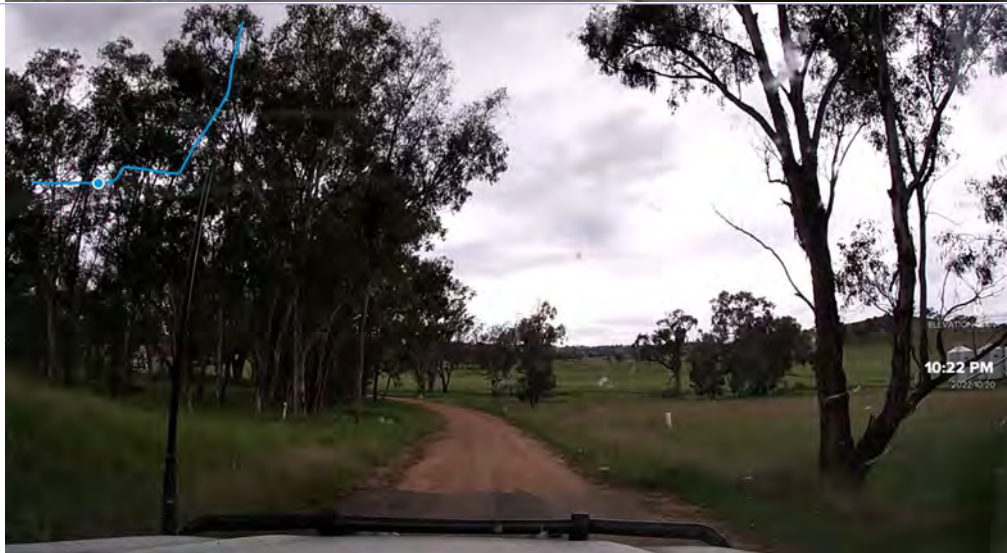
18.0	4800	4900	Sealed to unsealed road.

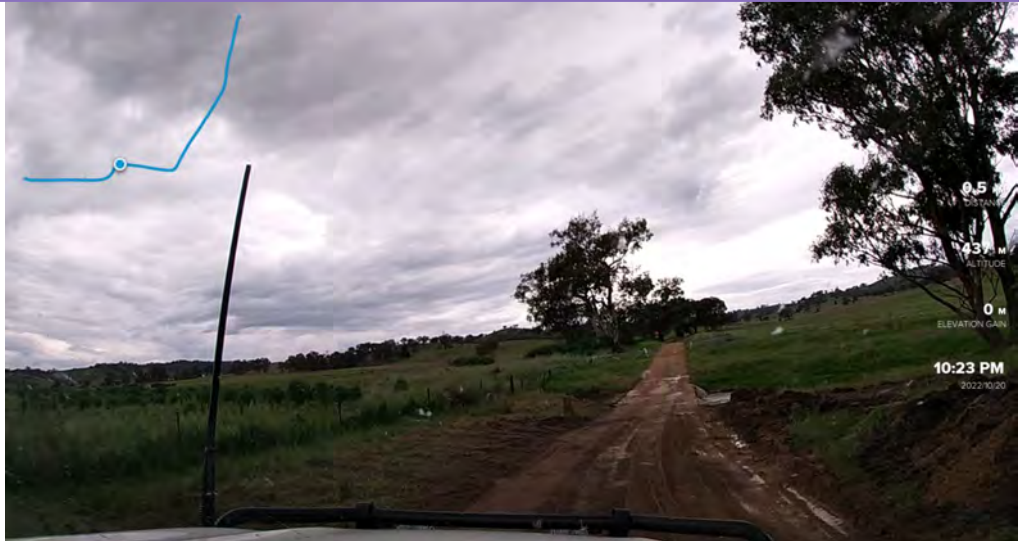
Defect ID	Start Ch	End Ch	Defect Type (and side of road)	Image
19.0	4900	5000	Corrugation (RHS) Surface scour (RHS) Drainage issue Cattle grid at fence line

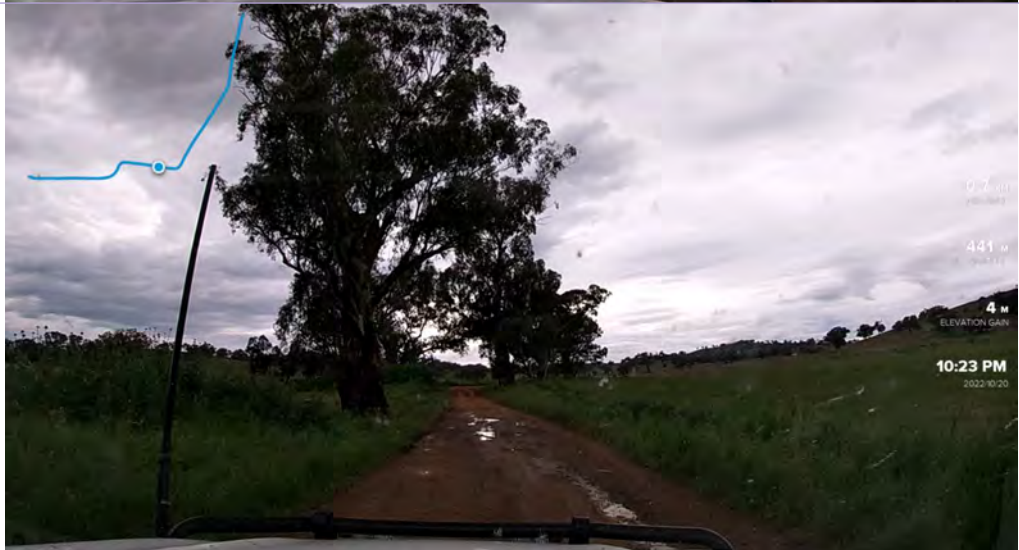
20.0	5000	5400	Pothole (CR) Surface scour (BS) Rutting (RHS) Drainage issue

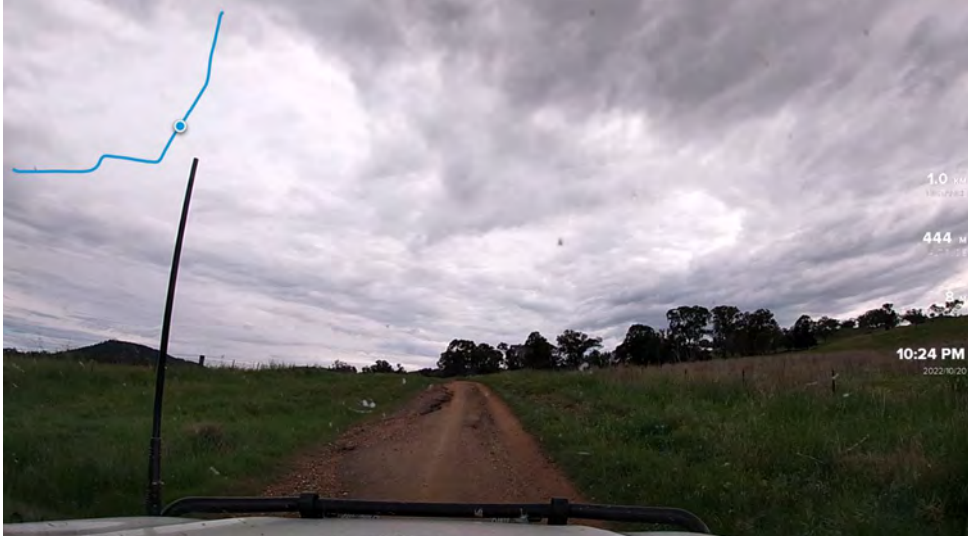
22.0	5400	5700	Rough surface

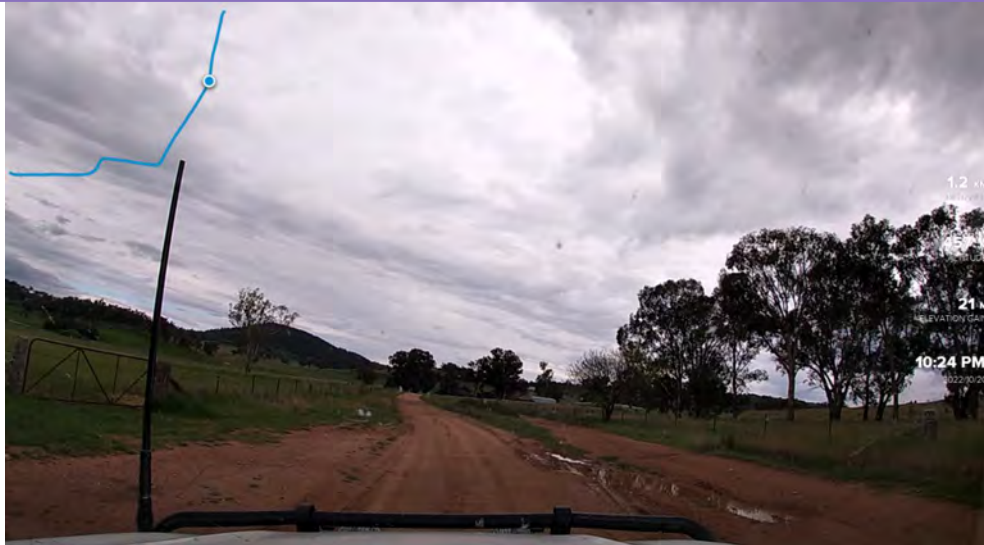
Defect ID	Start Ch	End Ch	Defect Type (and side of road)	Image
23.0	5700	6000	Corrugation (CR) Surface scour (RHS) Potholes (BS)

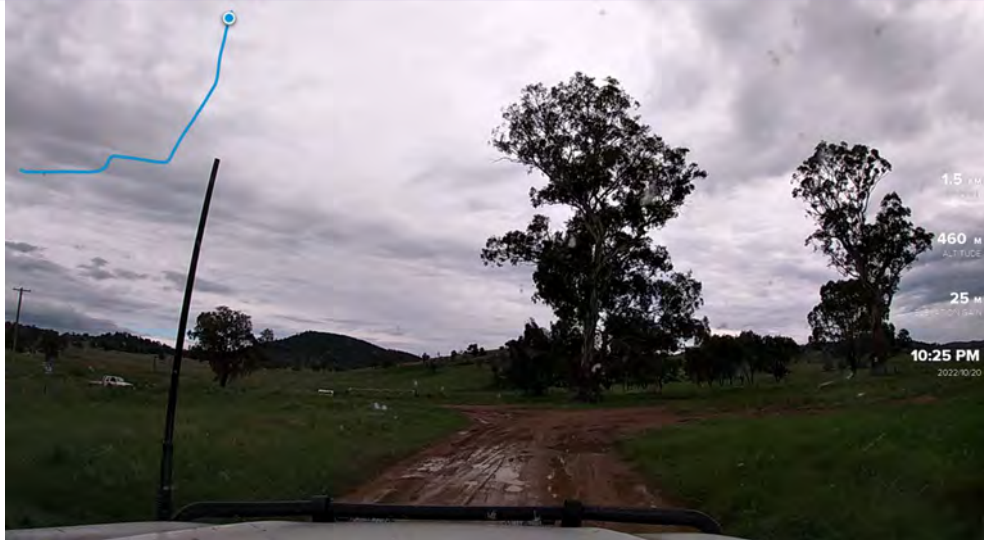
24.0	6000	6100	Slippery Surface Pothole (RHS) Pothole (CR) Rutting (BS) Drainage issue

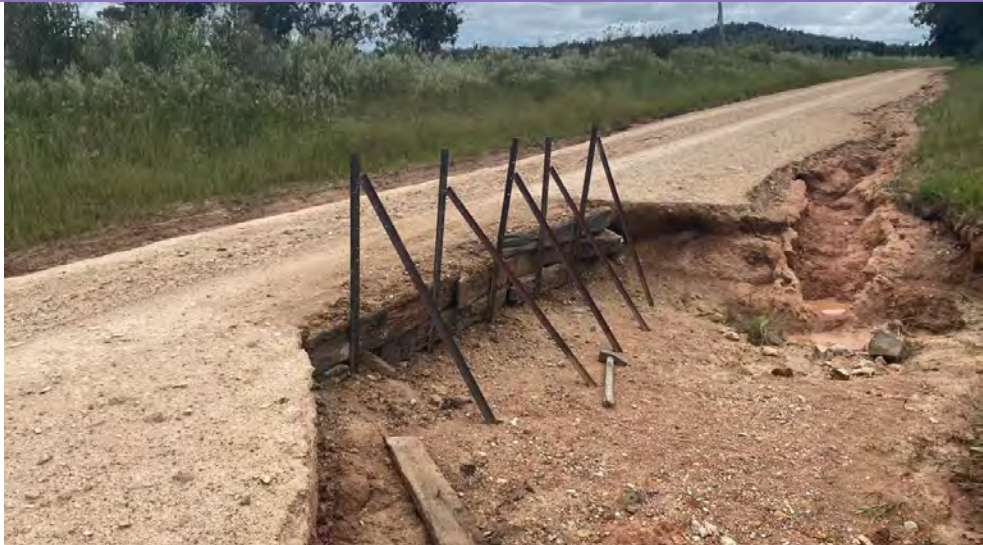
Defect ID	Start Ch	End Ch	Defect Type (and side of road)	
3.0	550	550	Erosion (RHS) Surface scour (RHS) Edge break (LHS) Local attempt to prevent further erosion.

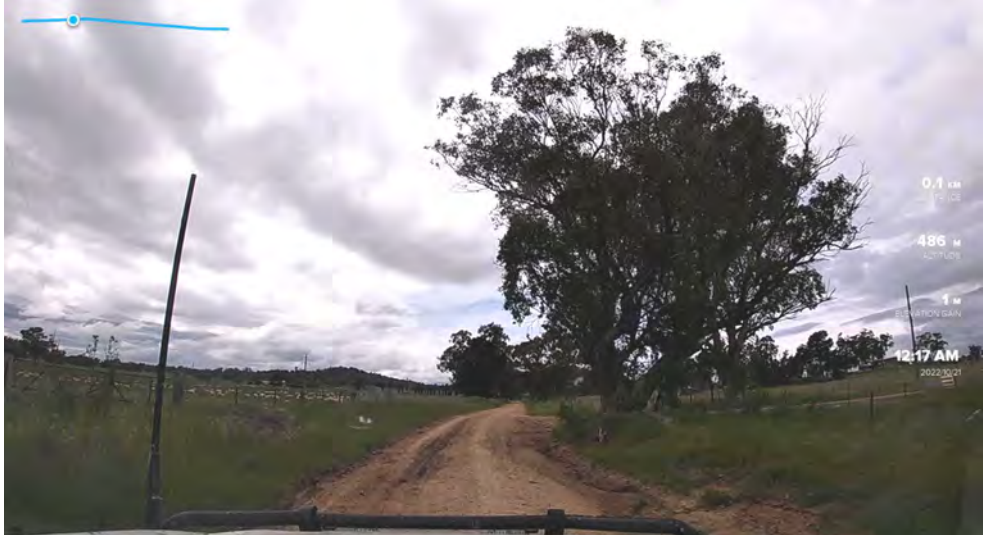
4.0	550	750	Rutting (BS)

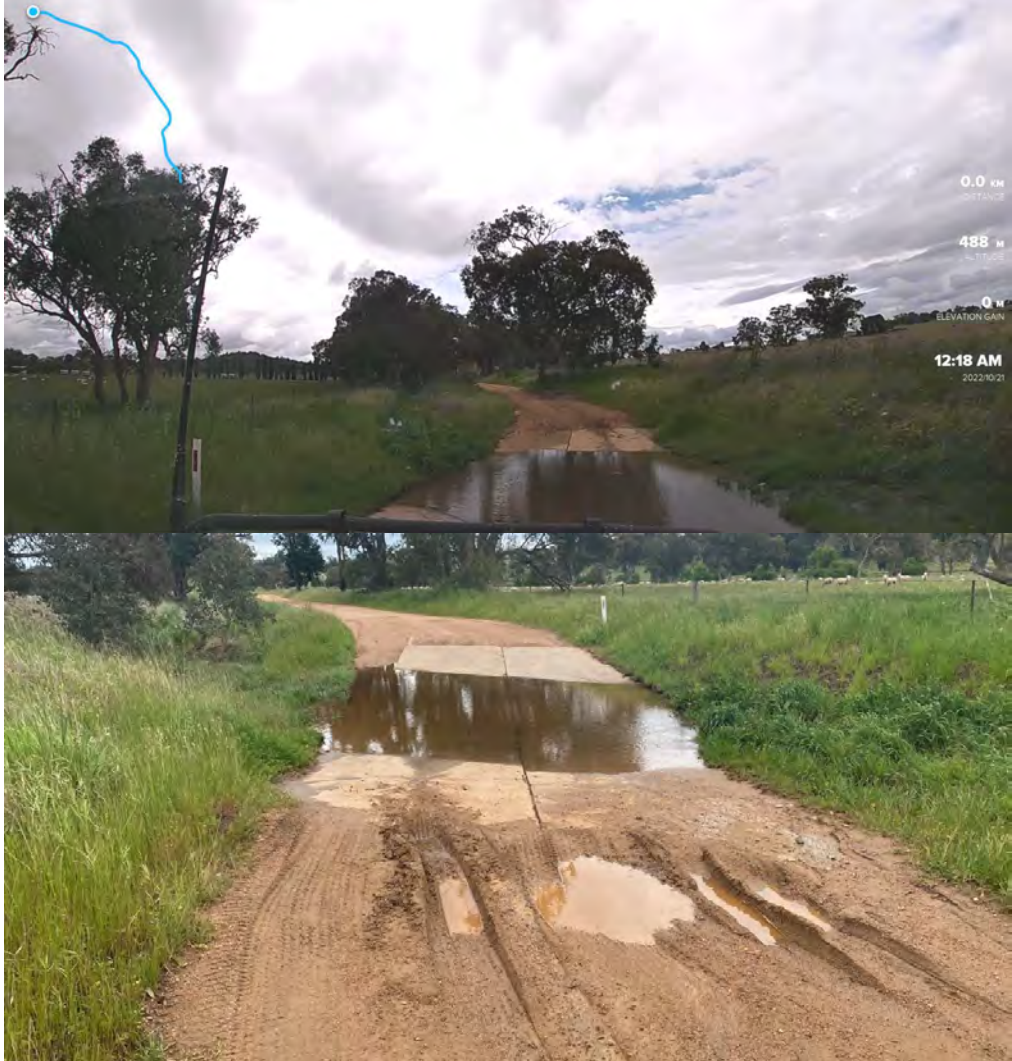
Defect ID	Start Ch	End Ch	Defect Type (and side of road)	
5.0	750	800	Causeway Rutting (BS) Pothole (CR) Drainage Issue

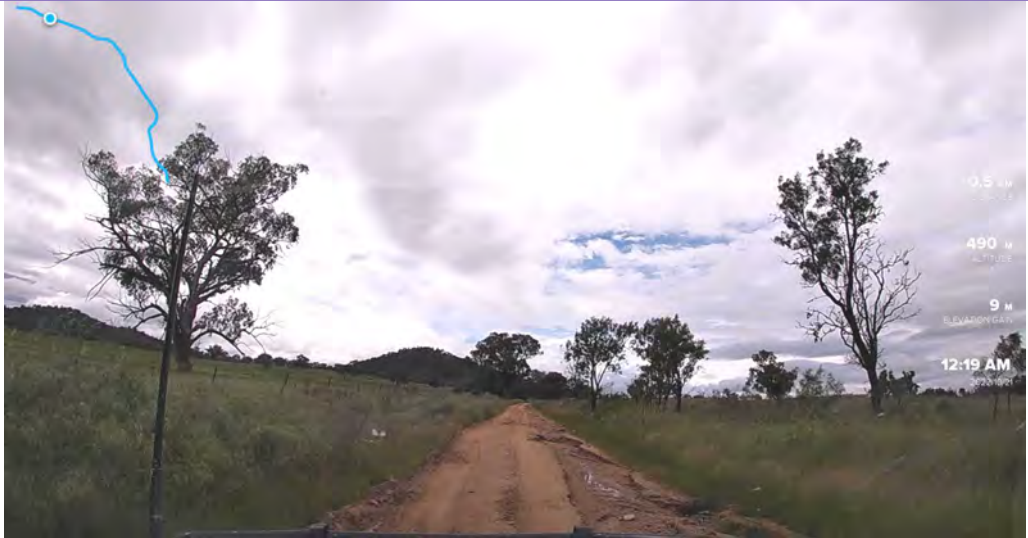
Defect ID	Start Ch	End Ch	Defect Type (and side of road)	
8.0	1200	1600	Surface scour (RHS) for 400m

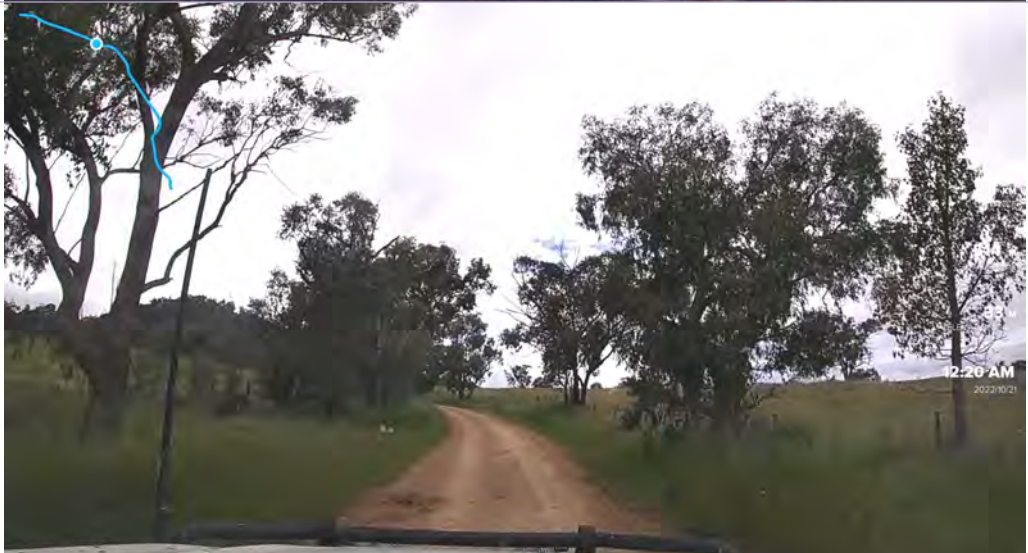
9.0	1600	2200	Rutting (LHS)

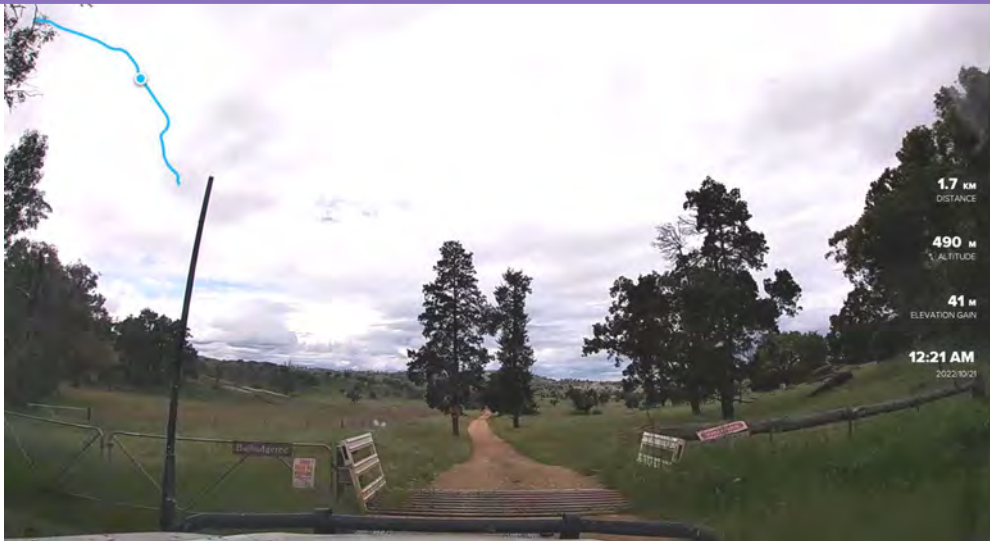
Defect ID	Start Ch	End Ch	Defect Type (and side of road)	
12.0	2500	3500	Cattle grid Rutting minor (CR) Rutting (RHS)

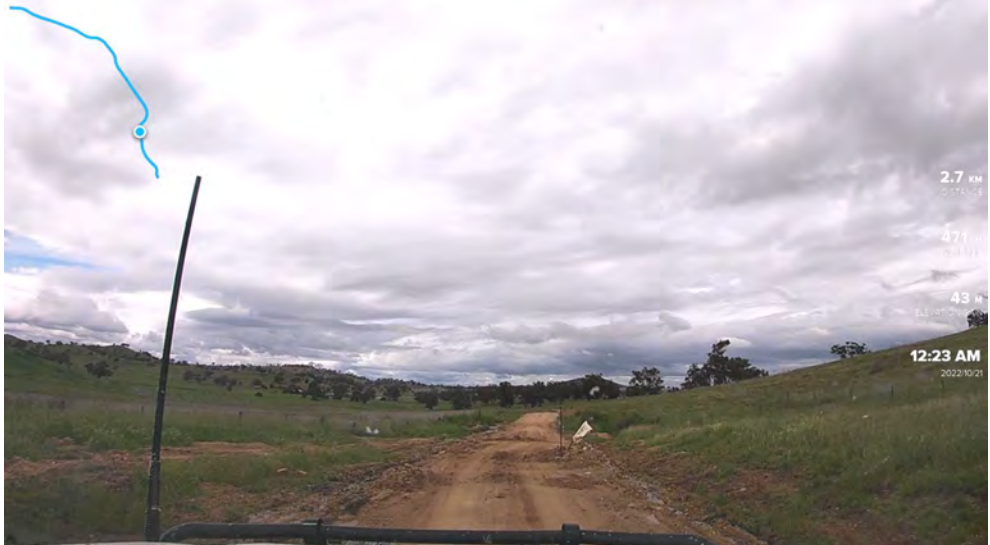
13.0	3500	3600	Rutting major (BS) Rocks in pavement Soft surface (LHS) Drainage issue.

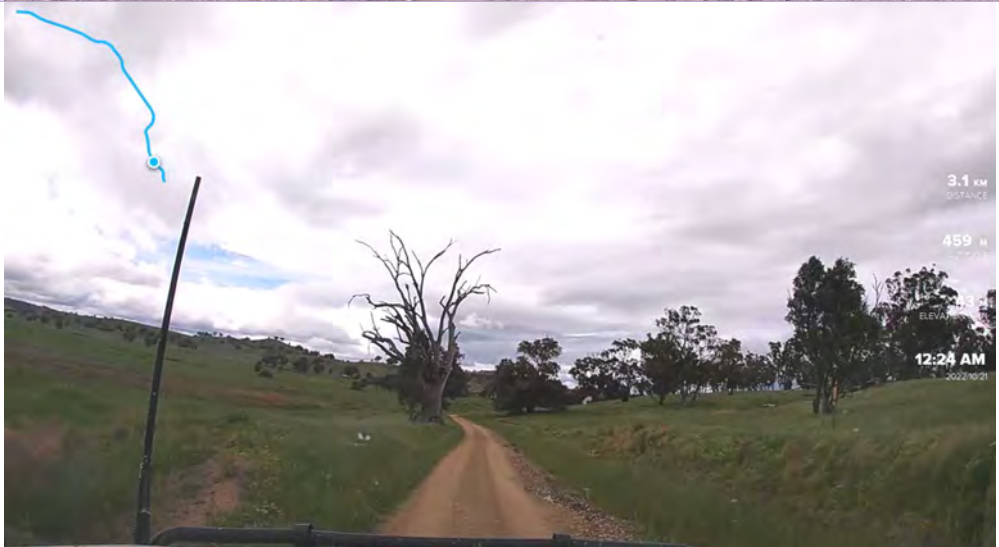
14.0	3600	4300	Edge break (RHS)

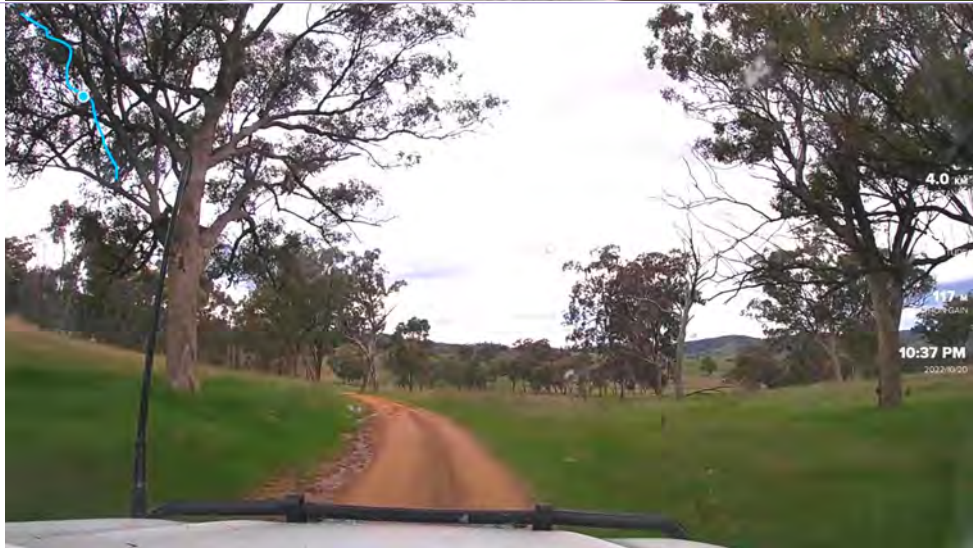
Defect ID	Start Ch	End Ch	Defect Type (and side of road)	
19.0	3800	3900	Cattle grid	 
20.0	3900	4200	Edge break (RHS)

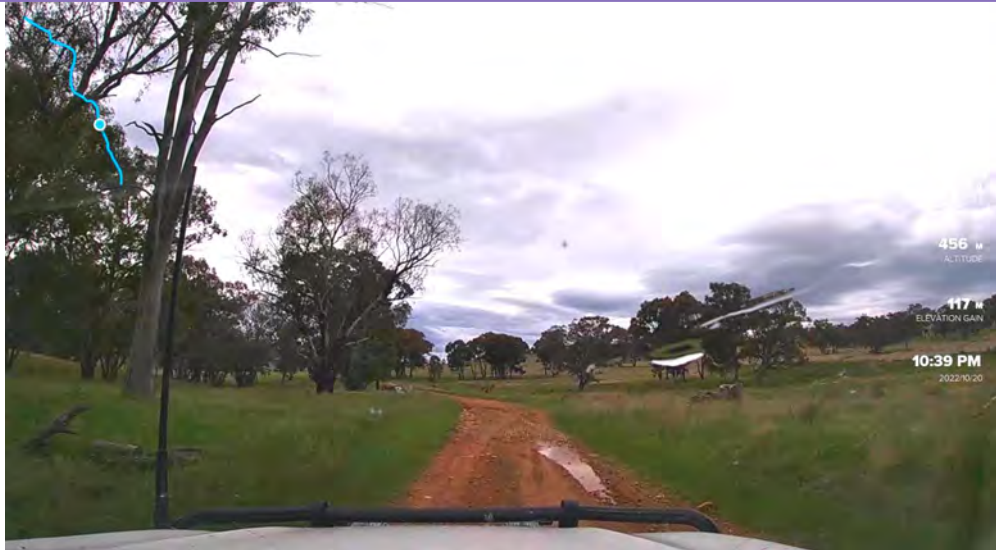
Defect ID	Start Ch	End Ch	Defect Type (and side of road)	
25.0	4900	5100	Rutting (RHS) Surface scour (LHS)

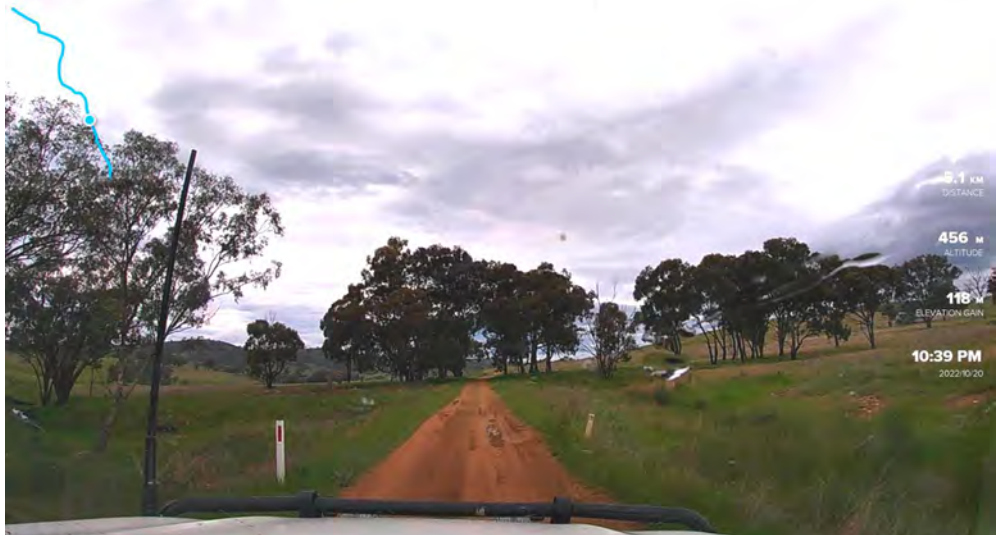
26.0	5000	5100	Rutting (RHS)

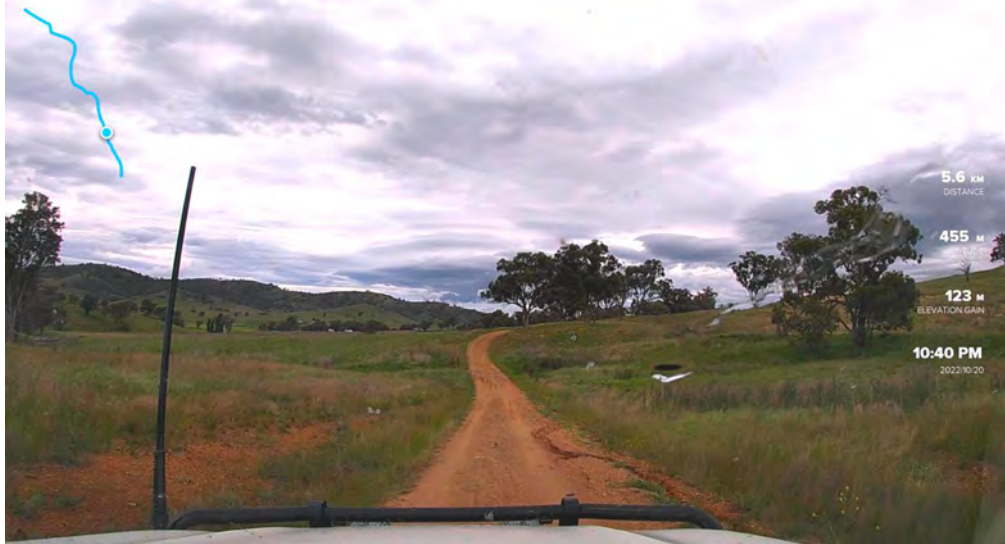
Defect ID	Start Ch	End Ch	Defect Type (and side of road)	
29.0	5200	5600	Surface scour (RHS) Edge break (RHS)

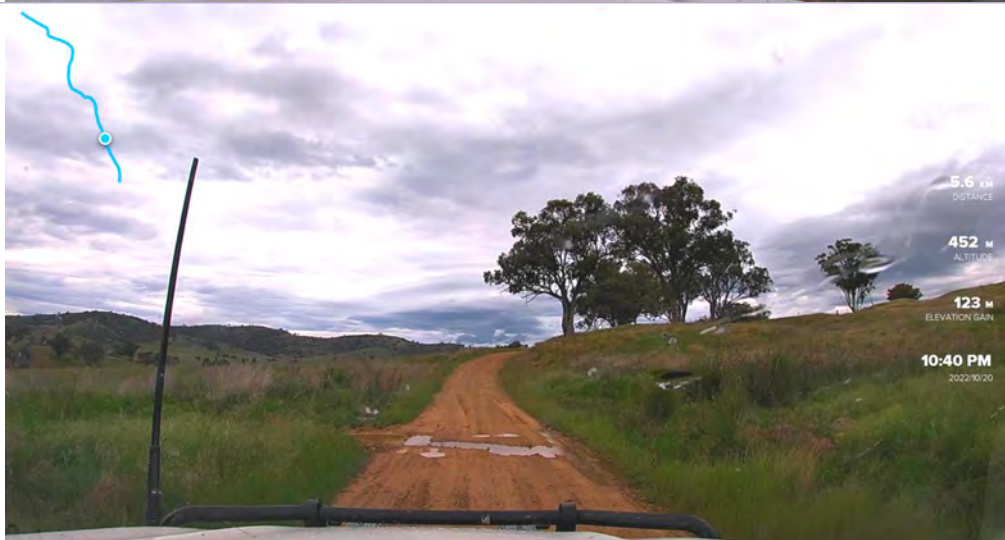
30.0	5600	5700	Depression Drainage issue

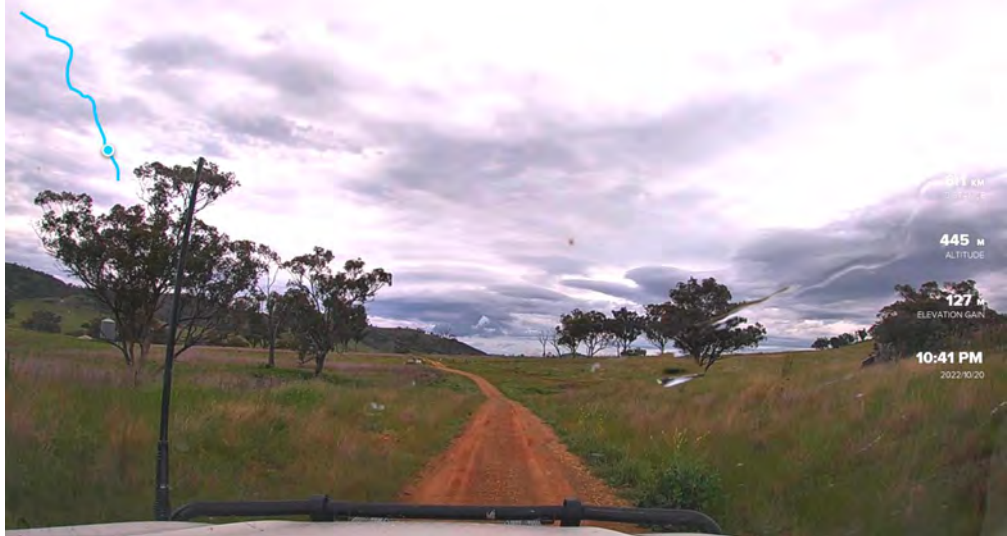
Defect ID	Start Ch	End Ch	Defect Type (and side of road)	
31.0	5700	5800	Corrugation (CR)	 
32.0	5800	6200	Rutting (BS)
