# Bango Wind Farm

Southern Tablelands, New South Wales

## Heritage Management Plan

June 2019

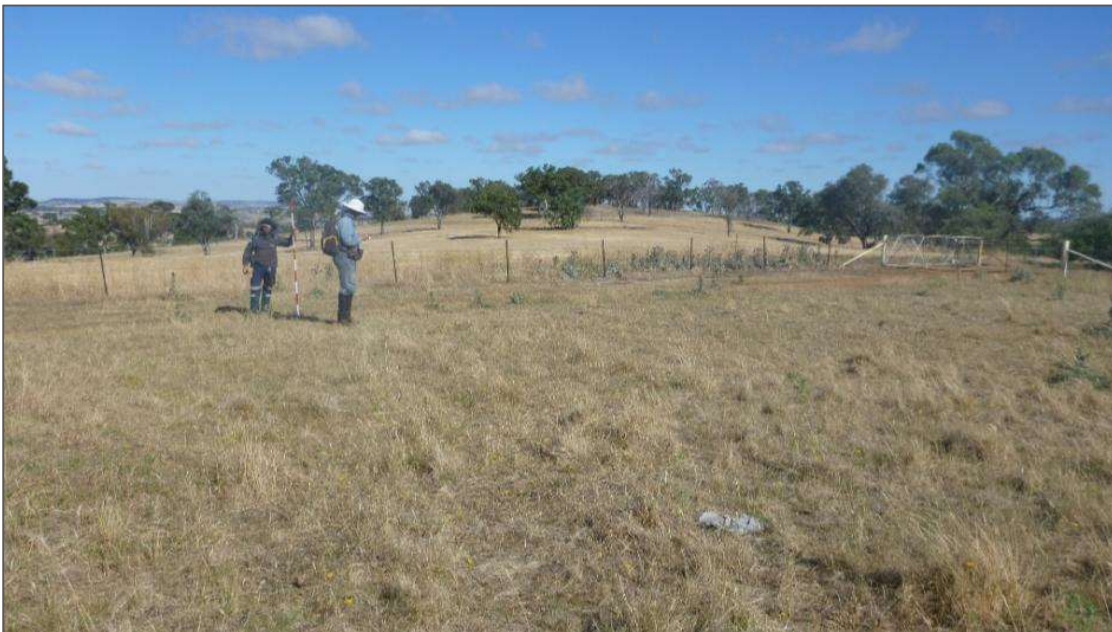
One stone artefact was recorded in an area of vehicle track exposure in this locale within Survey Unit 4. The landform is a broad crest of very gentle gradient and an open aspect. The artefact was located in an area measuring 50m x 5m, of which 20% was ground exposure, possessing 80% archaeological visibility. The effective survey coverage is high, and given that one artefact only was recorded, artefact density is assessed to be very low. The vehicle track area is highly disturbed, but away from this, additional artefacts may be present in a subsurface context, although these would be distributed at very low density.

*Bango WF SU4/L1 looking 285°*

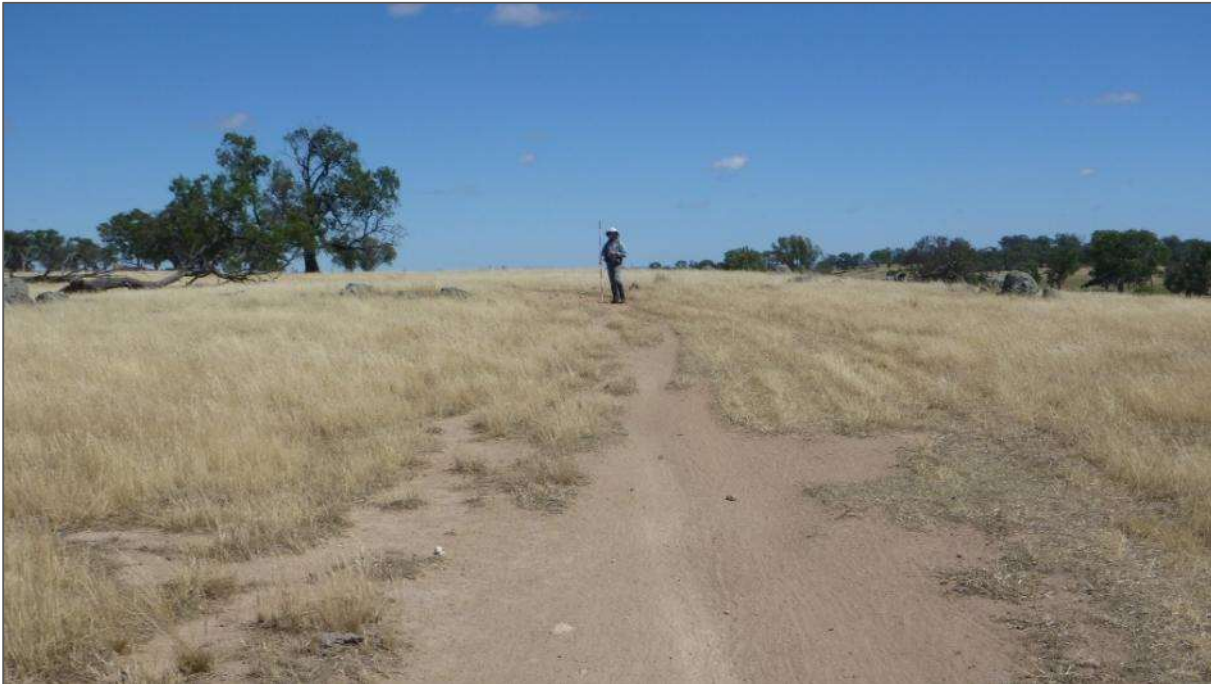
Five stone artefacts (plus 3 quartz *possible* artefact pieces) were recorded in a vehicle/animal track exposure at this locale in Survey Unit 8; the artefacts were in an area of 10 x 3m. The landform is broad undulating crest with very gentle gradient and open aspect. The artefacts were located in an exposure measuring 100m x 5m (overall), of which 60% was ground exposure, possessing 90% archaeological visibility. The effective survey coverage is high, and given that only five artefacts were recorded, artefact density is assessed to be very low. The site has subsurface potential given some depth to the soils, but artefact density is predicted to be very low.

*Bango WF SU8/L1 looking 300°.*

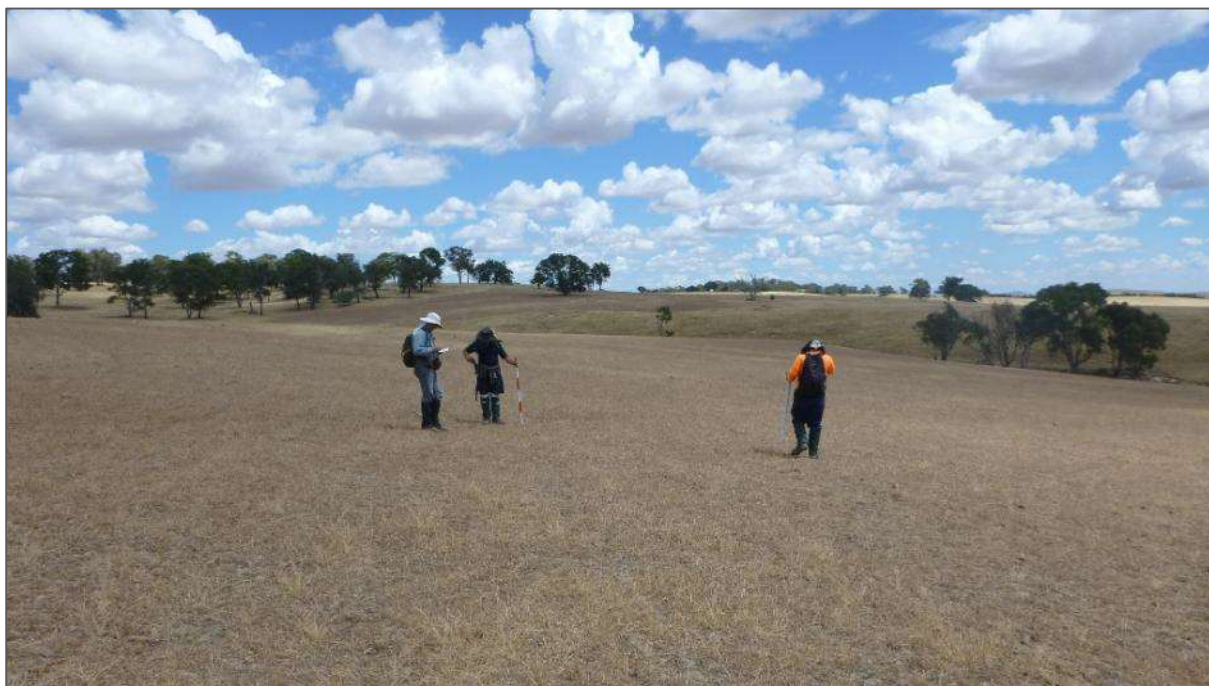
One stone artefact was recorded in a previously ploughed paddock at this locale within Survey Unit 9. The landform is a simple slope with gentle gradient and an aspect to 30°. The broad paddock area possesses 30% ground exposure, with 60% archaeological visibility. The effective survey coverage within the entire paddock is high and given that one artefact only was recorded it is assessed to be a genuine isolated find, and artefact density for this locale is assessed to be very low. The site has subsurface potential given some depth to the soils, and artefact density is predicted to be very low.

*Bango WF SU9/L1 looking 300°*

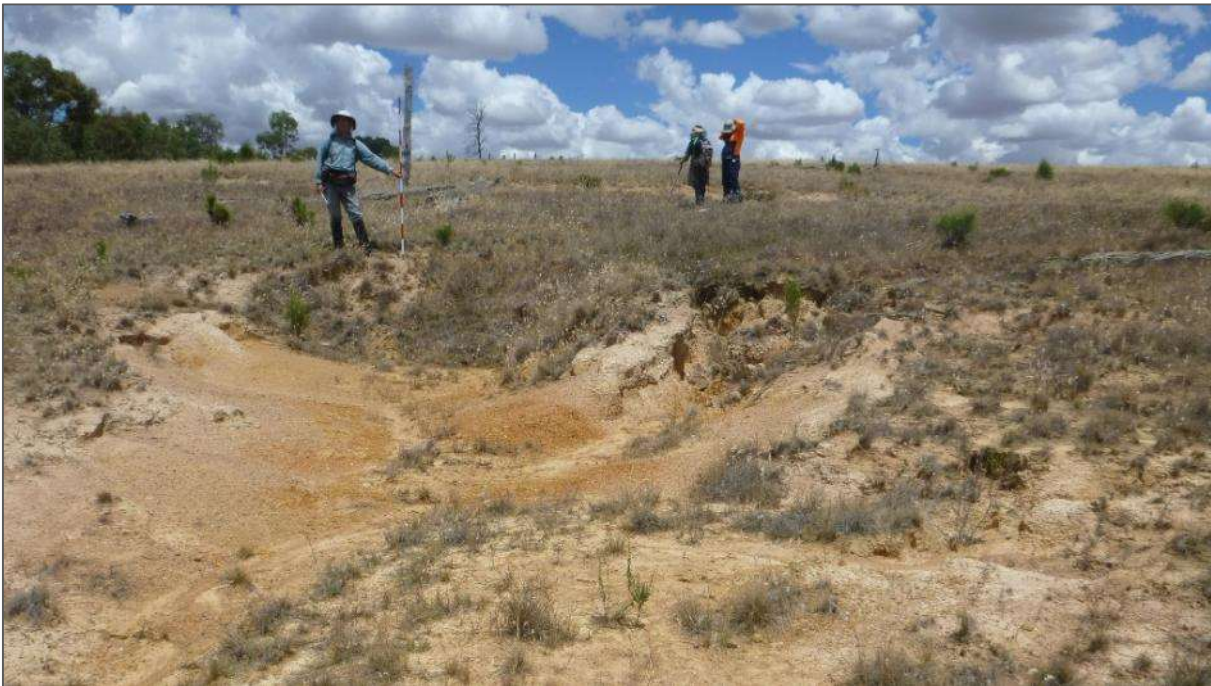
Five stone artefacts and 3 possible quartz artefact pieces were recorded in an extensive area of sheet and gully erosion in this locale within Survey Unit 9. The landform is a simple slope of gentle gradient and an aspect to 90°. The artefacts were located in an area of 50 x 50 m, within a broader area (75 x 85m) which has 10% ground exposure, of which 90% was archaeological visibility. The effective survey coverage is high, and artefact density is assessed to be very low. The locale may contain additional artefacts (in areas which have not sustained erosion), but these would be present in very low density. To the east, nearer to the creek line, there is some subsurface potential and artefact density is assessed to be low/moderate.

*Bango WF SU9/L2 looking 230°*

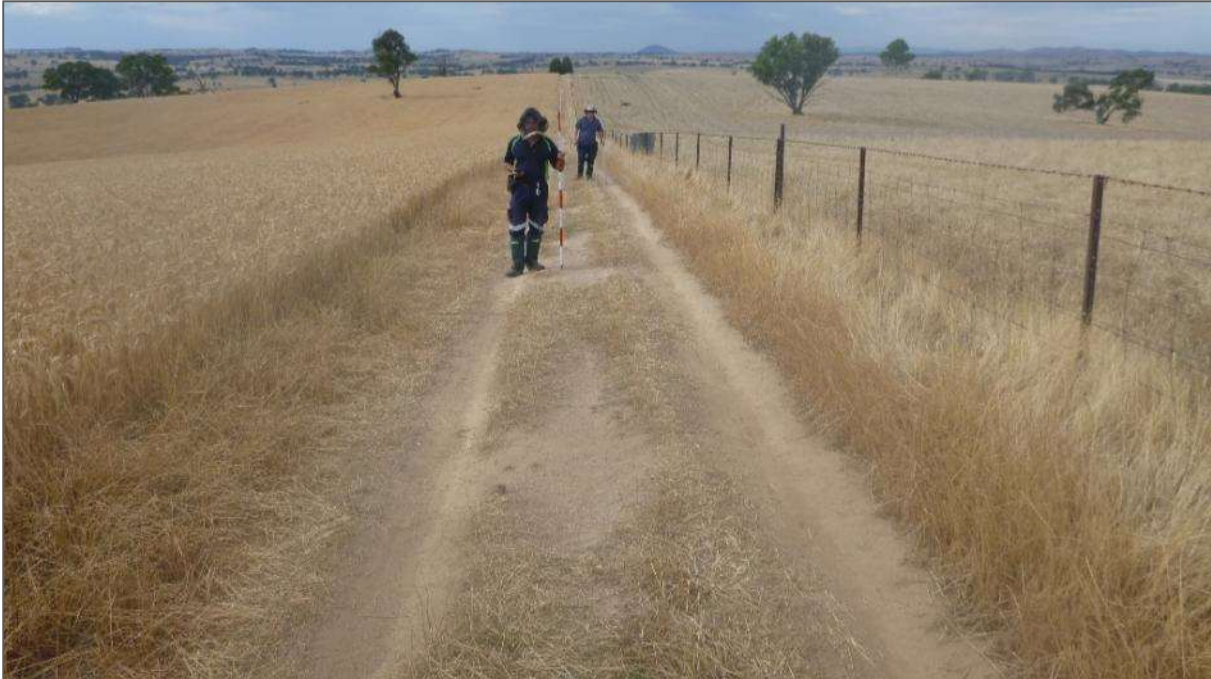
Seven stone artefacts were recorded in an area of vehicle track exposure in this locale within Survey Unit 14. The landform is a broad crest of very gentle gradient and an aspect to 150°. The artefacts were in an area of exposure measuring 75 x 3m, possessing ground exposure of 50%, of which 60% was archaeological visibility. The effective survey coverage during field survey was high, and artefact density is assessed to be very low. The locale has subsurface potential given some depth to the soils, and artefact density is predicted to be very low.

*Bango WF SU14/L1 looking 150°*

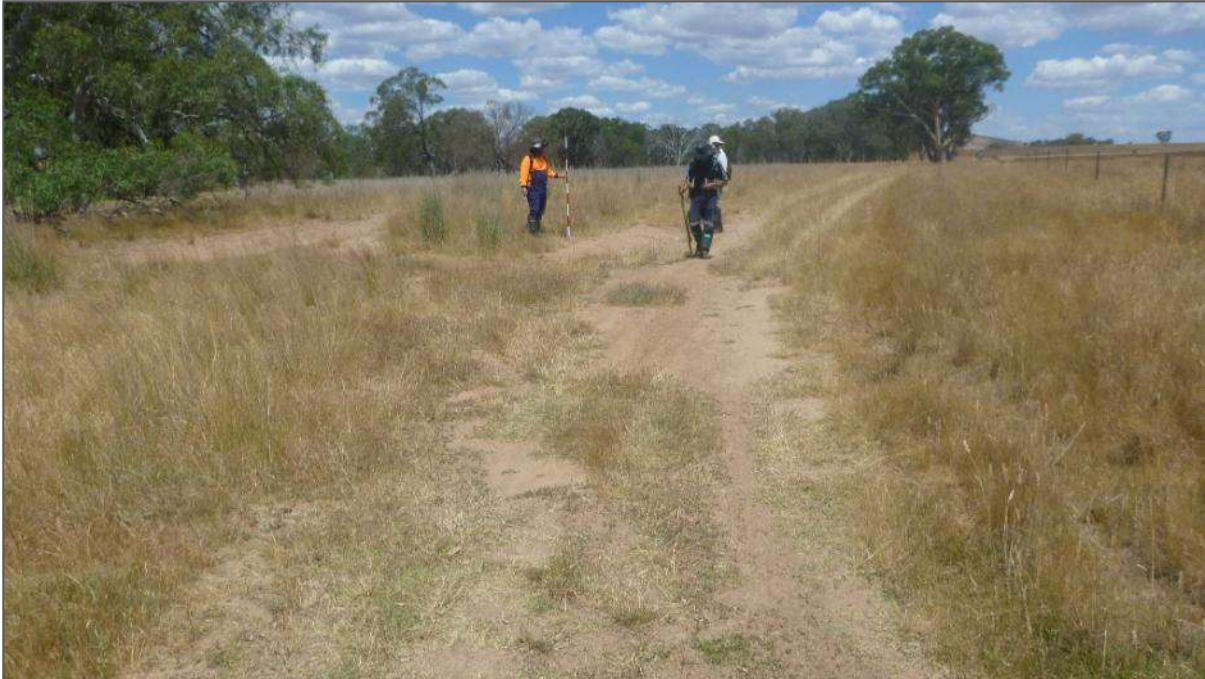
Five stone artefacts were recorded in an area of vehicle track exposure at this locale within Survey Unit 16. The landform is a basal slope of very gentle gradient and open aspect, c. 60m from a creek, and is generally disturbed. The artefacts were recorded in an area measuring 125 x 2m, possessing actual ground exposure of 40%, of which 50% was archaeological visibility. The effective survey coverage is high, and artefact density is assessed to be low. The locale is predicted to contain additional artefacts, distributed at low density and in a disturbed context.

*Bango WF SU16/L1 looking 120°*

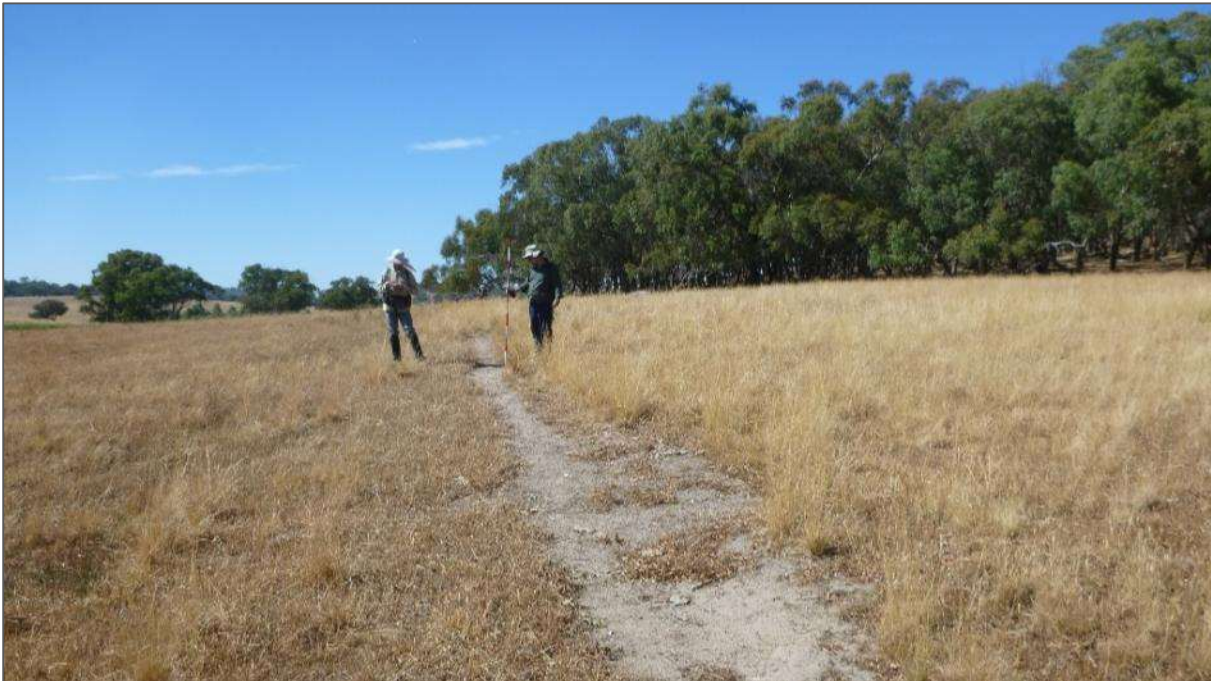
Three stone artefacts were recorded in an area of exposure associated with an animal track in this locale within Survey Unit 27. The landform is an eroded crest of gentle gradient and an aspect to 90°. The area in which artefacts were recorded measures 30 x 0.5m of which 90% is ground exposure, possessing 90% archaeological visibility. The effective survey coverage is high, and artefact density is assessed to be low. The locale may contain additional artefacts, with some subsurface potential, but these would be present in low density.

*Bango WF SU27/L1 looking 175°*

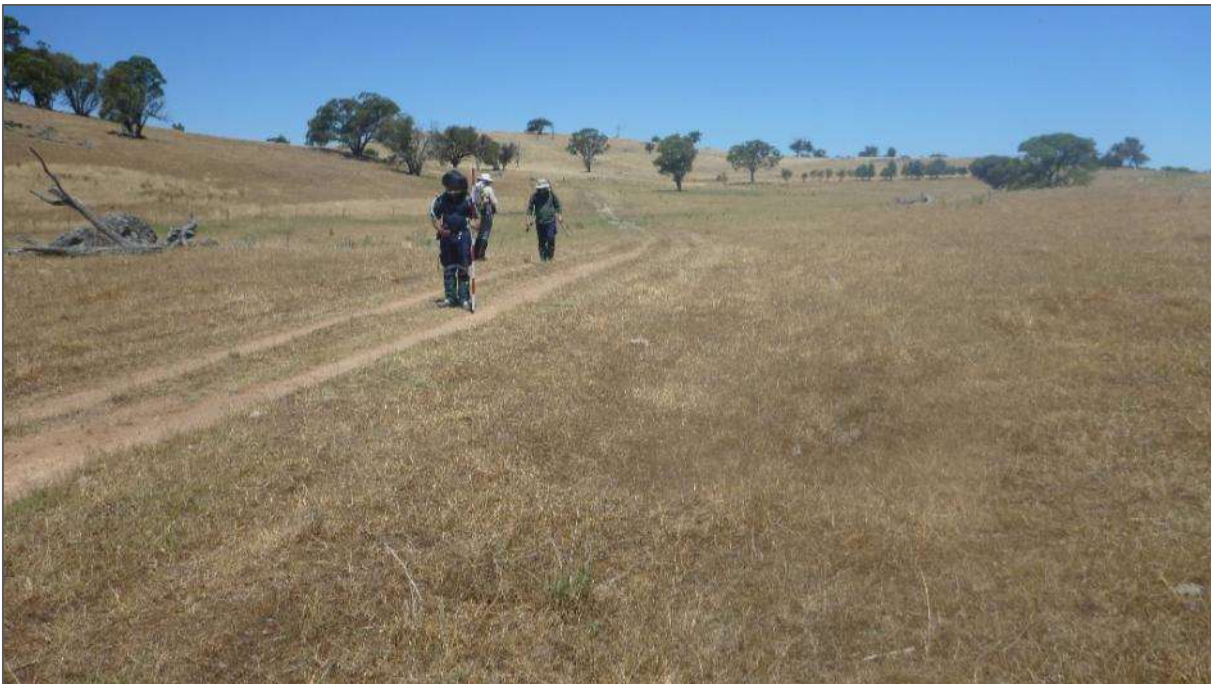
Seventeen stone artefacts were recorded in a highly disturbed area of ground exposure associated with a graded vehicle track and accompanying water diversion ditch within this locale. The landform is an upper slope/open depression interface with gentle gradient and northerly aspect. The artefacts were located in an area of 75 x 3m, within a broader 150 x 50m area possessing 80% ground exposure, of which 80% was archaeological visibility. The effective survey coverage is high, and artefact density is assessed to be low/moderate. The upper section of the soil profile throughout much of this locale has been removed through the construction of the vehicle track and water drainage ditch so that while there may be subsurface artefacts present, these would be situated in a highly disturbed context.

*Bango WF SU31/L1 looking 160°*

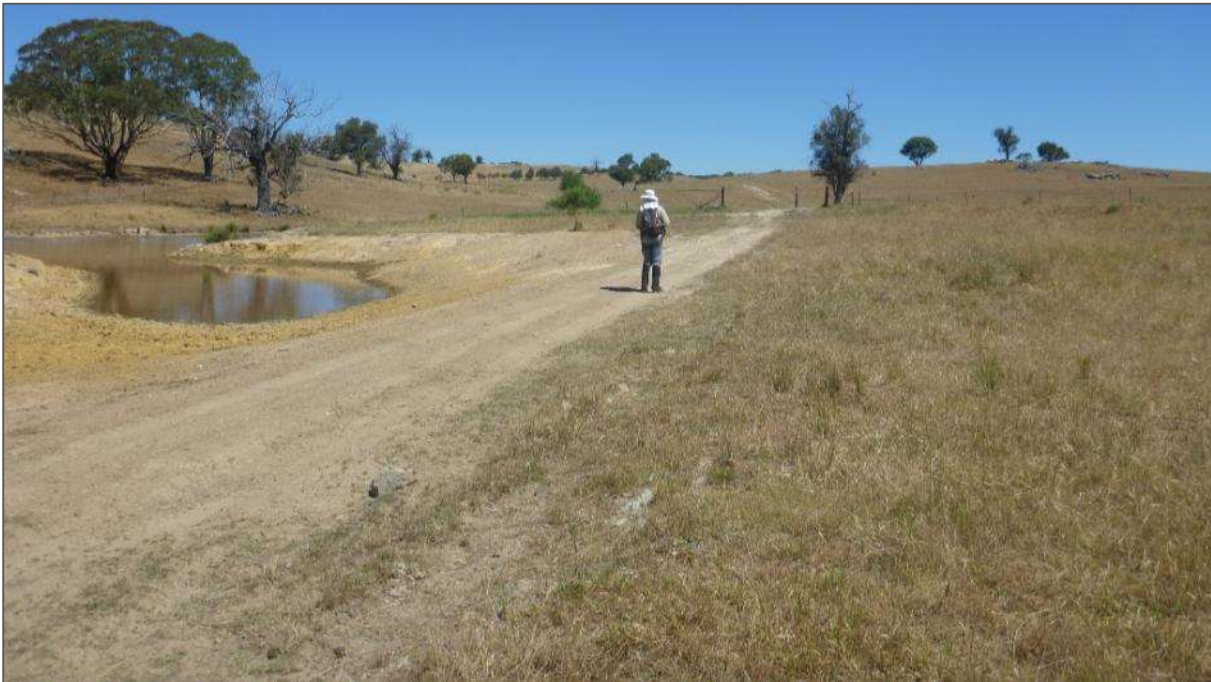
Three stone artefacts were recorded in an area of vehicle track ground exposure at this locale within Survey Unit 31. The landform is a upper slope/open depression interface of very gentle gradient and an aspect to 300°. The artefacts were located in an area measuring 50 x 3m, with 80% ground exposure of which 60% was archaeological visibility. The effective survey coverage is high, and artefact density is assessed to be low/moderate. This locale is highly disturbed due to the construction of a water drainage ditch and the vehicle track, wherein soils have been imported and used as road base. Accordingly, while there may be subsurface artefacts situated within this locale, these would be present in a highly disturbed context.

*Bango WF SU31/L2 looking 150°*

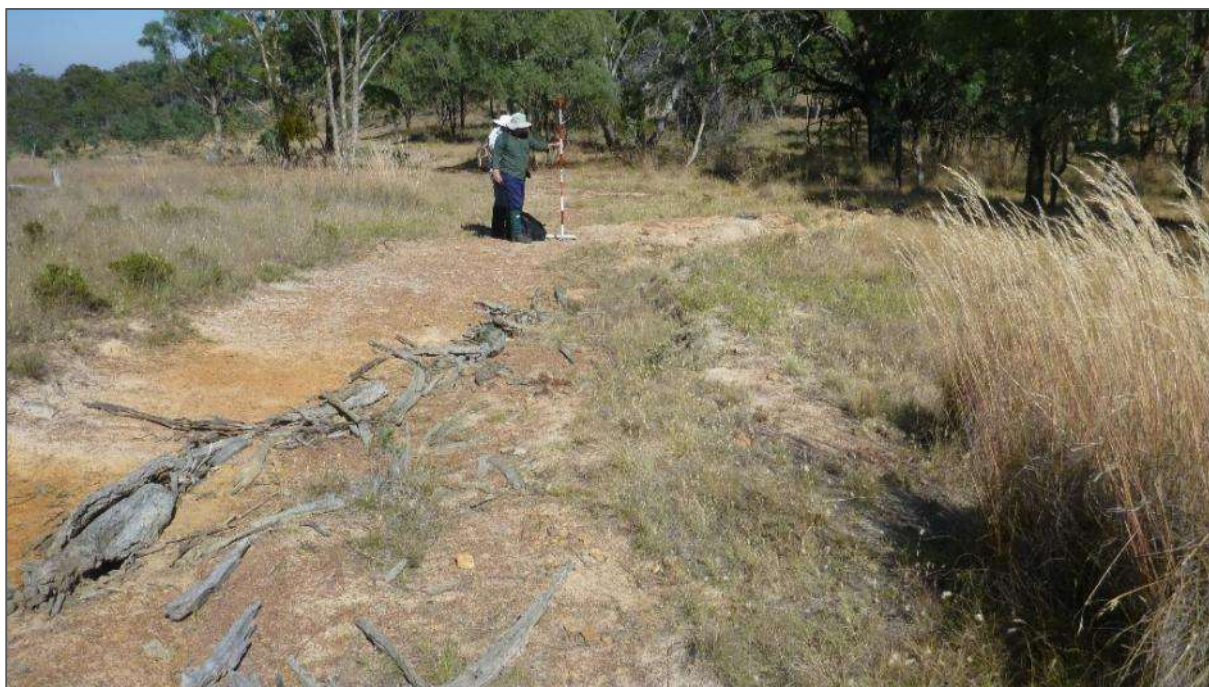
Three stone artefacts, probably derived from the same knapping event, were recorded in a 10 x 3m area of ground exposure associated with an eroded and graded vehicle track in this locale within Survey Unit 33. The landform is a crest of very gentle gradient and an open aspect. The effective survey coverage is high, and given that these were the only artefacts recorded, it is surmised that they were produced as the result of an isolated knapping event. The locale may contain additional artefacts, but these would be present in low density and in a disturbed context due to track grading works.

*Bango WF SU33/L1 looking 270°*

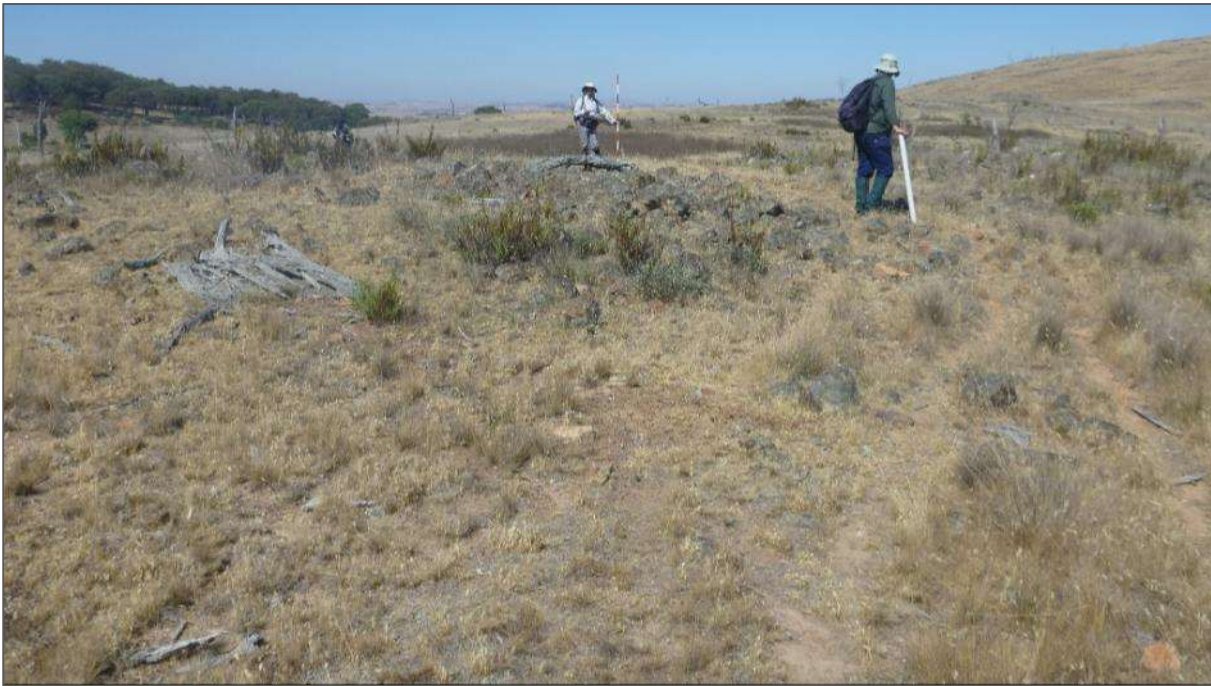
Two stone artefacts (8 m apart) were recorded in an area of bare earth exposure in this locale within Survey Unit 33. The area is a slight rise which is very rocky. The landform is a crest of very gentle gradient and open aspect. The broader area has ground exposure of 30%, of which 60% was archaeological visibility. The effective survey coverage is reasonable, and given that two artefacts only were recorded, artefact density is assessed to be very low. The locale may contain additional artefacts, but these would be present in very low density. Because of the skeletal nature of the lithosol the site has no subsurface potential.

*Bango WF SU33/L2 looking 230°*

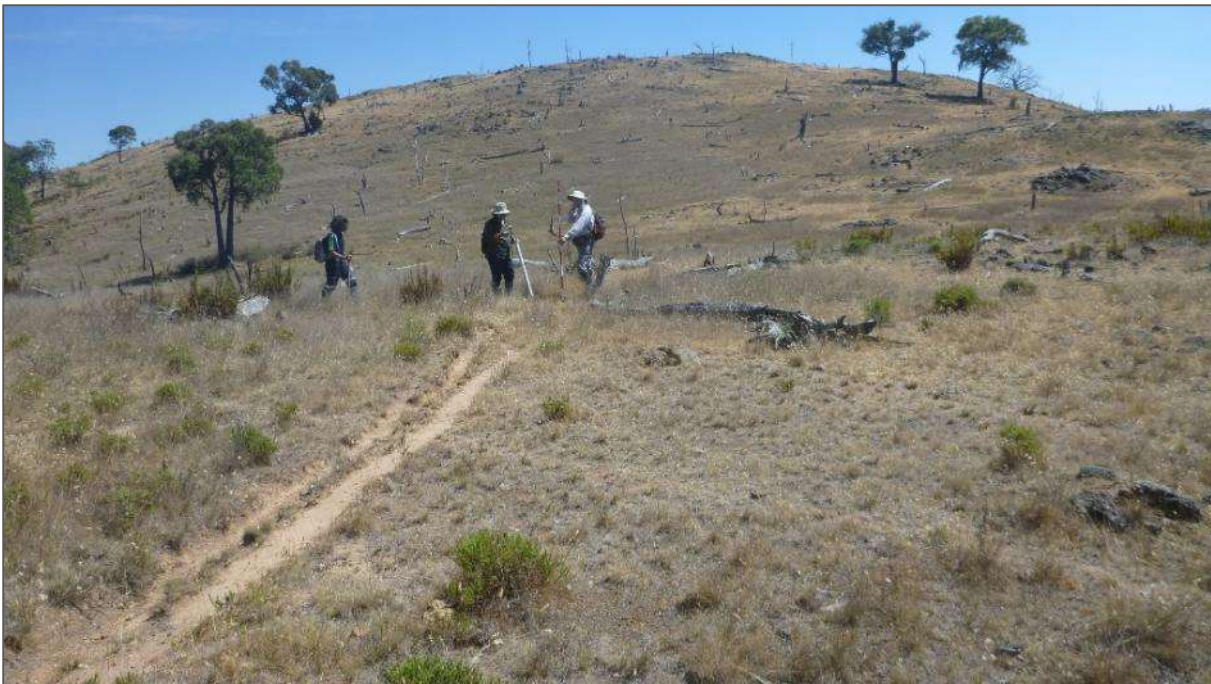
Two stone artefacts (c. 2 m apart) were recorded in an area of bare earth exposure in this locale within Survey Unit 34. The landform is a saddle of gentle gradient and open aspect. The broader saddle area has ground exposure of 10%, of which 90% was archaeological visibility. The effective survey coverage is reasonable, and given that two artefacts only were recorded, artefact density is assessed to be very low. The locale may contain additional artefacts, but these would be present in very low density. Because of the skeletal nature of the lithosol the site has limited subsurface potential.

*Bango WF SU34/L1 looking 0°*

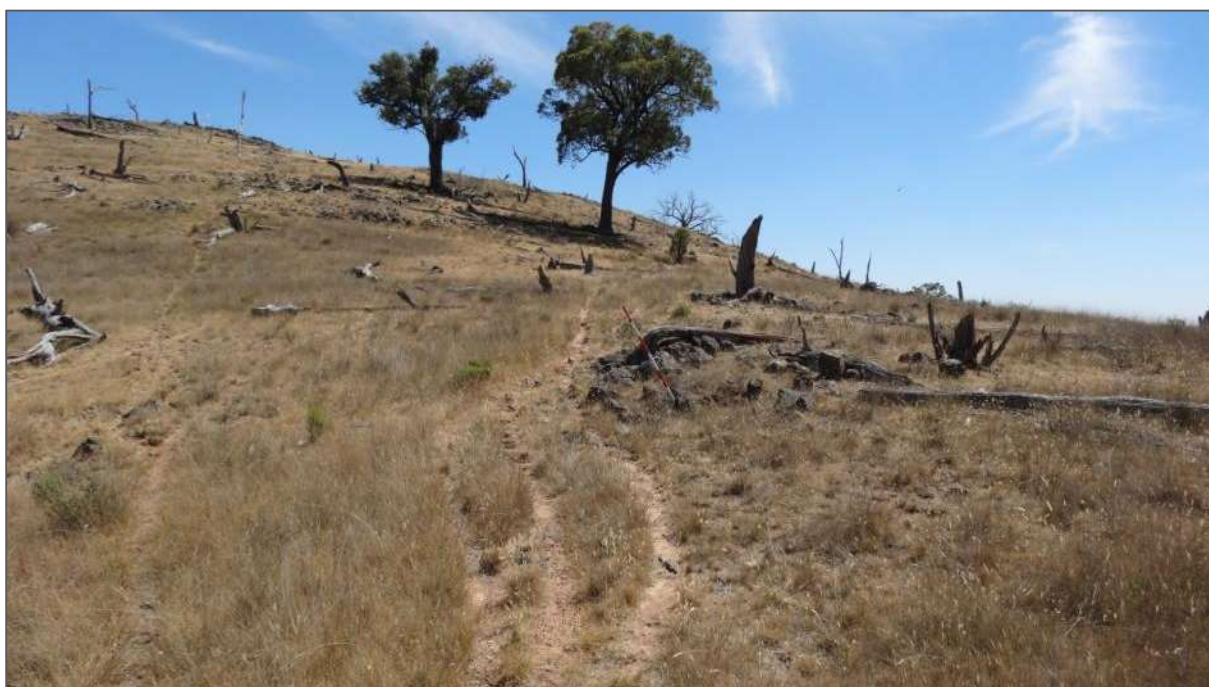
One stone artefact was recorded in an area of bare earth exposure in this locale within Survey Unit 34. The landform is a crest of gentle gradient and an aspect to 150°. The broader crest area has ground exposure of 10%, of which 60% was archaeological visibility. The effective survey coverage is reasonable, and given that one artefact only was recorded, artefact density is assessed to be very low. The locale may contain additional artefacts, but these would be present in very low density. Because of the skeletal nature of the lithosol the site has no subsurface potential.

*Bango WF SU34/L2 looking 0°*

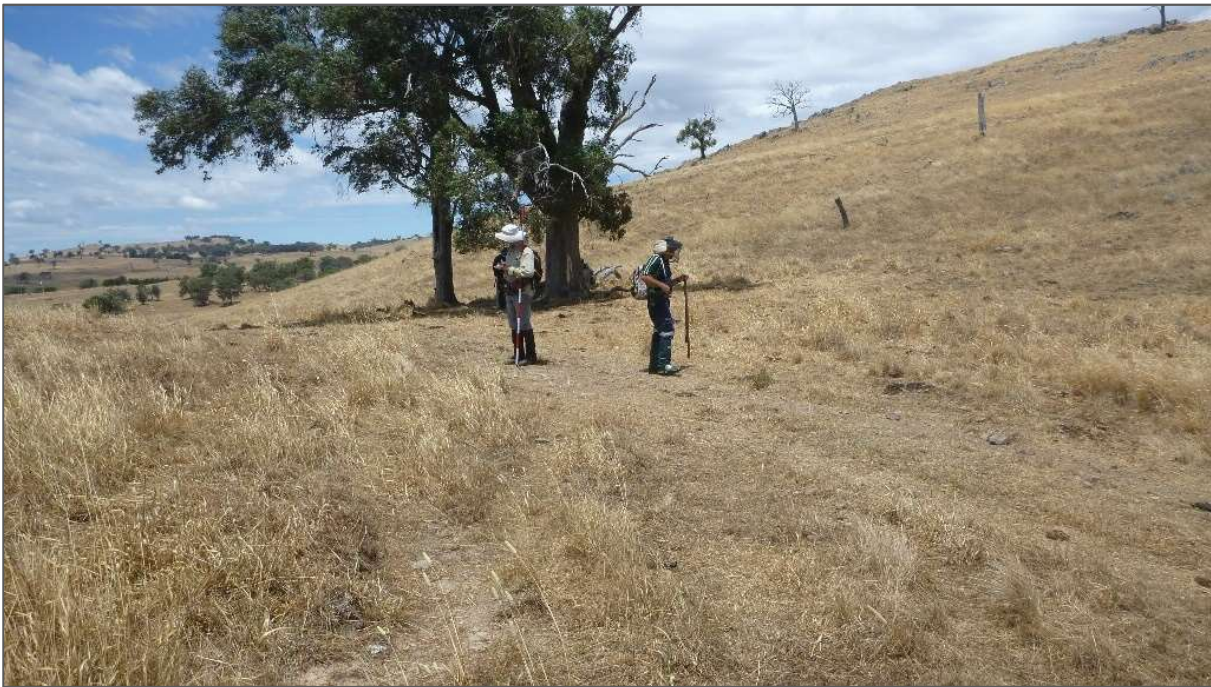
Two stone artefacts were recorded in an area of bare earth exposure in this locale within Survey Unit 40. The landform is a saddle on a crest of gentle gradient. The broader area has ground exposure of 5%, of which 90% was archaeological visibility. The effective survey coverage is reasonable, and given that two artefacts only were recorded, artefact density is assessed to be very low. The locale may contain additional artefacts but these would be present in very low density. Because of the eroded and skeletal nature of the lithosol the site has no subsurface potential.

*Bango WF SU40/L1 looking 150°*

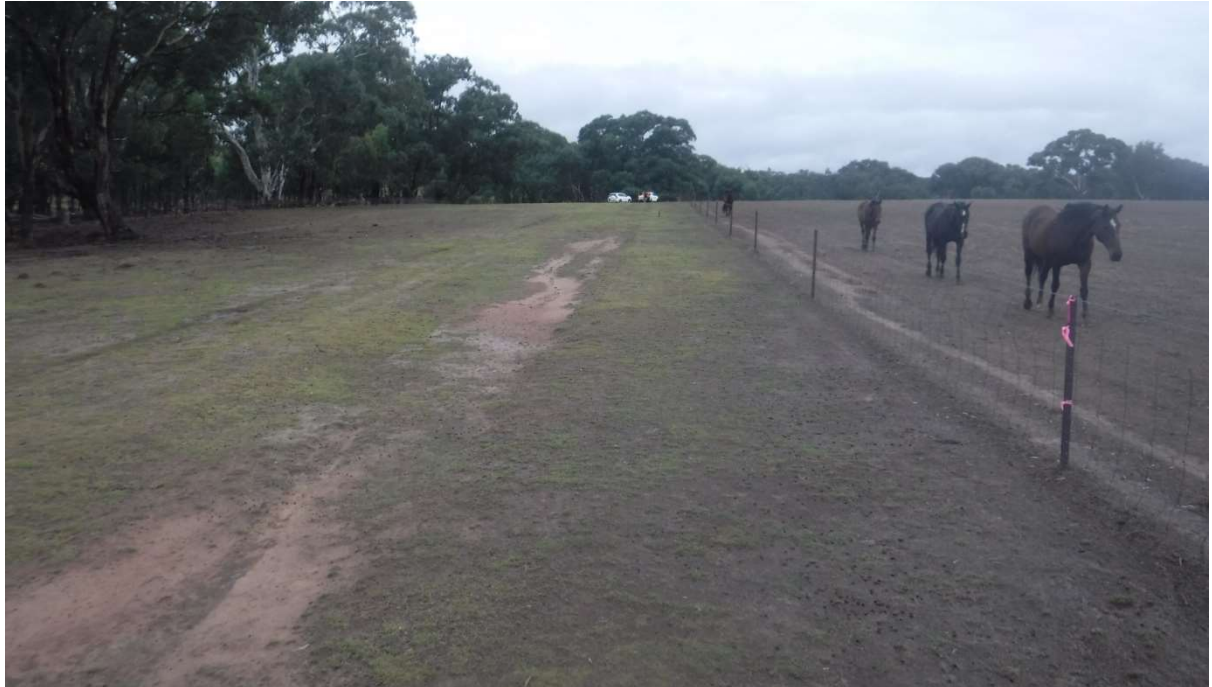
Aboriginal object locale SU16/L1 (Plate 1) is situated immediately adjacent and to the north of an existing farm fence line. In order to avoid this site it was determined that impacts in this area, which entails the construction of an access track, should be relocated to the southern side of the fence, away from the nearby creek, and into a heavily worked paddock (Plate 2).

Plate 1. SU16/L1 looking east.

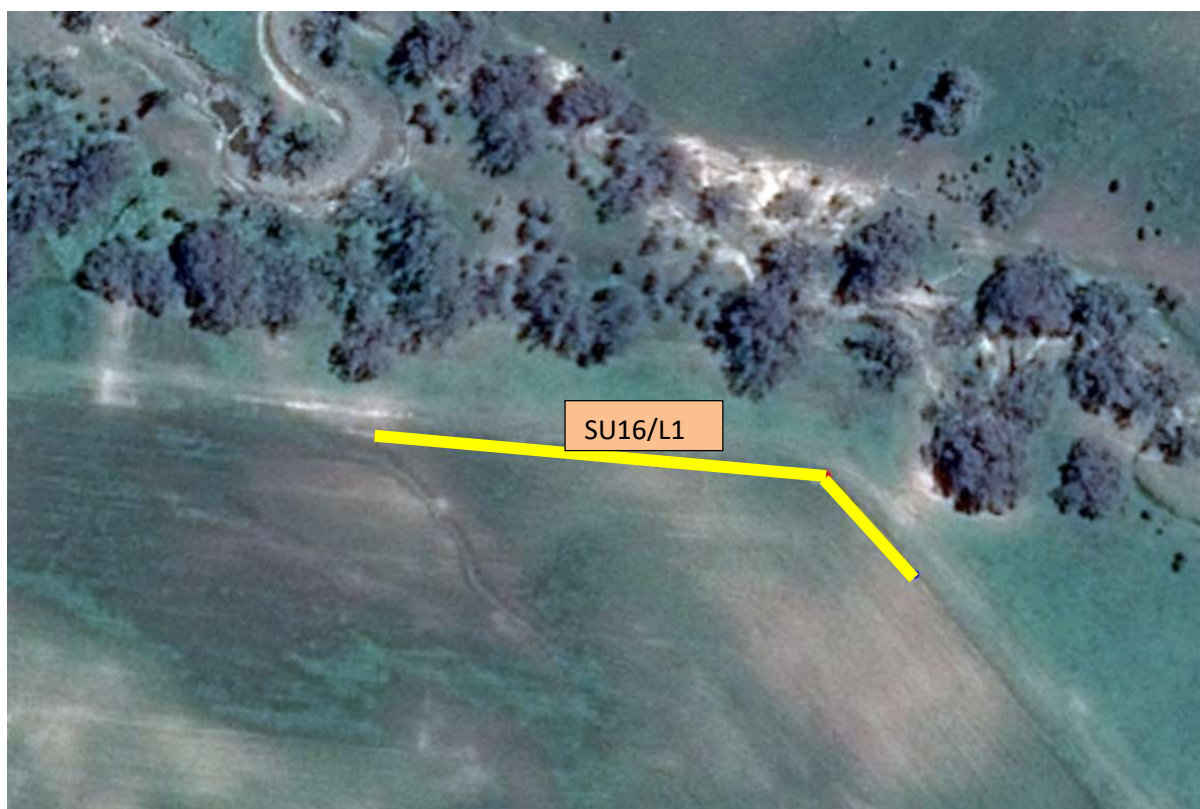
Plate 2. Yellow line showing the fence line adjacent to SU16/L1, any impacts should be relocated to the south of this fence.

Locale	Proposed Impact	New Location	Grid Points
SU16/L1	Access track	To the south of the existing adjacent paddock fence	To the south of the line formed by: 660655e.6175630n; 660634e.6175655n; 660523e.6175667n.
SU31/L1 & SU31/L2	Access track	To the west of the existing water diversion mounds	To the west of the line formed by: 671816e.6170295n; 671820e.6170072n; 671854e.6169967n; 671877e.6169872n; 671949e.6169796n;

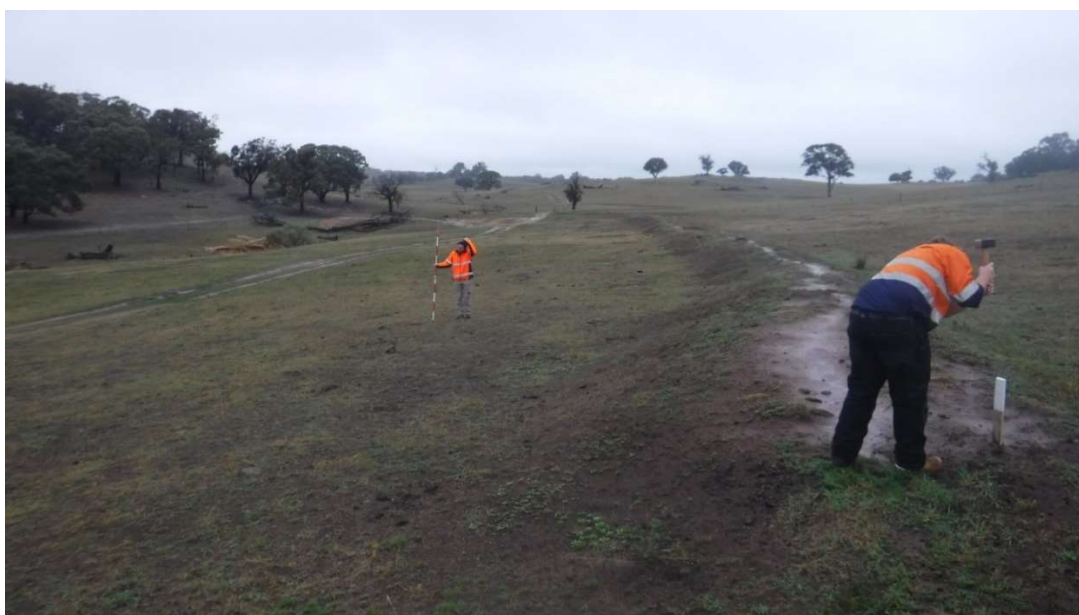
Aboriginal object locales SU31/L1 and SU31/L2 (Plate 3) are situated to the west of a south to north running drainage line. The locales area reasonably closely sited, and the proposed impact for both is the construction of an access track. It was determined in the field that the most expedient way to avoid both locales was to construct the track to the west of existing water diversion mounds (Plate 4), in areas which had already been impacted through the construction of those mounds.

Plate 3. SU31/L1 looking southeast.

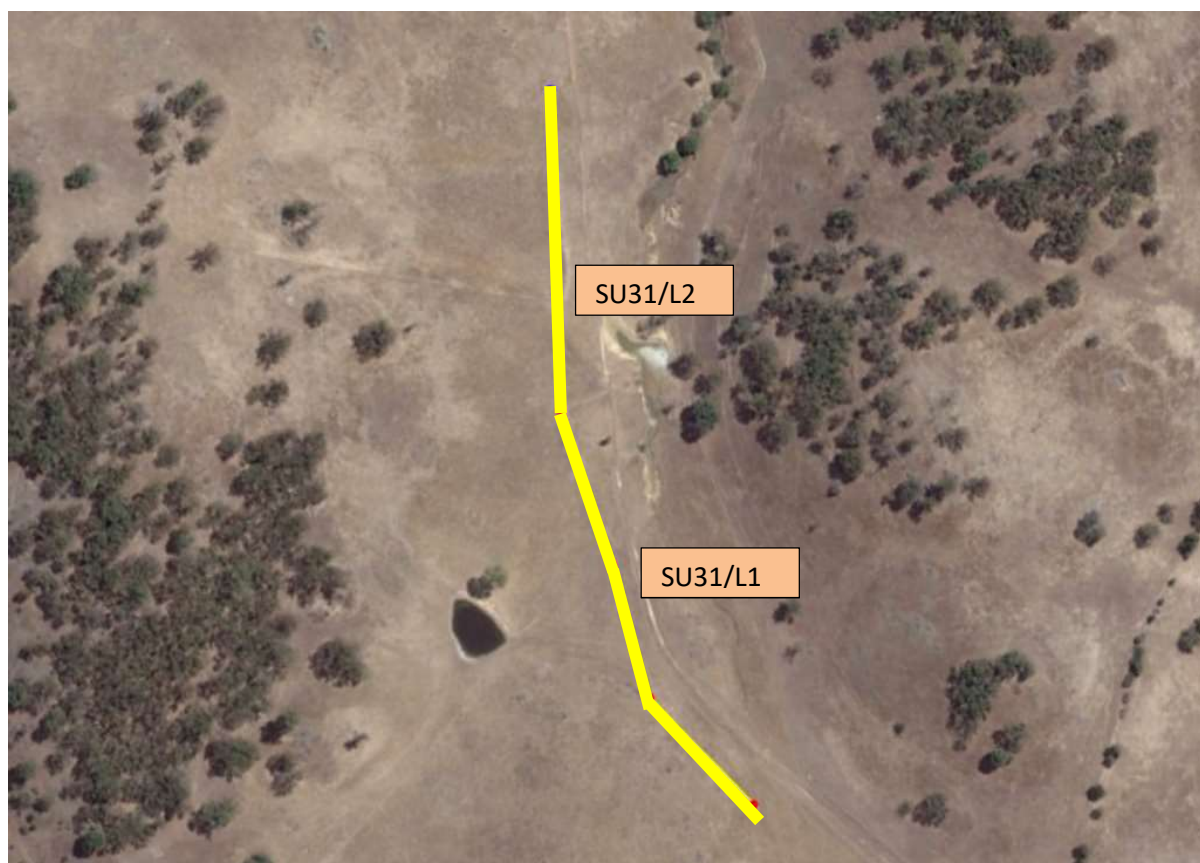
Plate 4. SU31/L1 and SU31/L2 with the yellow line delineating the position where water diversion mounds are situated. Any impacts should be relocated to the west of this mark.
