Biodiversity Management Plan

CLARKE CREEK WIND FARM

SEPTEMBER 2021

Project Title: Clarke Creek Wind Farm - Biodiversity Management Plan

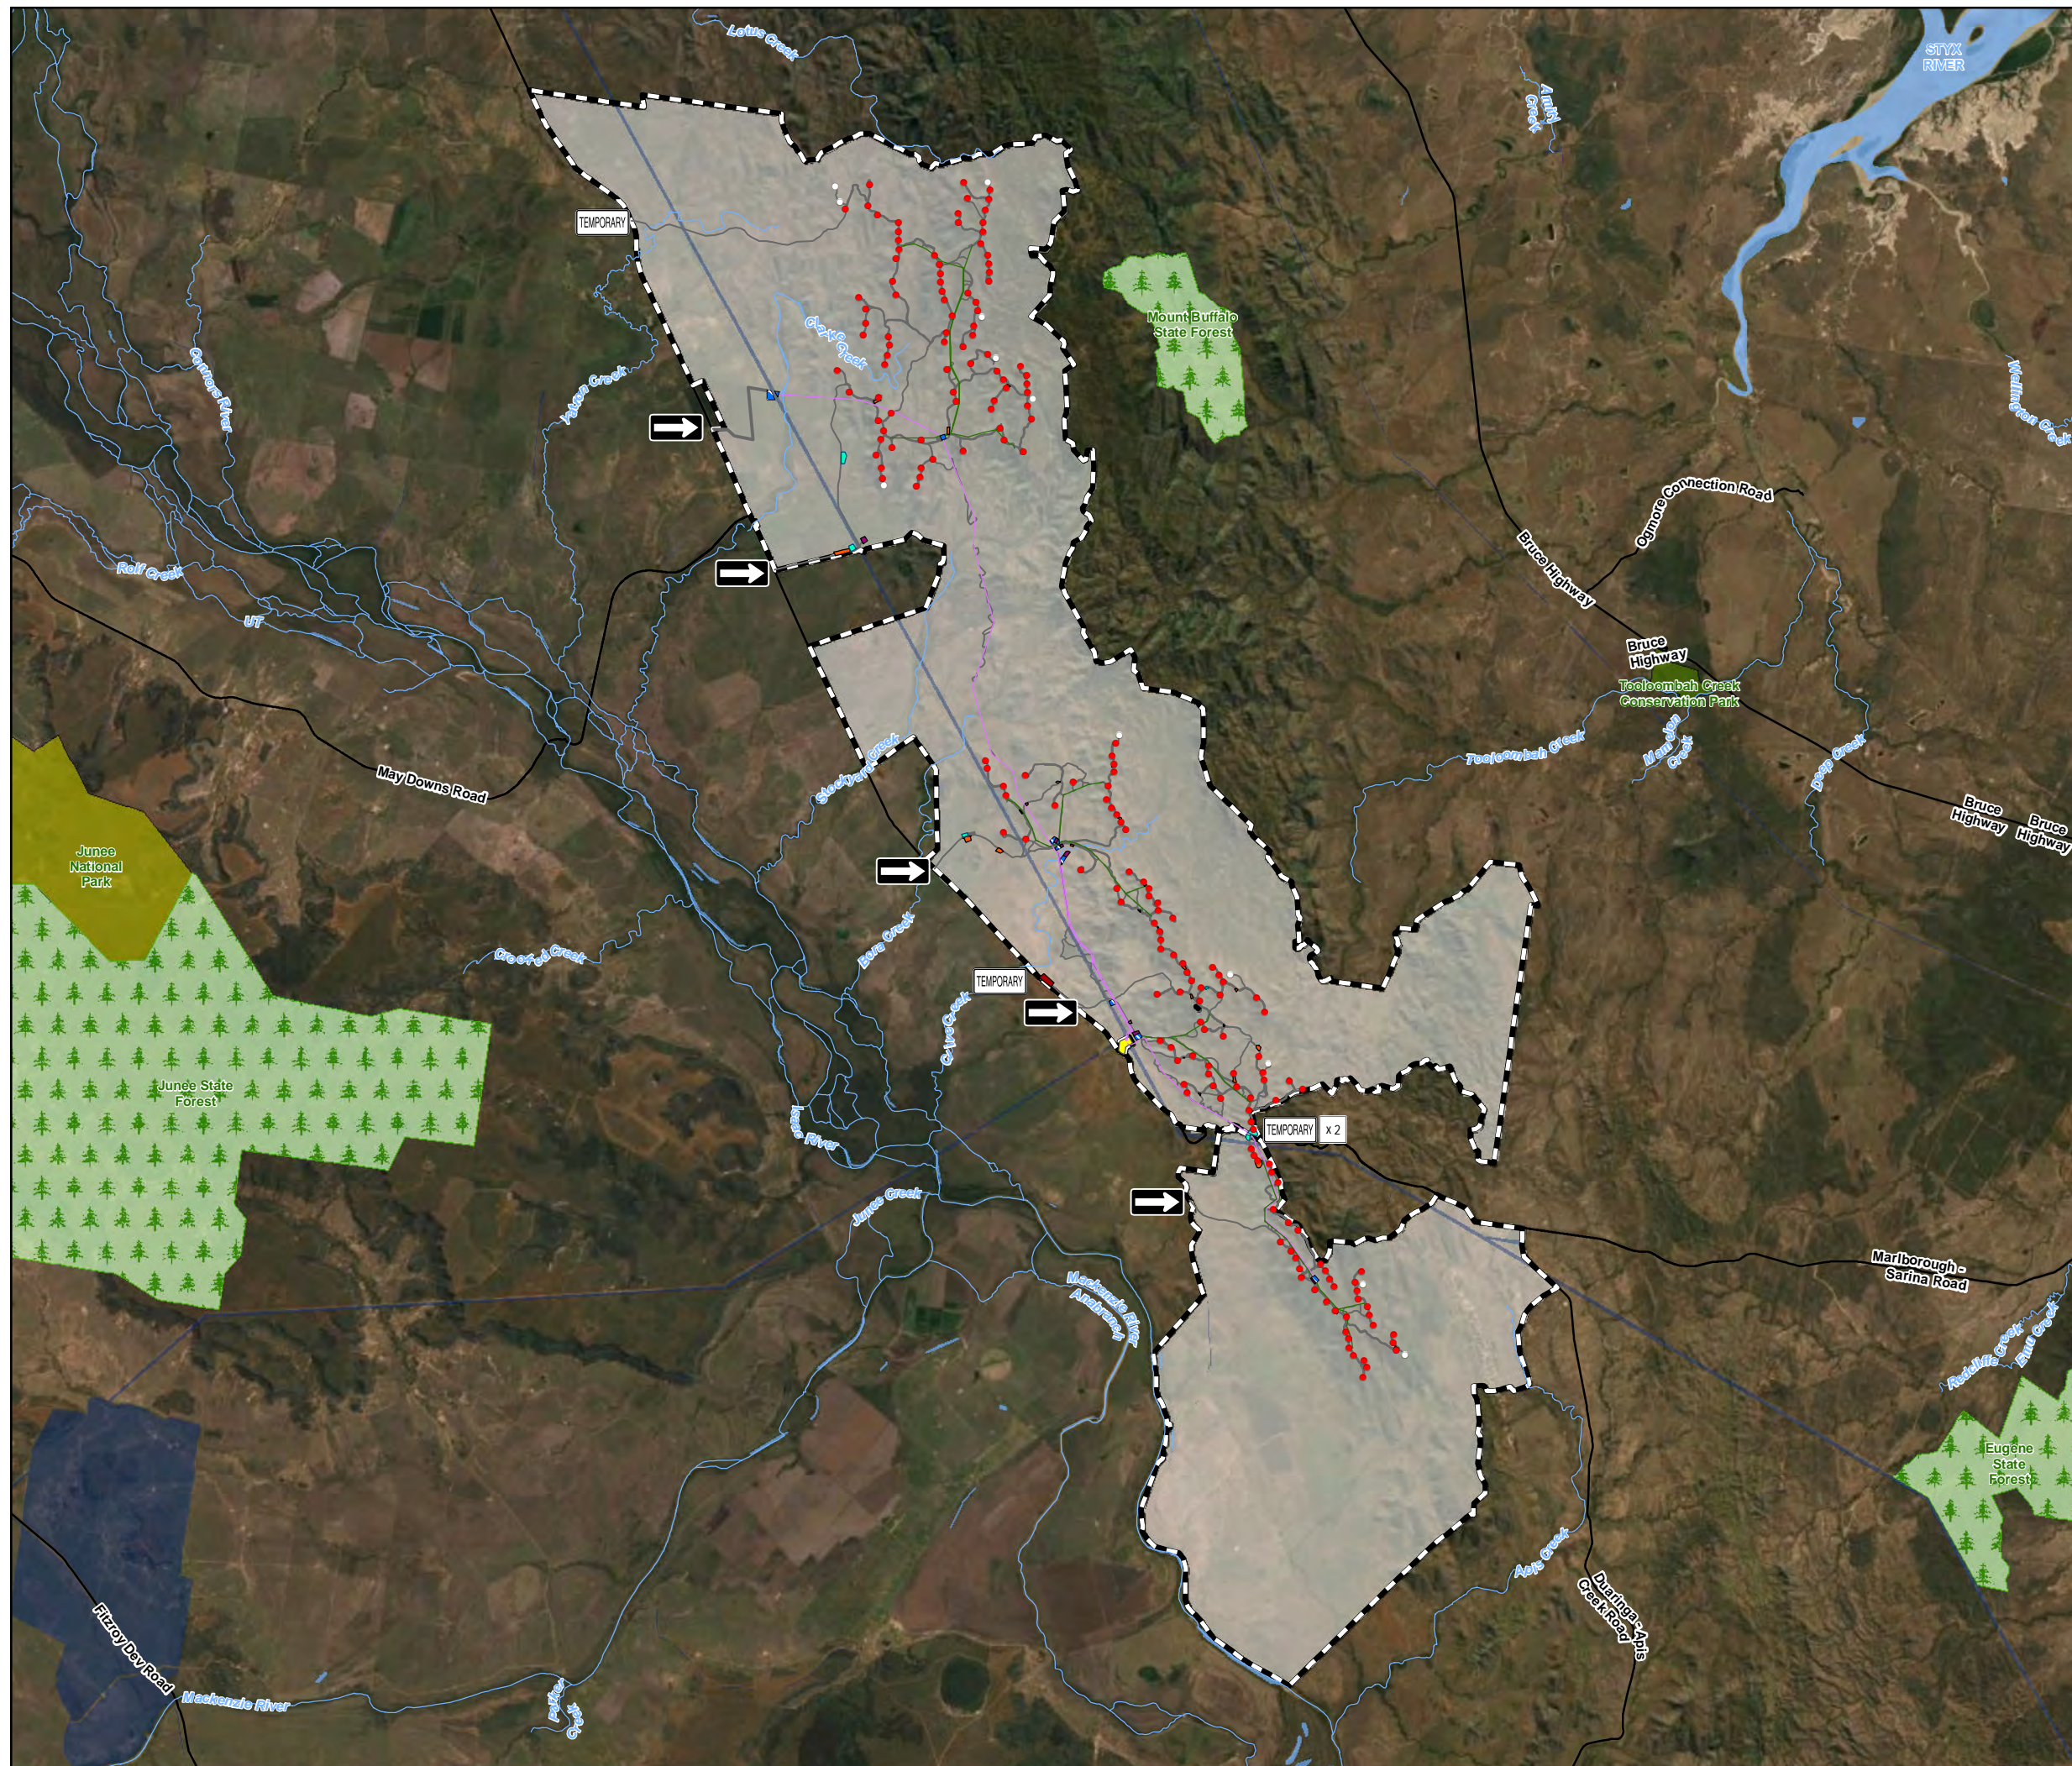
**Figure 1-1
 Map 1 of 3**

- Temporary Site Entrance Locations
 - Permanent Site Entrance Locations
 - Wind Turbines
 - Permanent Wind Monitoring Tower
 - Watercourse
 - State Controlled Roads
 - Medium Voltage Powerline
 - High Voltage Powerline
 - Substations / Battery Energy Storage System
 - Existing Broadband Substation Location
 - Temporary Construction Compounds
 - Temporary Laydown Area and Stockpiles
 - Site Offices and Workshops
 - Temporary Accommodation Camp
 - Roads and Hardstanding Footprint
 - Powerlink Easement
 - Project Area
- Protected Areas (by Estate Type)**
- National Park
 - Conservation Park
 - State Forest

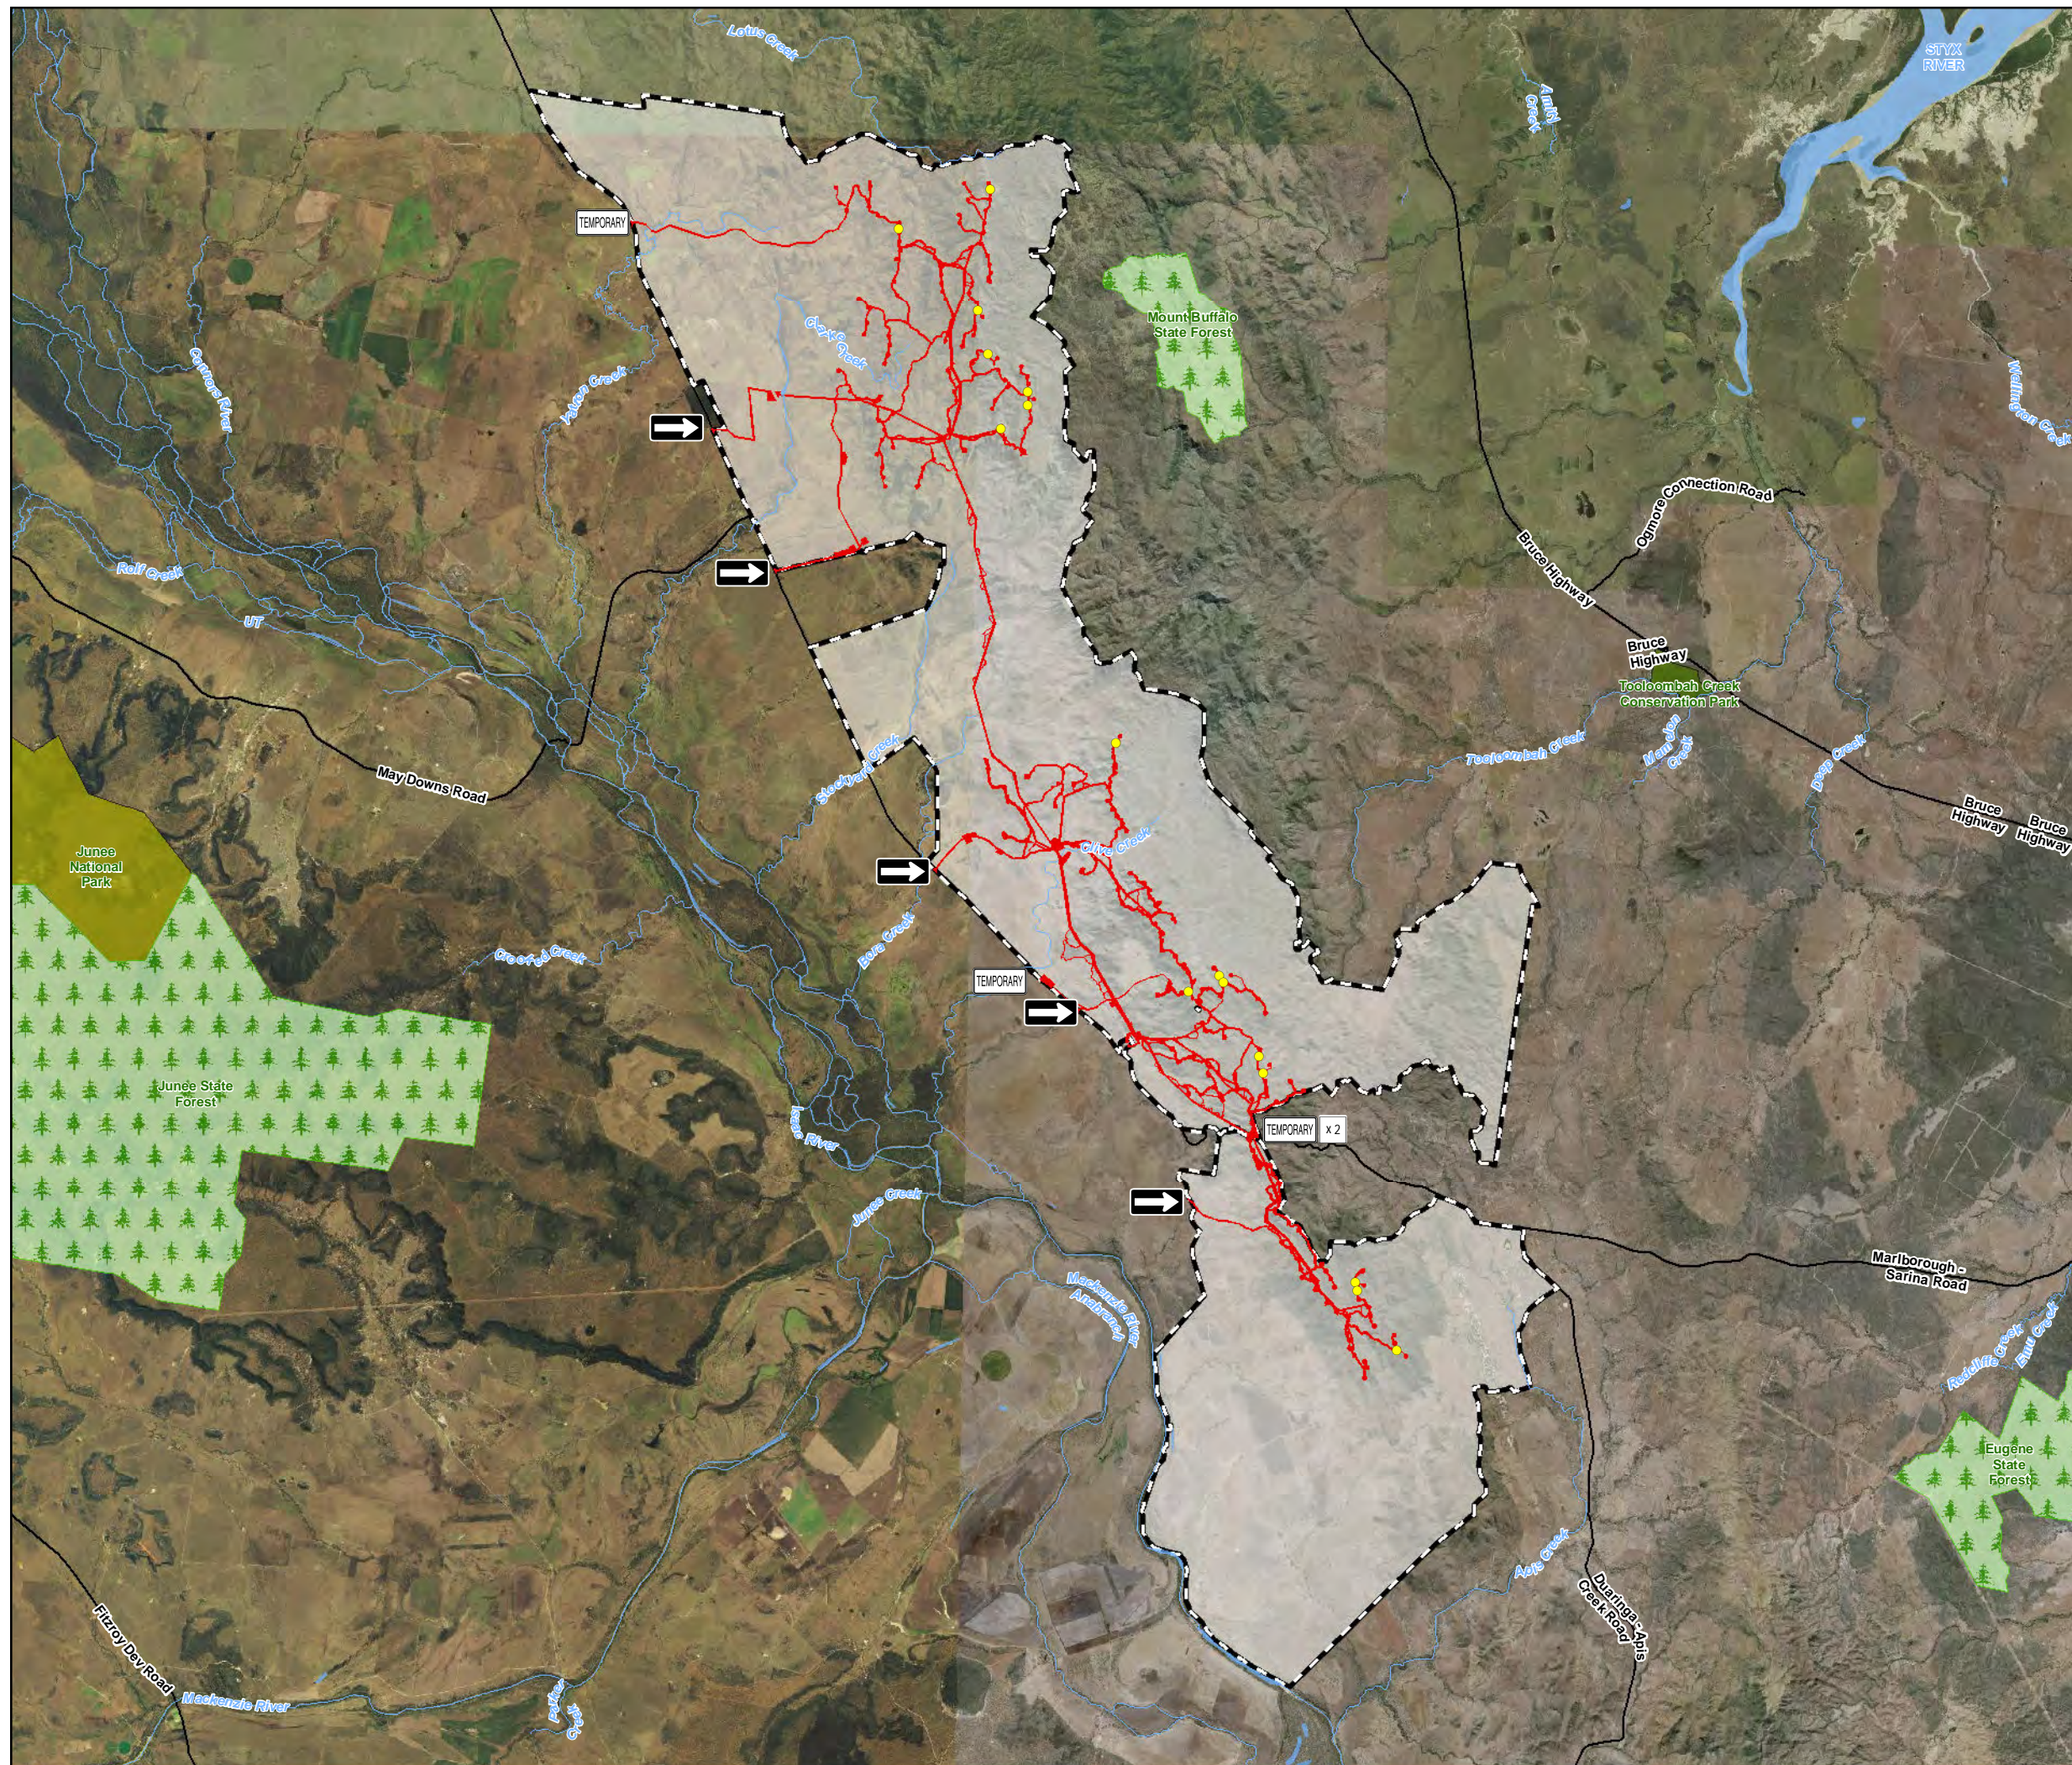
**Figure 1-1
Map 2 of 3**

- Legend**
- Temporary Wind Monitoring Towers (Indicative locations within footprint corridor)
 - Watercourse
 - State Controlled Roads
 - Footprint Corridor
 - Project Area
- Protected Areas (by Estate Type)**
- National Park
 - Conservation Park
 - State Forest

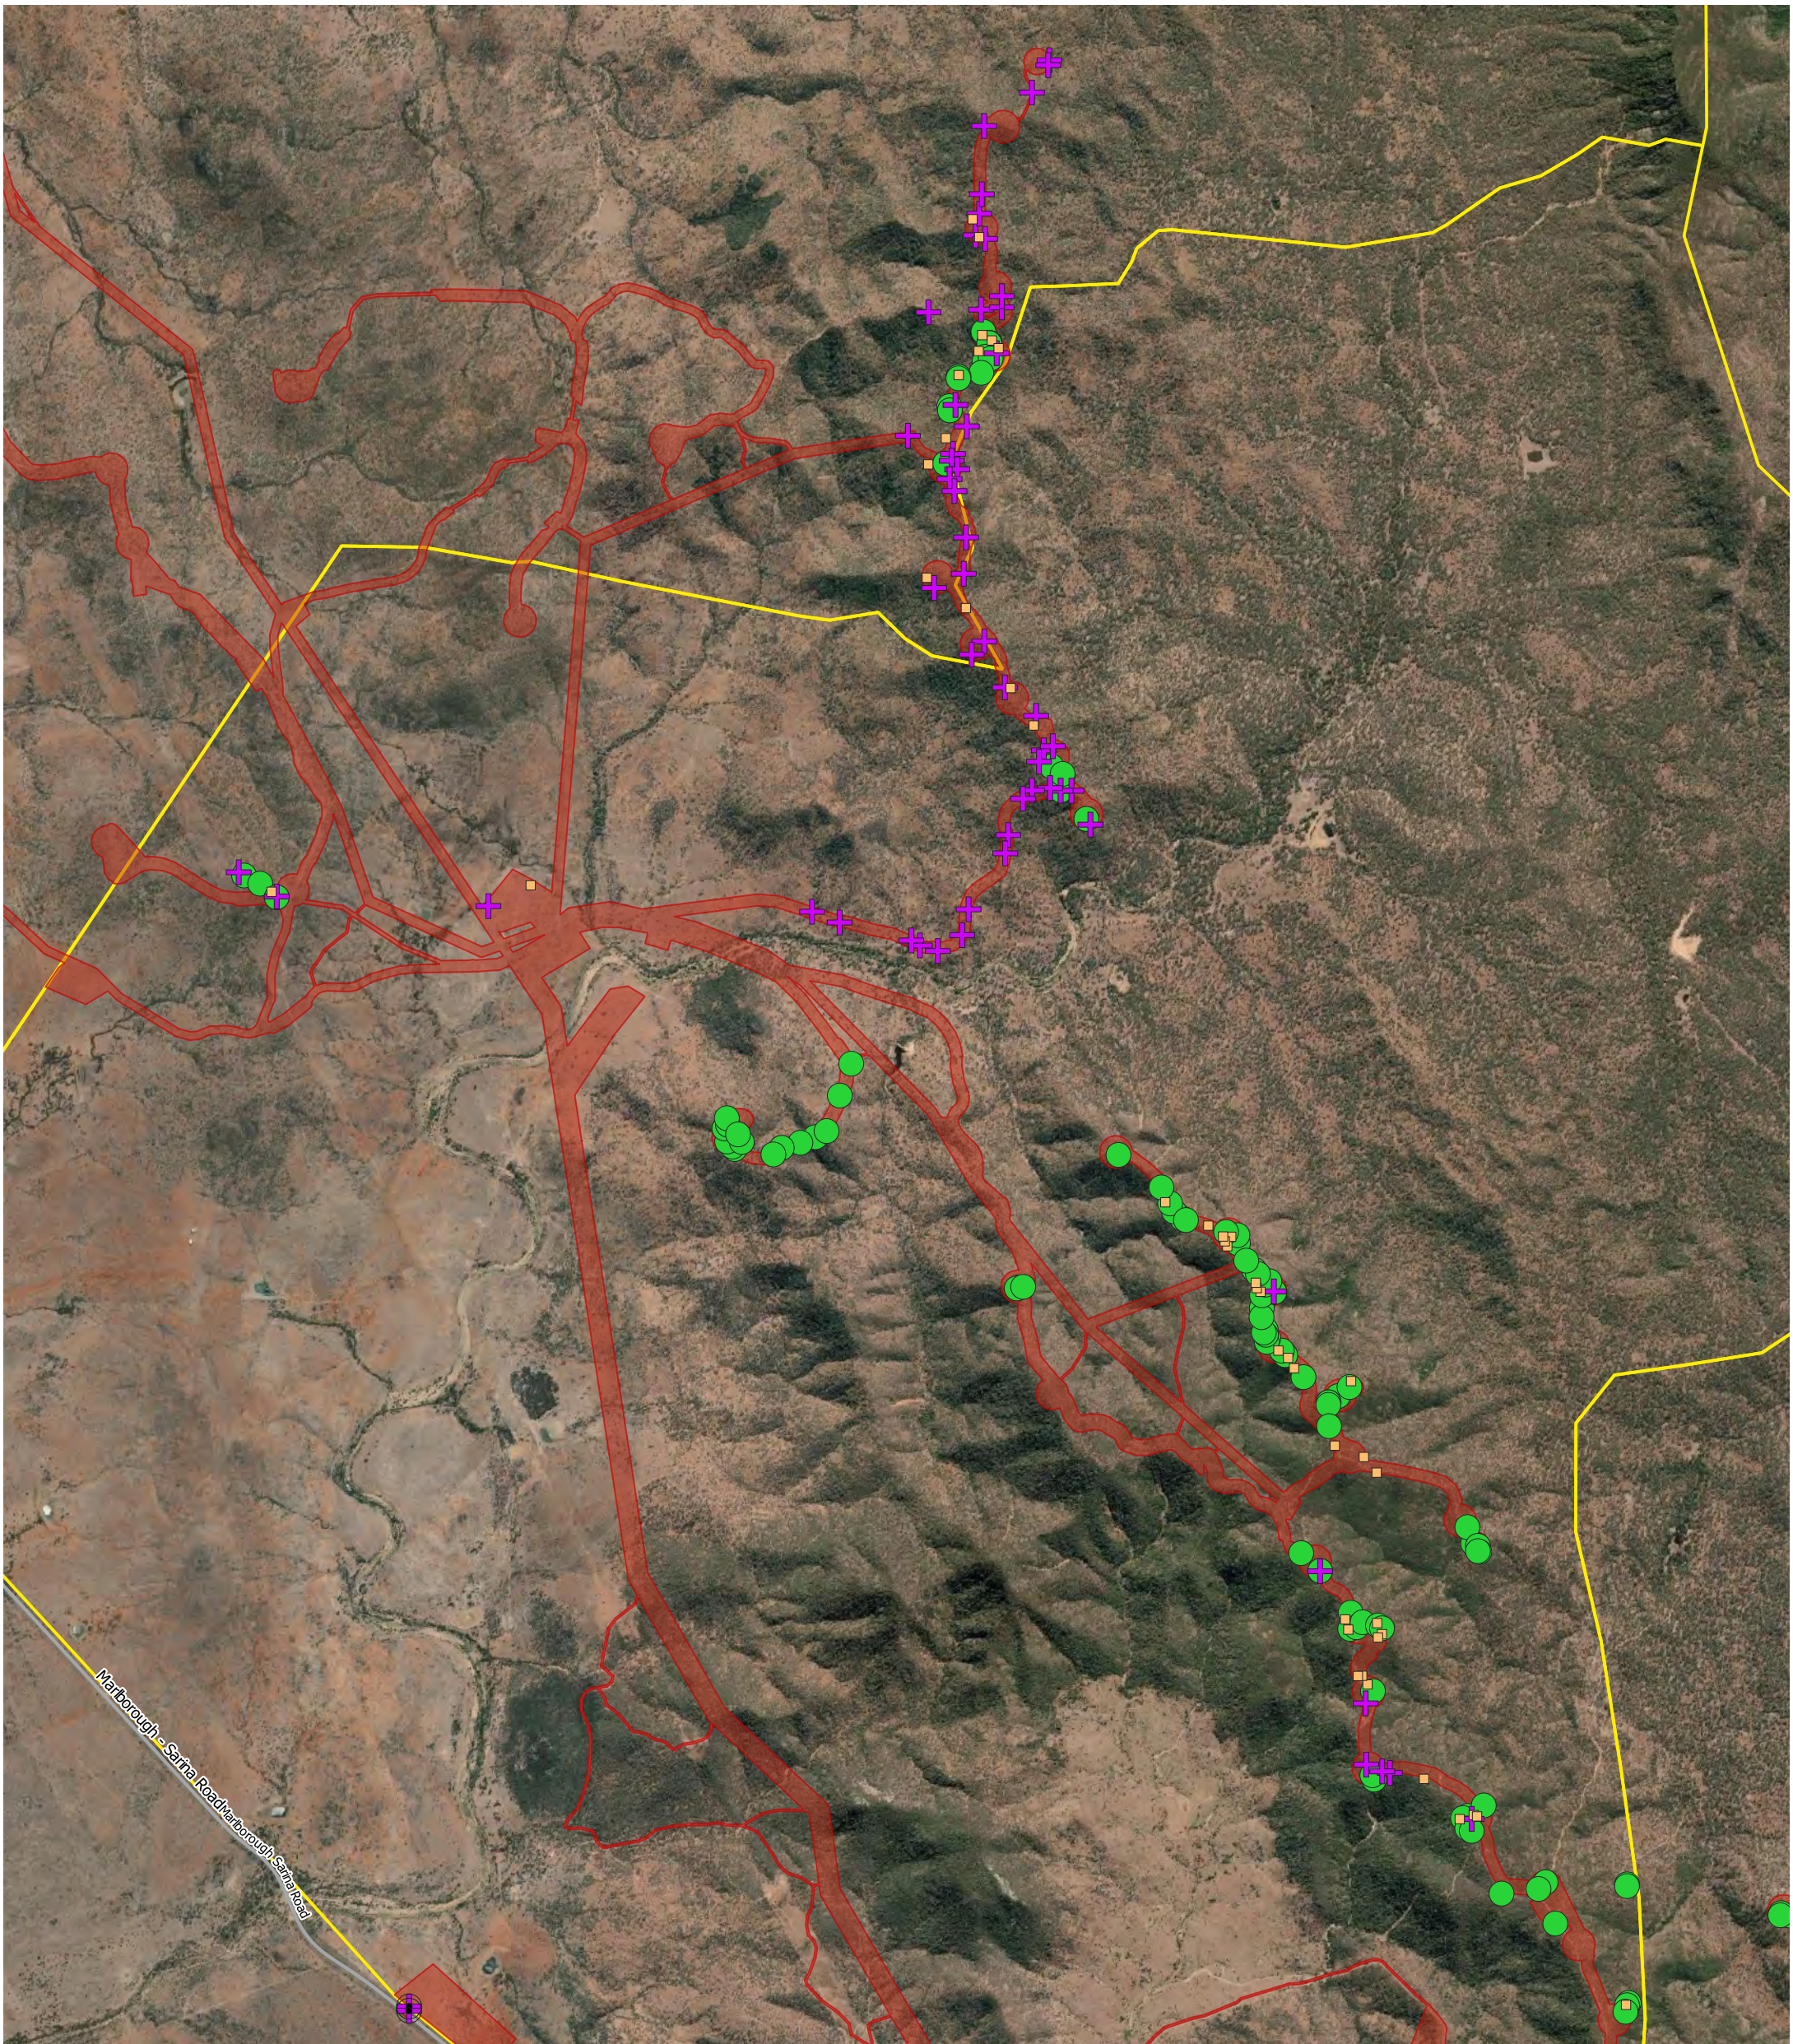
Figure 3-1 Identified potential animal breeding places
Map 1 of 4

- Legend**
- Disturbance footprint
 - Property Boundaries
- Identified potential breeding places**
- Hollow bearing trees
 - Rock piles
 - Other habitat features
 - Bird nests

Type	Number of individuals	Potential for use by (Least Concern as well as threatened)
Hollow bearing tree	474	Gliding mammals; birds; possums; reptiles; microbats
Nests	7	Birds
Rockpiles	403	Reptiles, mammals
Other habitat features (including dense vegetation, boulder fields, termite mounds, riparian vegetation, log piles, hollow logs)	136	Reptiles; mammals; amphibians
Dams	1	Reptiles, including turtles; fish; amphibians
Burrow	1	Echidna; pests, including rabbit, fox
Cracking clay	Area	Reptiles (i.e., Ornamental Snake).

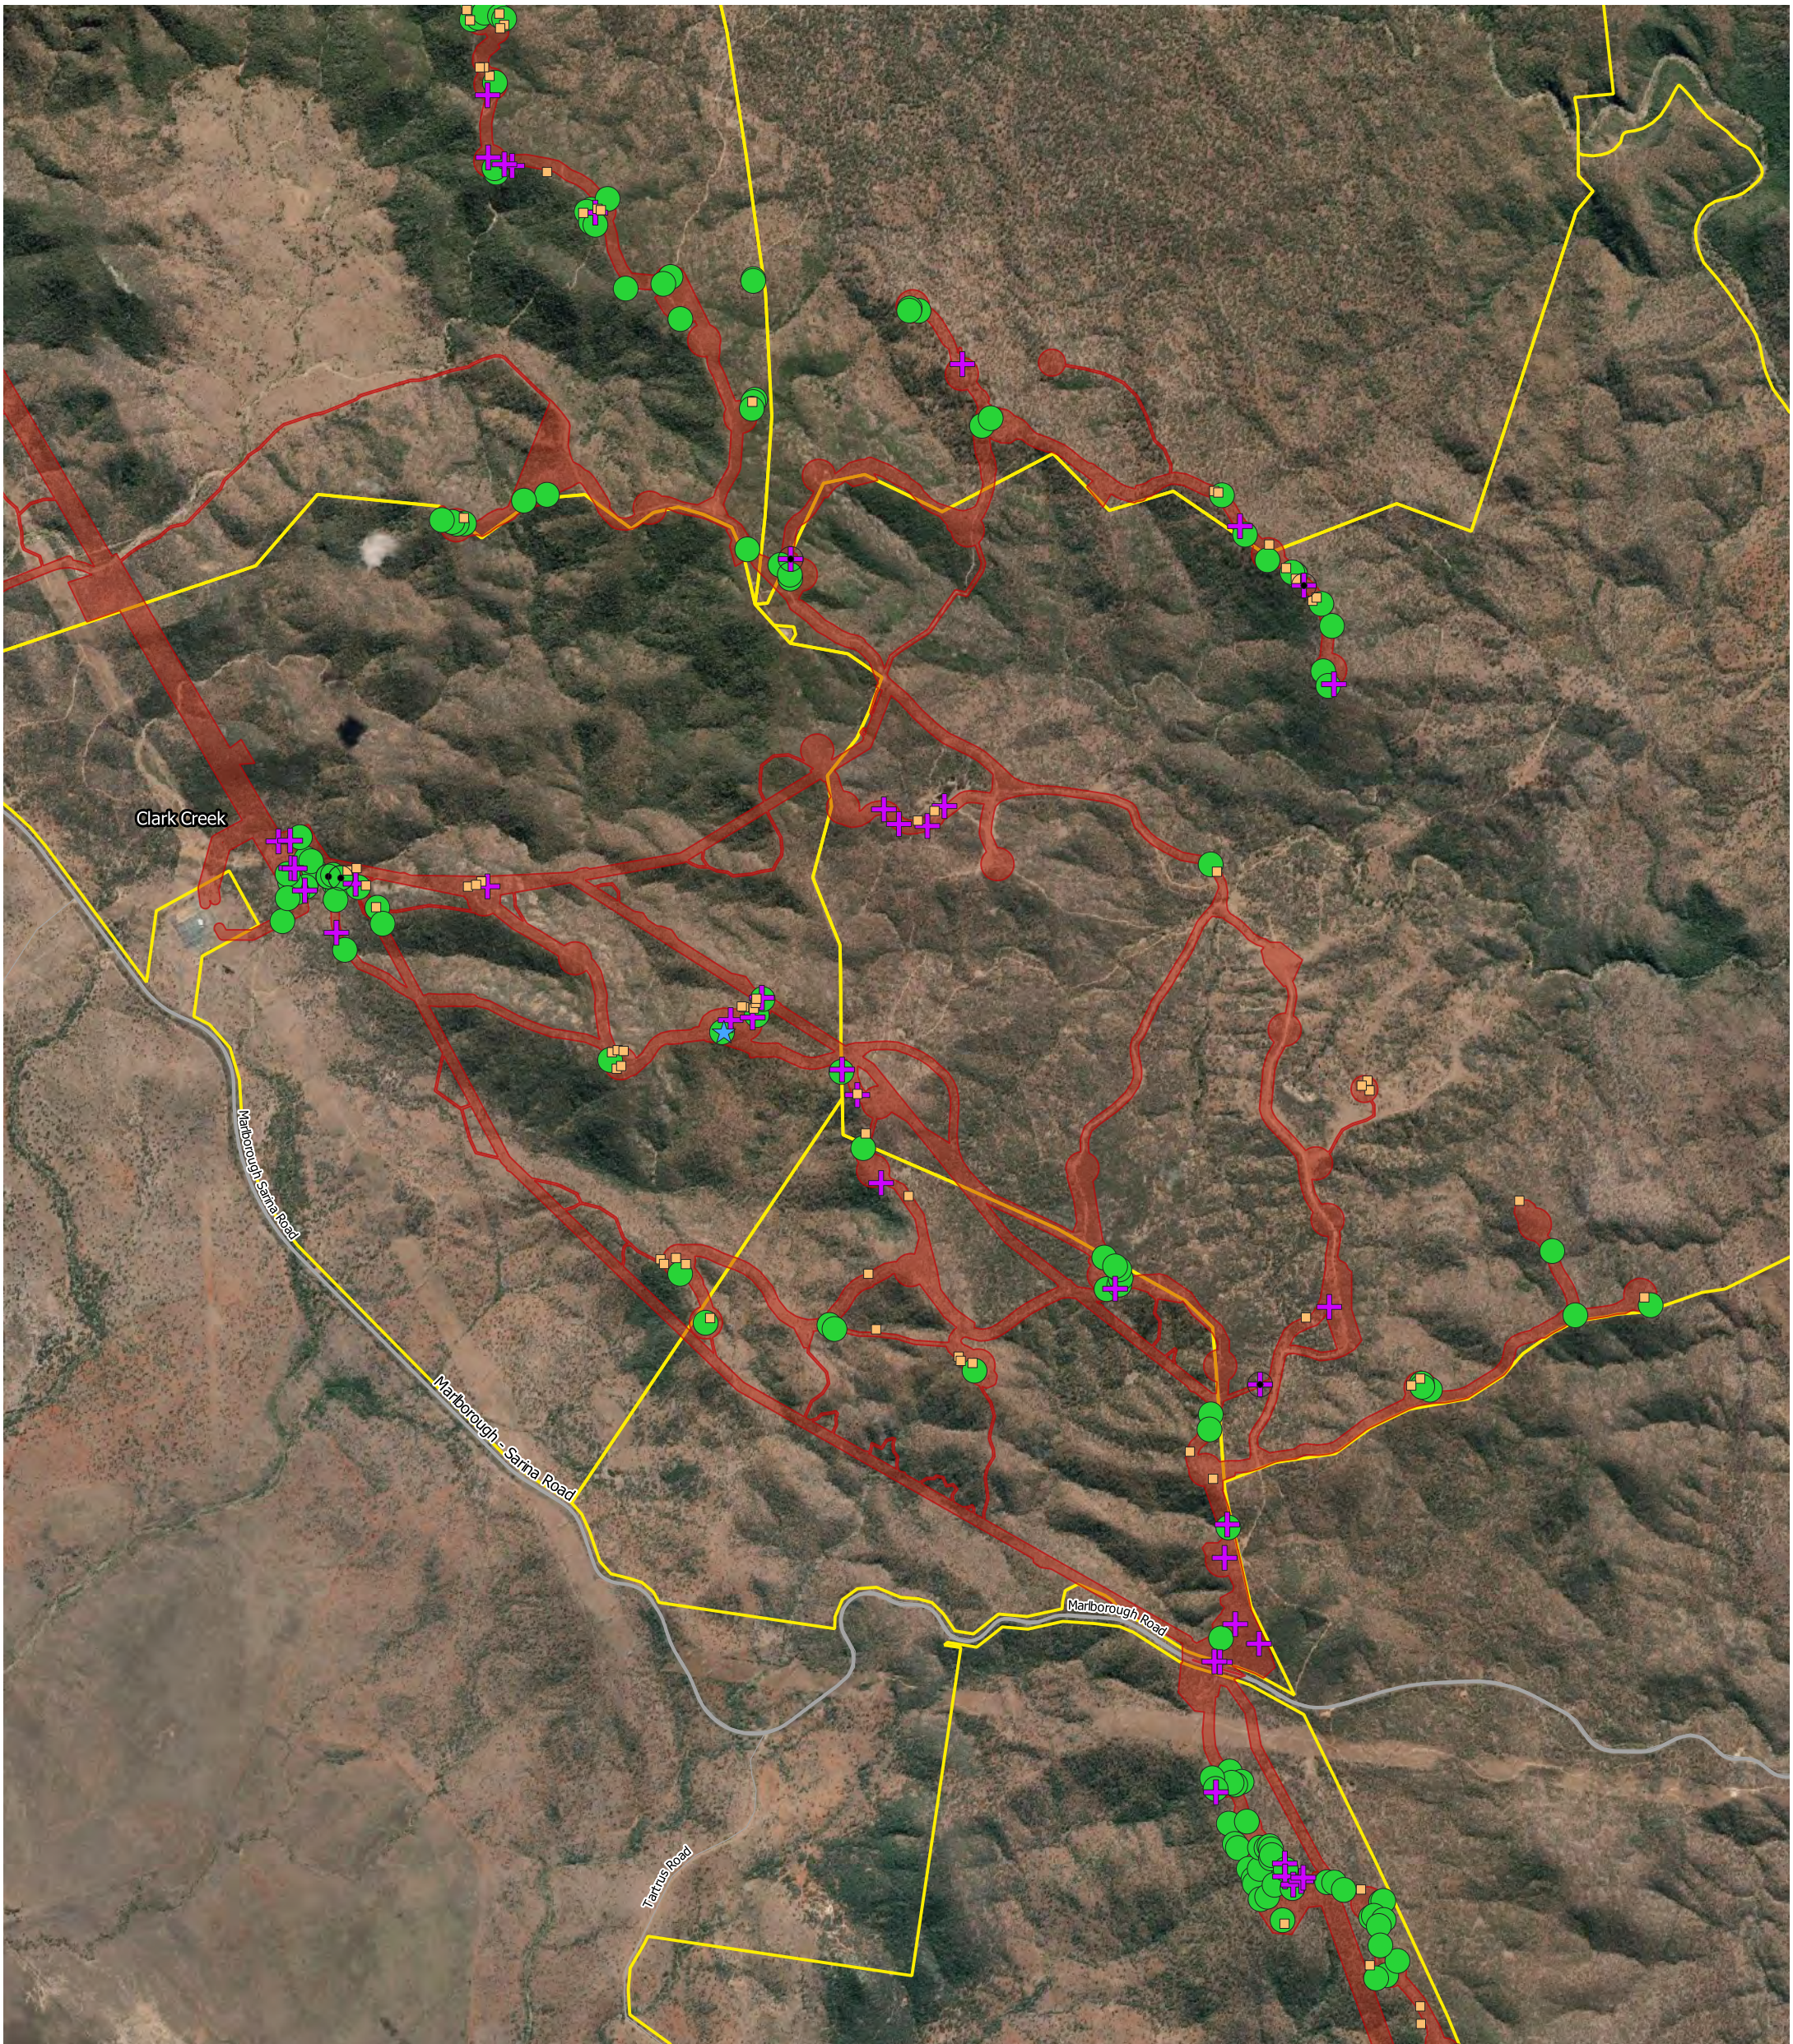
Figure 3-1 Identified potential animal breeding places
Map 2 of 4

- Legend**
- Disturbance footprint
 - Property Boundaries
- Identified potential breeding places**
- Hollow bearing trees
 - Rock piles
 - Burrow
 - Other habitat features
 - Bird nests

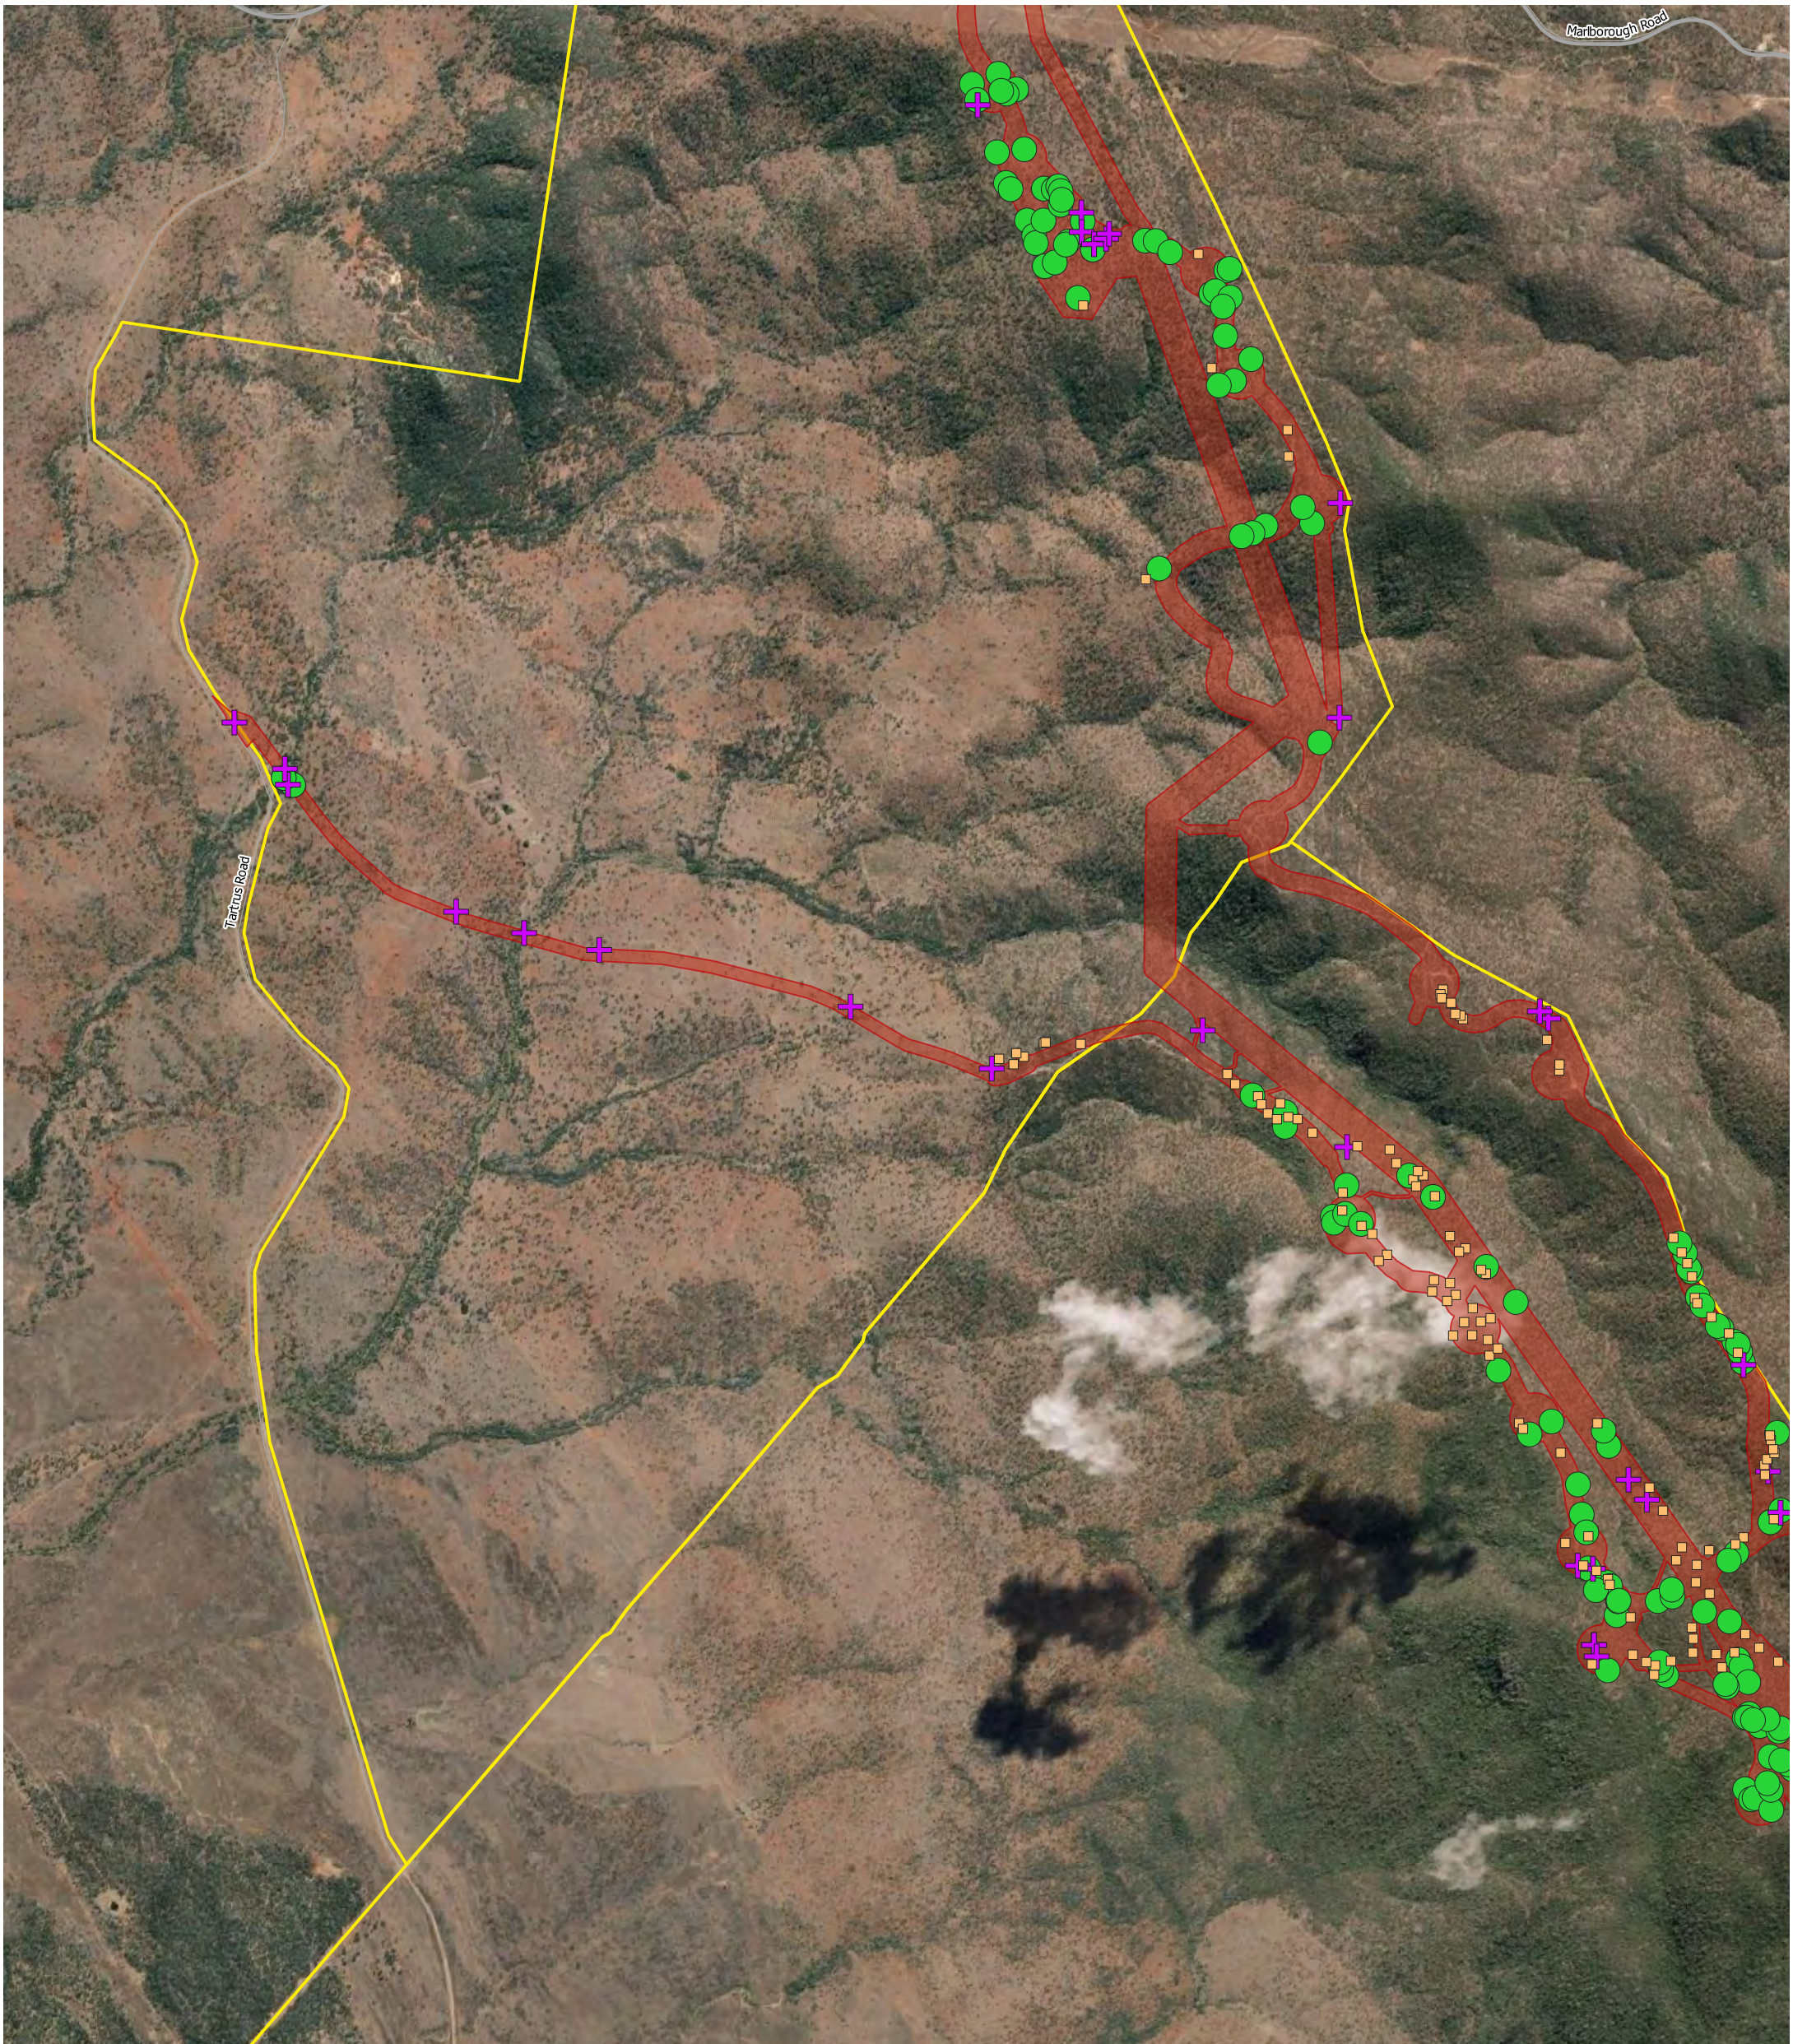
Figure 3-1 Identified potential animal breeding places
Map 3 of 4

- Legend**
- Disturbance footprint
 - Property Boundaries
- Identified potential breeding places**
- Hollow bearing trees
 - Rock piles
 - Other habitat features

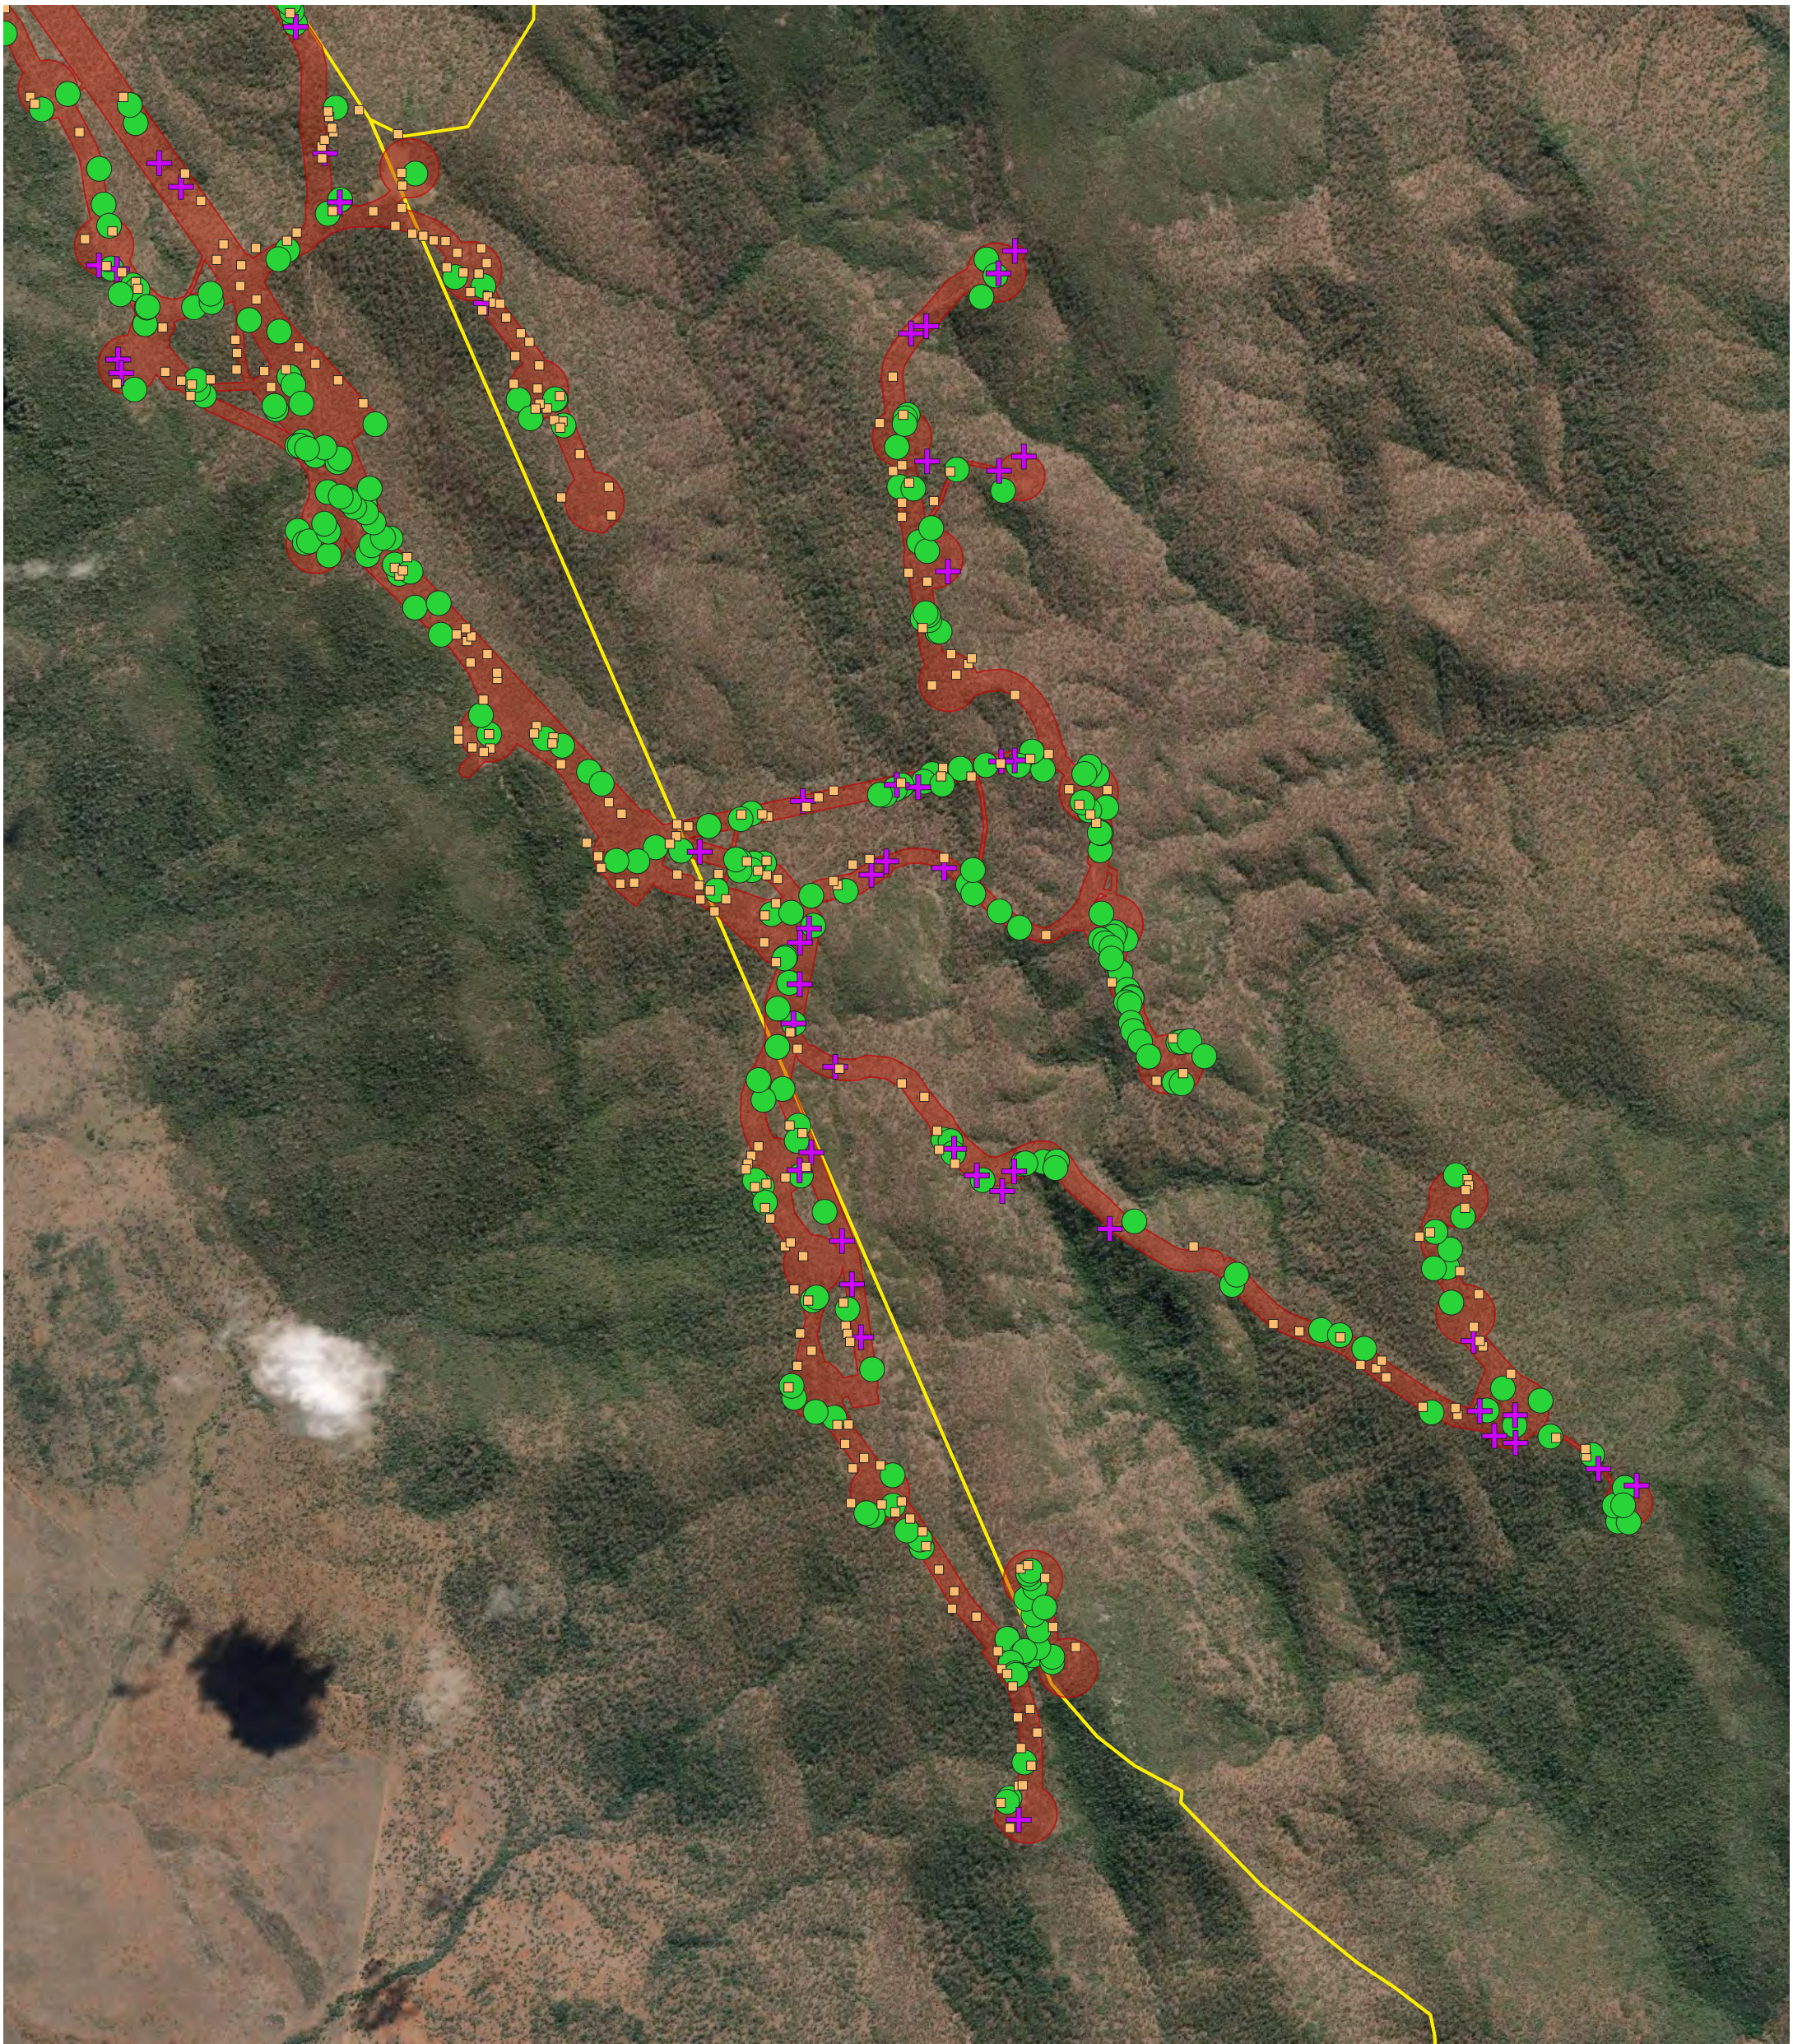
Figure 3-1 Identified potential animal breeding places
Map 4 of 4

- Legend**
- Disturbance footprint
 - Property Boundaries
- Identified potential breeding places**
- Hollow bearing trees
 - Rock piles
 - Other habitat features
