Biodiversity Management Plan

CLARKE CREEK WIND FARM

SEPTEMBER 2021

Project Title: Clarke Creek Wind Farm - Biodiversity Management Plan

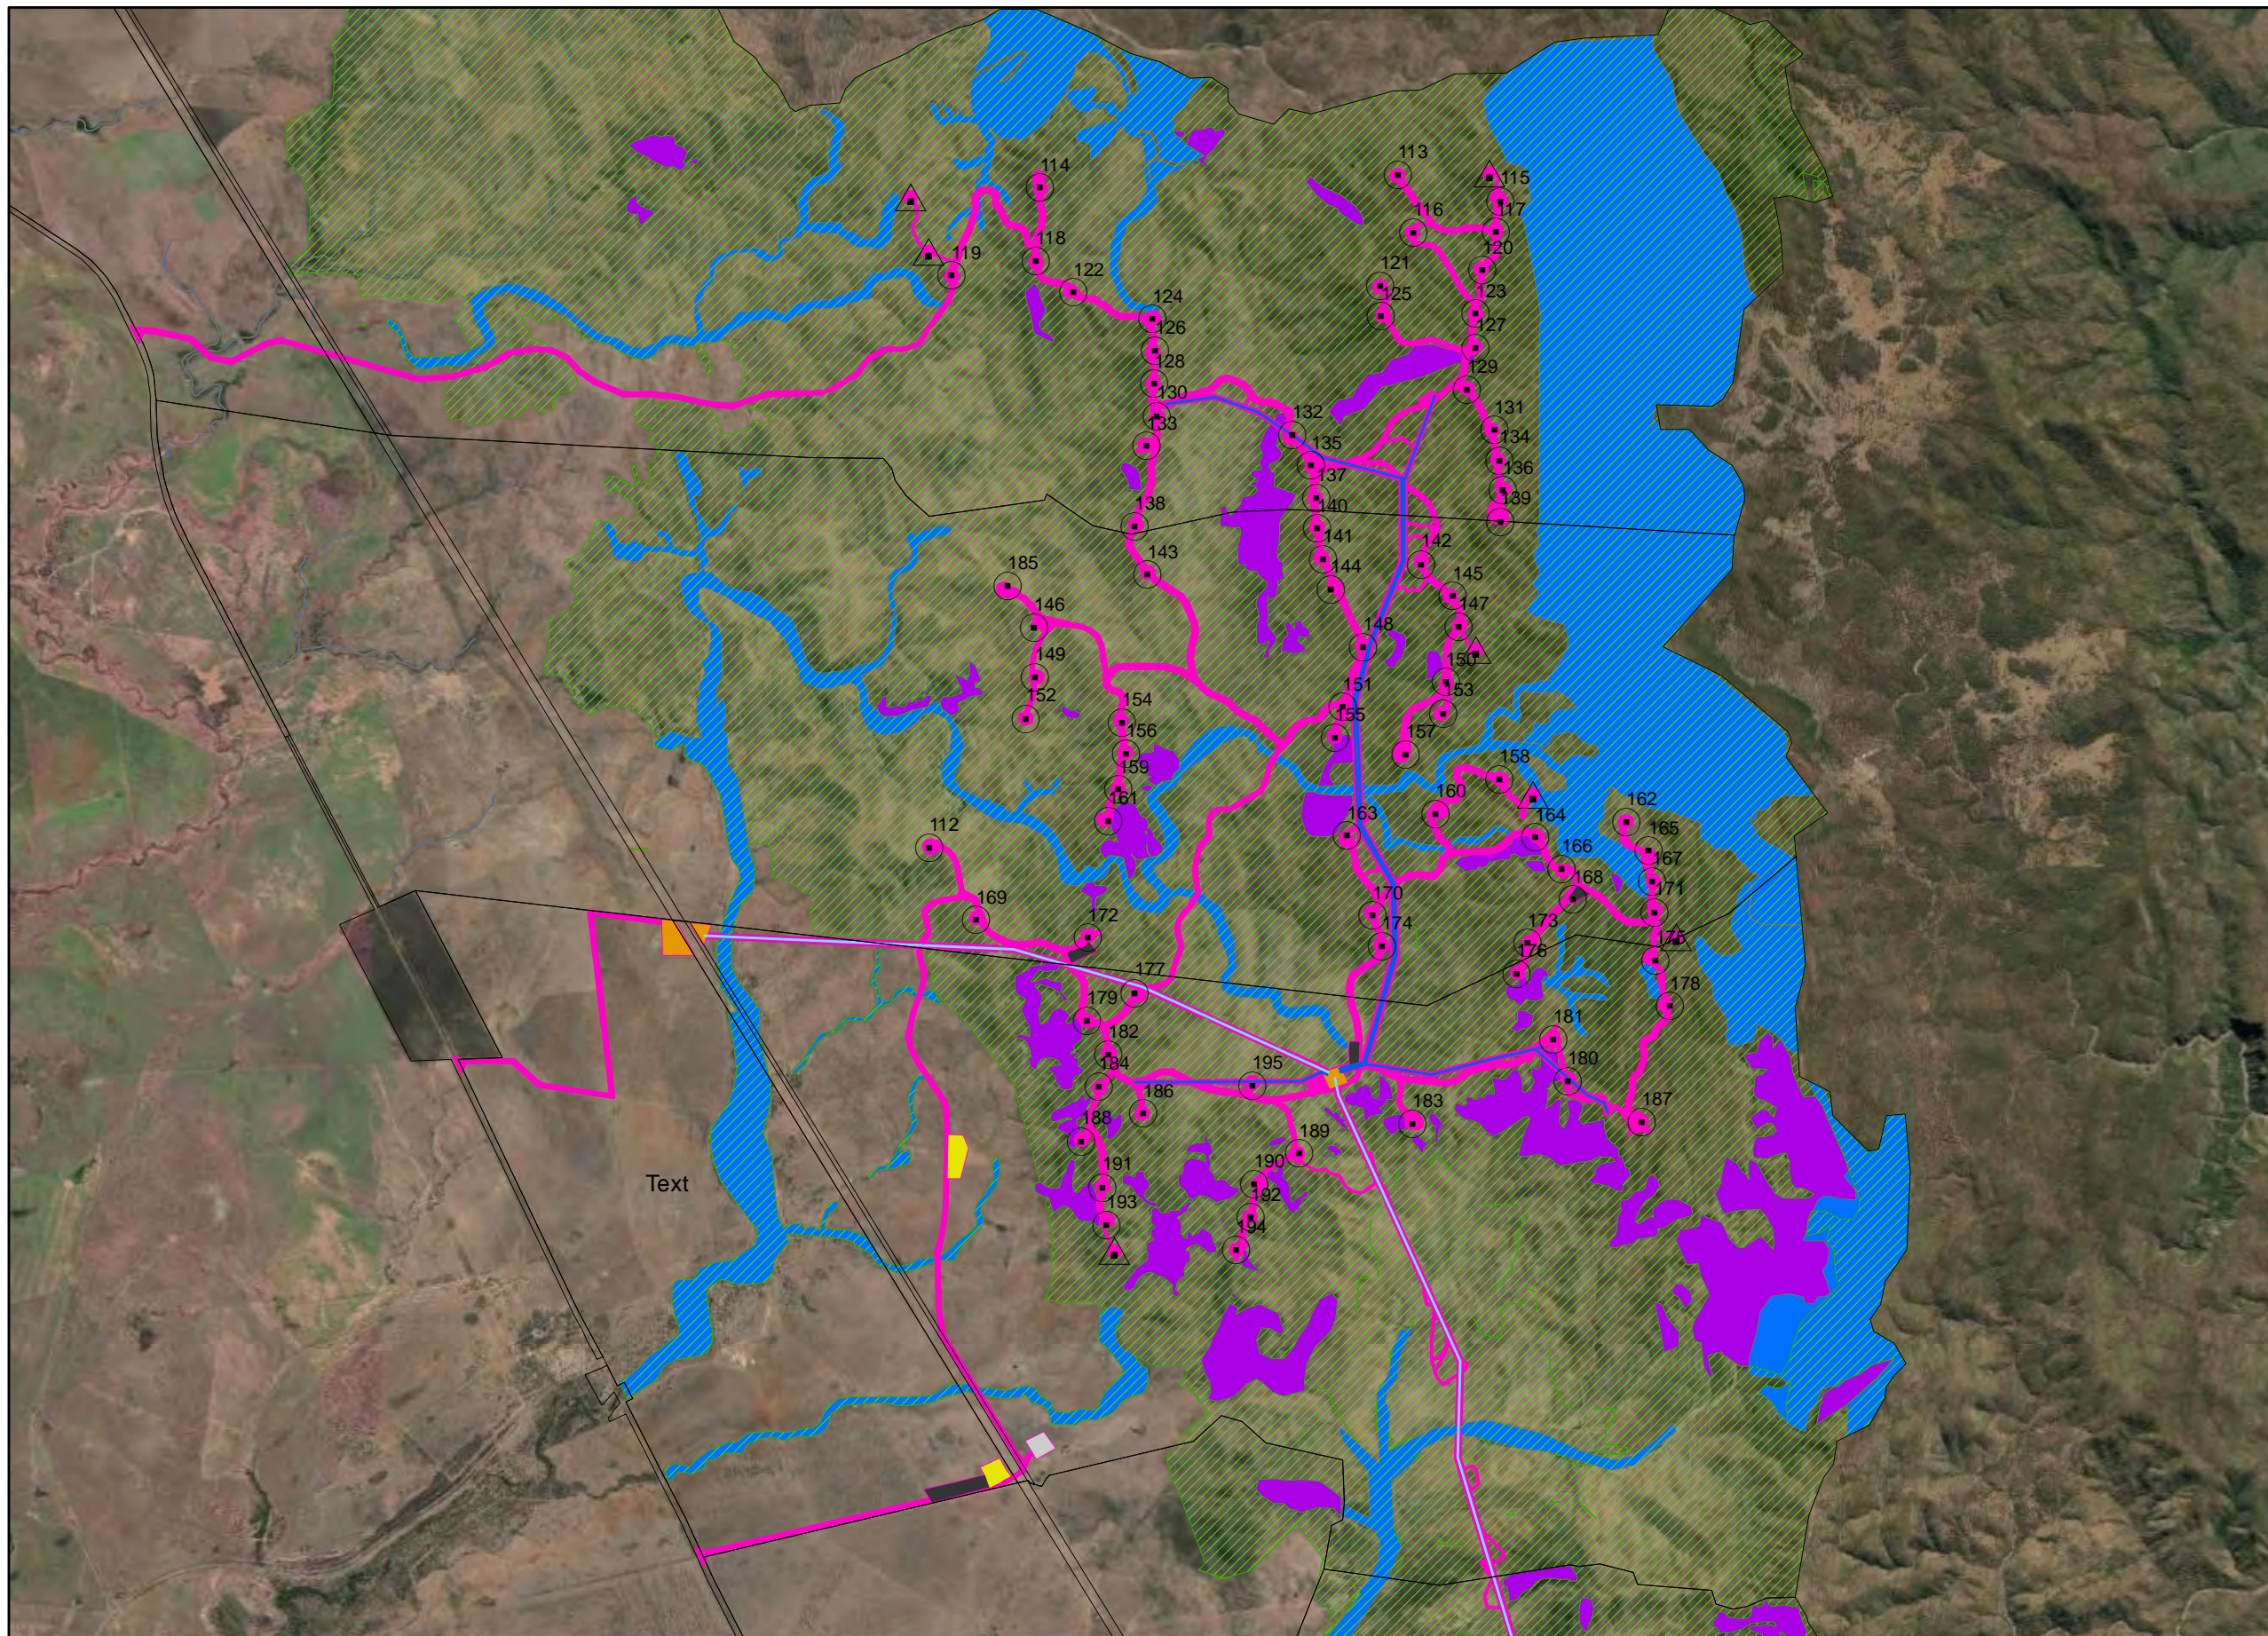
- Permanent masts
- Turbines
- Medium voltage overheadlines
- High voltage voltage overheadlines
- Accommodation camp
- Site offices and workshop
- Substations
- Temporary construction compounds
- Temporary laydown areas
- Project Footprint
- Project area

- Environmental Significant Areas**
- Koala Habitat (Max. 1513Ha clearing permitted)
 - Greater Glider and Squatter Pigeon Habitat (Max.17.83Ha clearing permitted)
 - RE within watercourses (Max.60.49ha clearing permitted)
 - SEVT/ RE11.4.1 (Max. 45.22Ha clearing permitted)
 - Of Concern RE11.11.10 (Max. 4.57ha clearing permitted)
 - RE 11.2.31/11.3.3/11.3.27/11.3.21 (Max 0.93Ha clearing permitted)

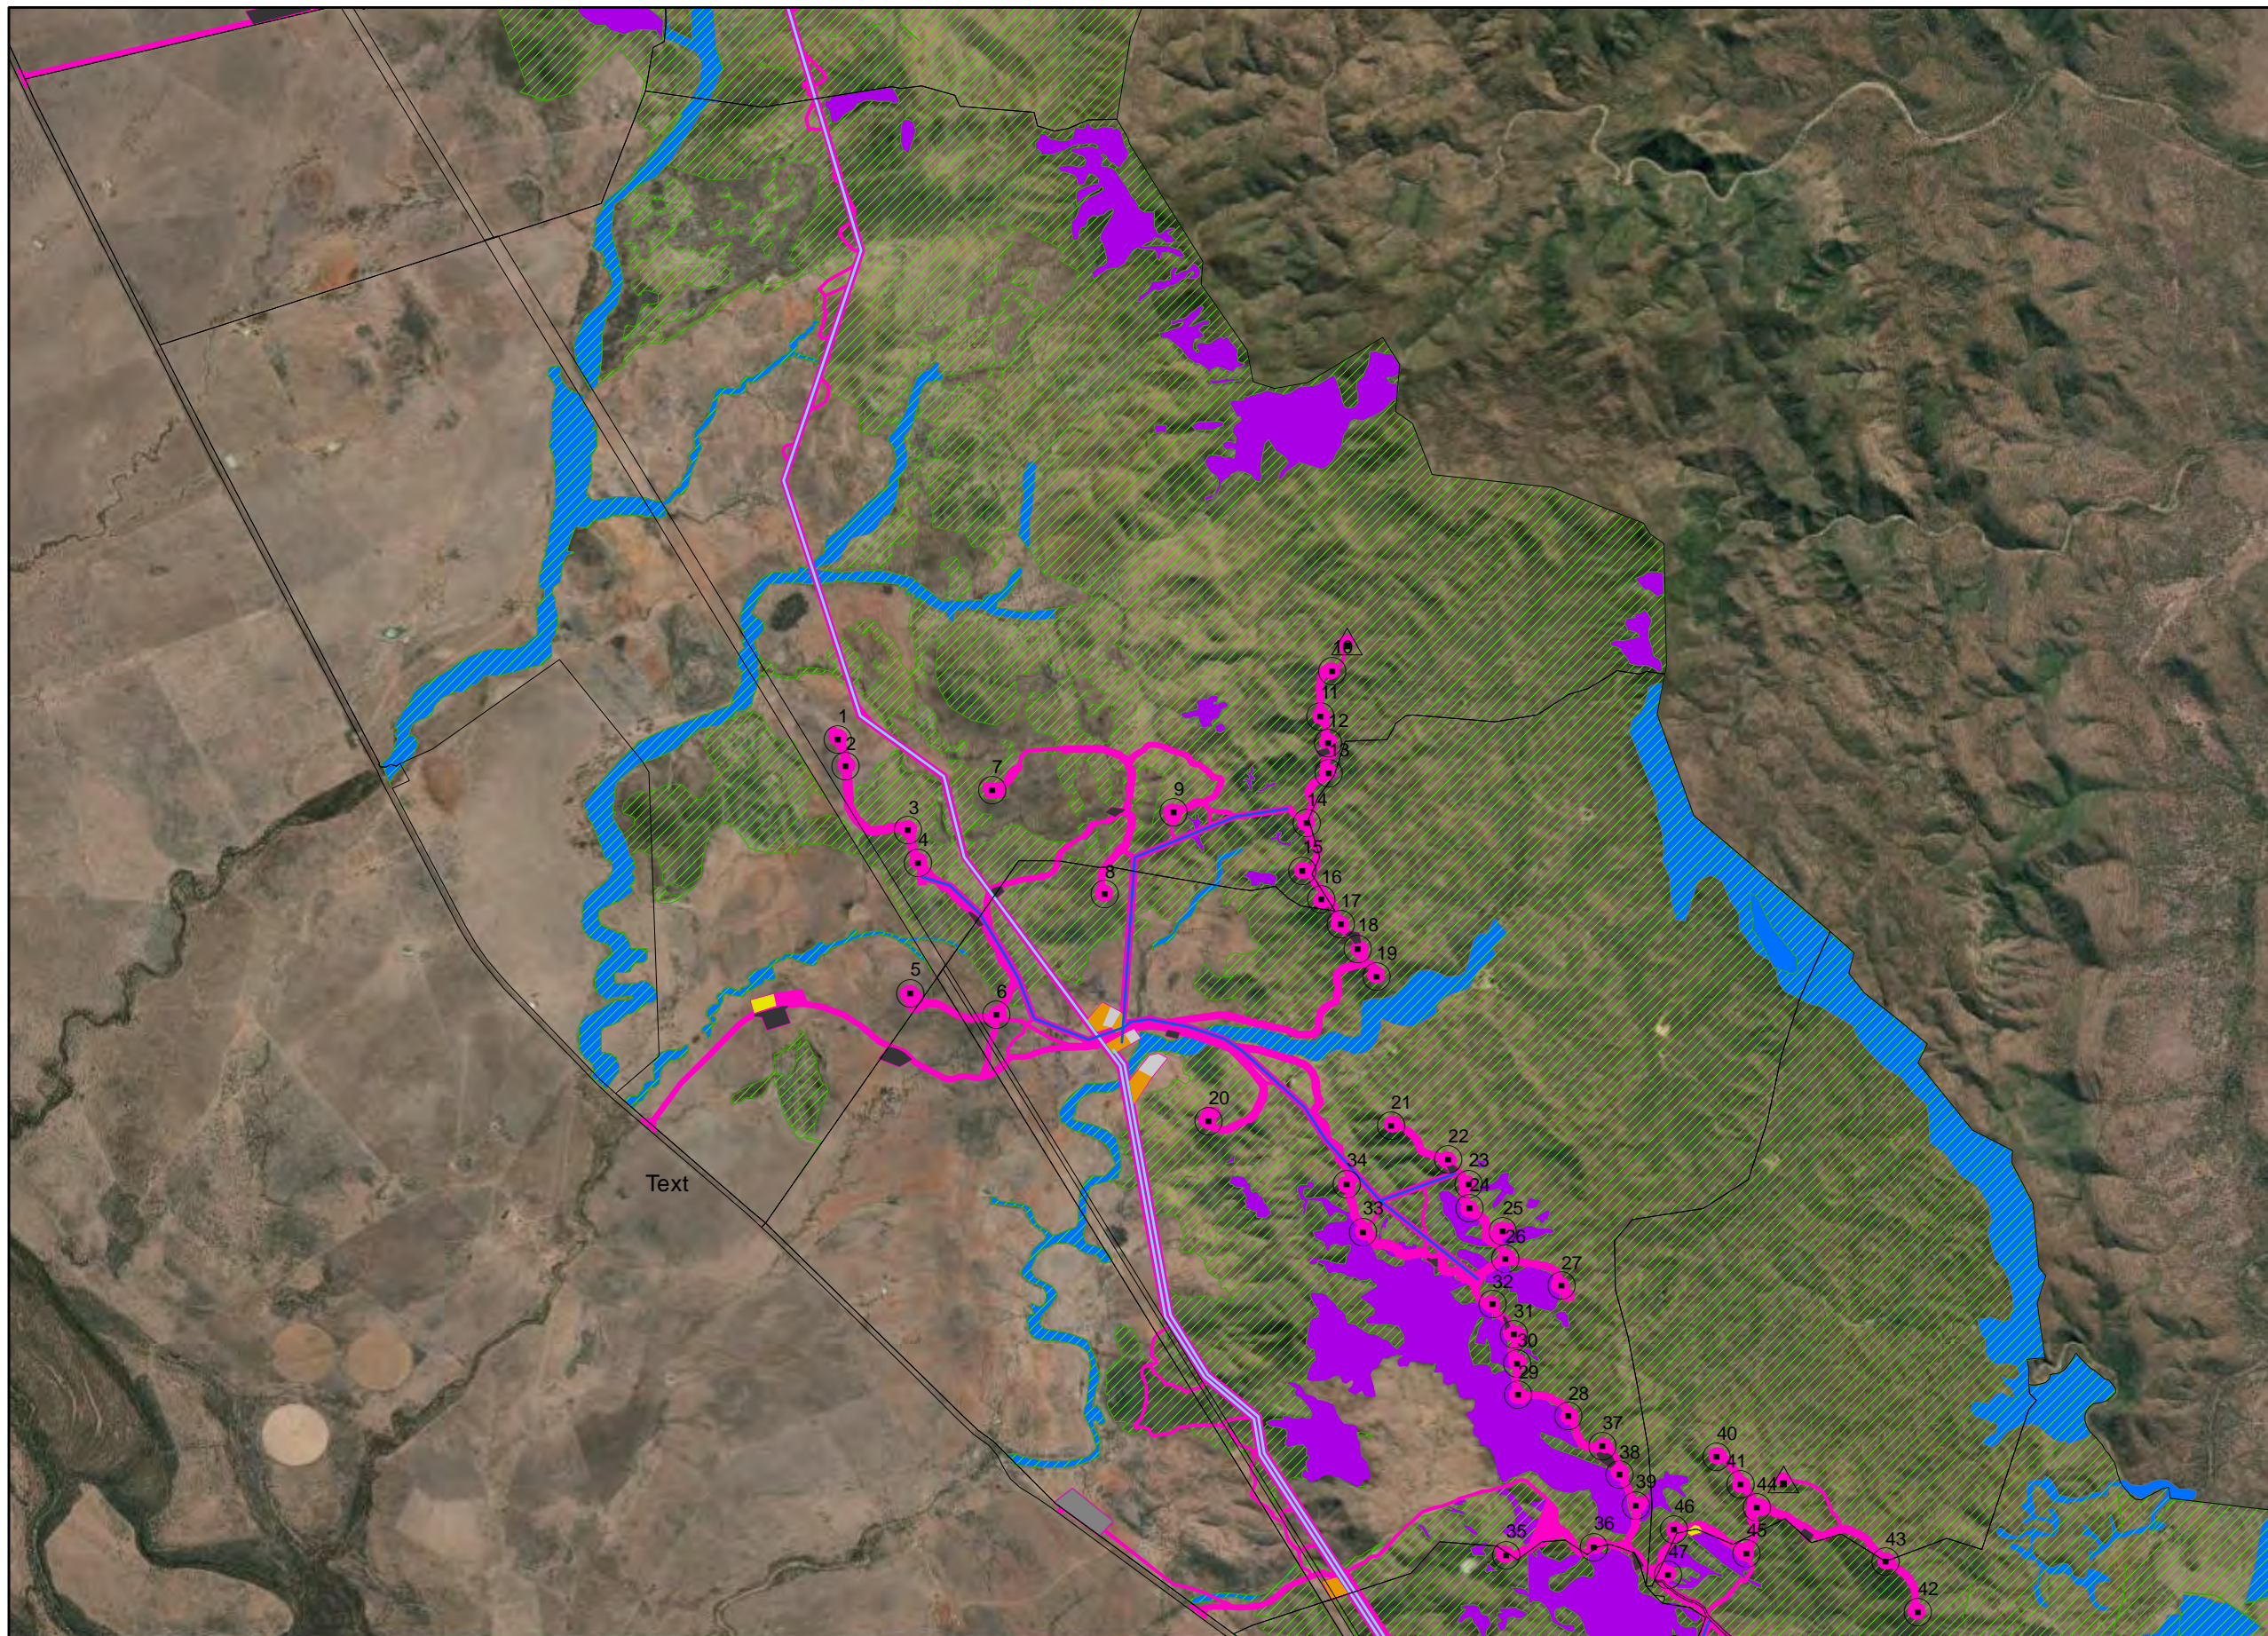
- Permanent masts
 - Turbines
 - Medium voltage overheadlines
 - High voltage overheadlines
 - Accommodation camp
 - Site offices and workshop
 - Substations
 - Temporary construction compounds
 - Temporary laydown areas
 - Project Footprint
 - Project area
- Environmental Significant Areas**
- Koala Habitat (Max. 1513Ha clearing permitted)
 - Greater Glider and Squatter Pigeon Habitat (Max.17.83Ha clearing permitted)
 - RE within watercourses (Max.60.49ha clearing permitted)
 - SEVT/ RE11.4.1 (Max. 45.22Ha clearing permitted)
 - Of Concern RE11.11.10 (Max. 4.57ha clearing permitted)
 - RE 11.2.31/11.3.3/11.3.27/11.3.21 (Max 0.93Ha clearing permitted)

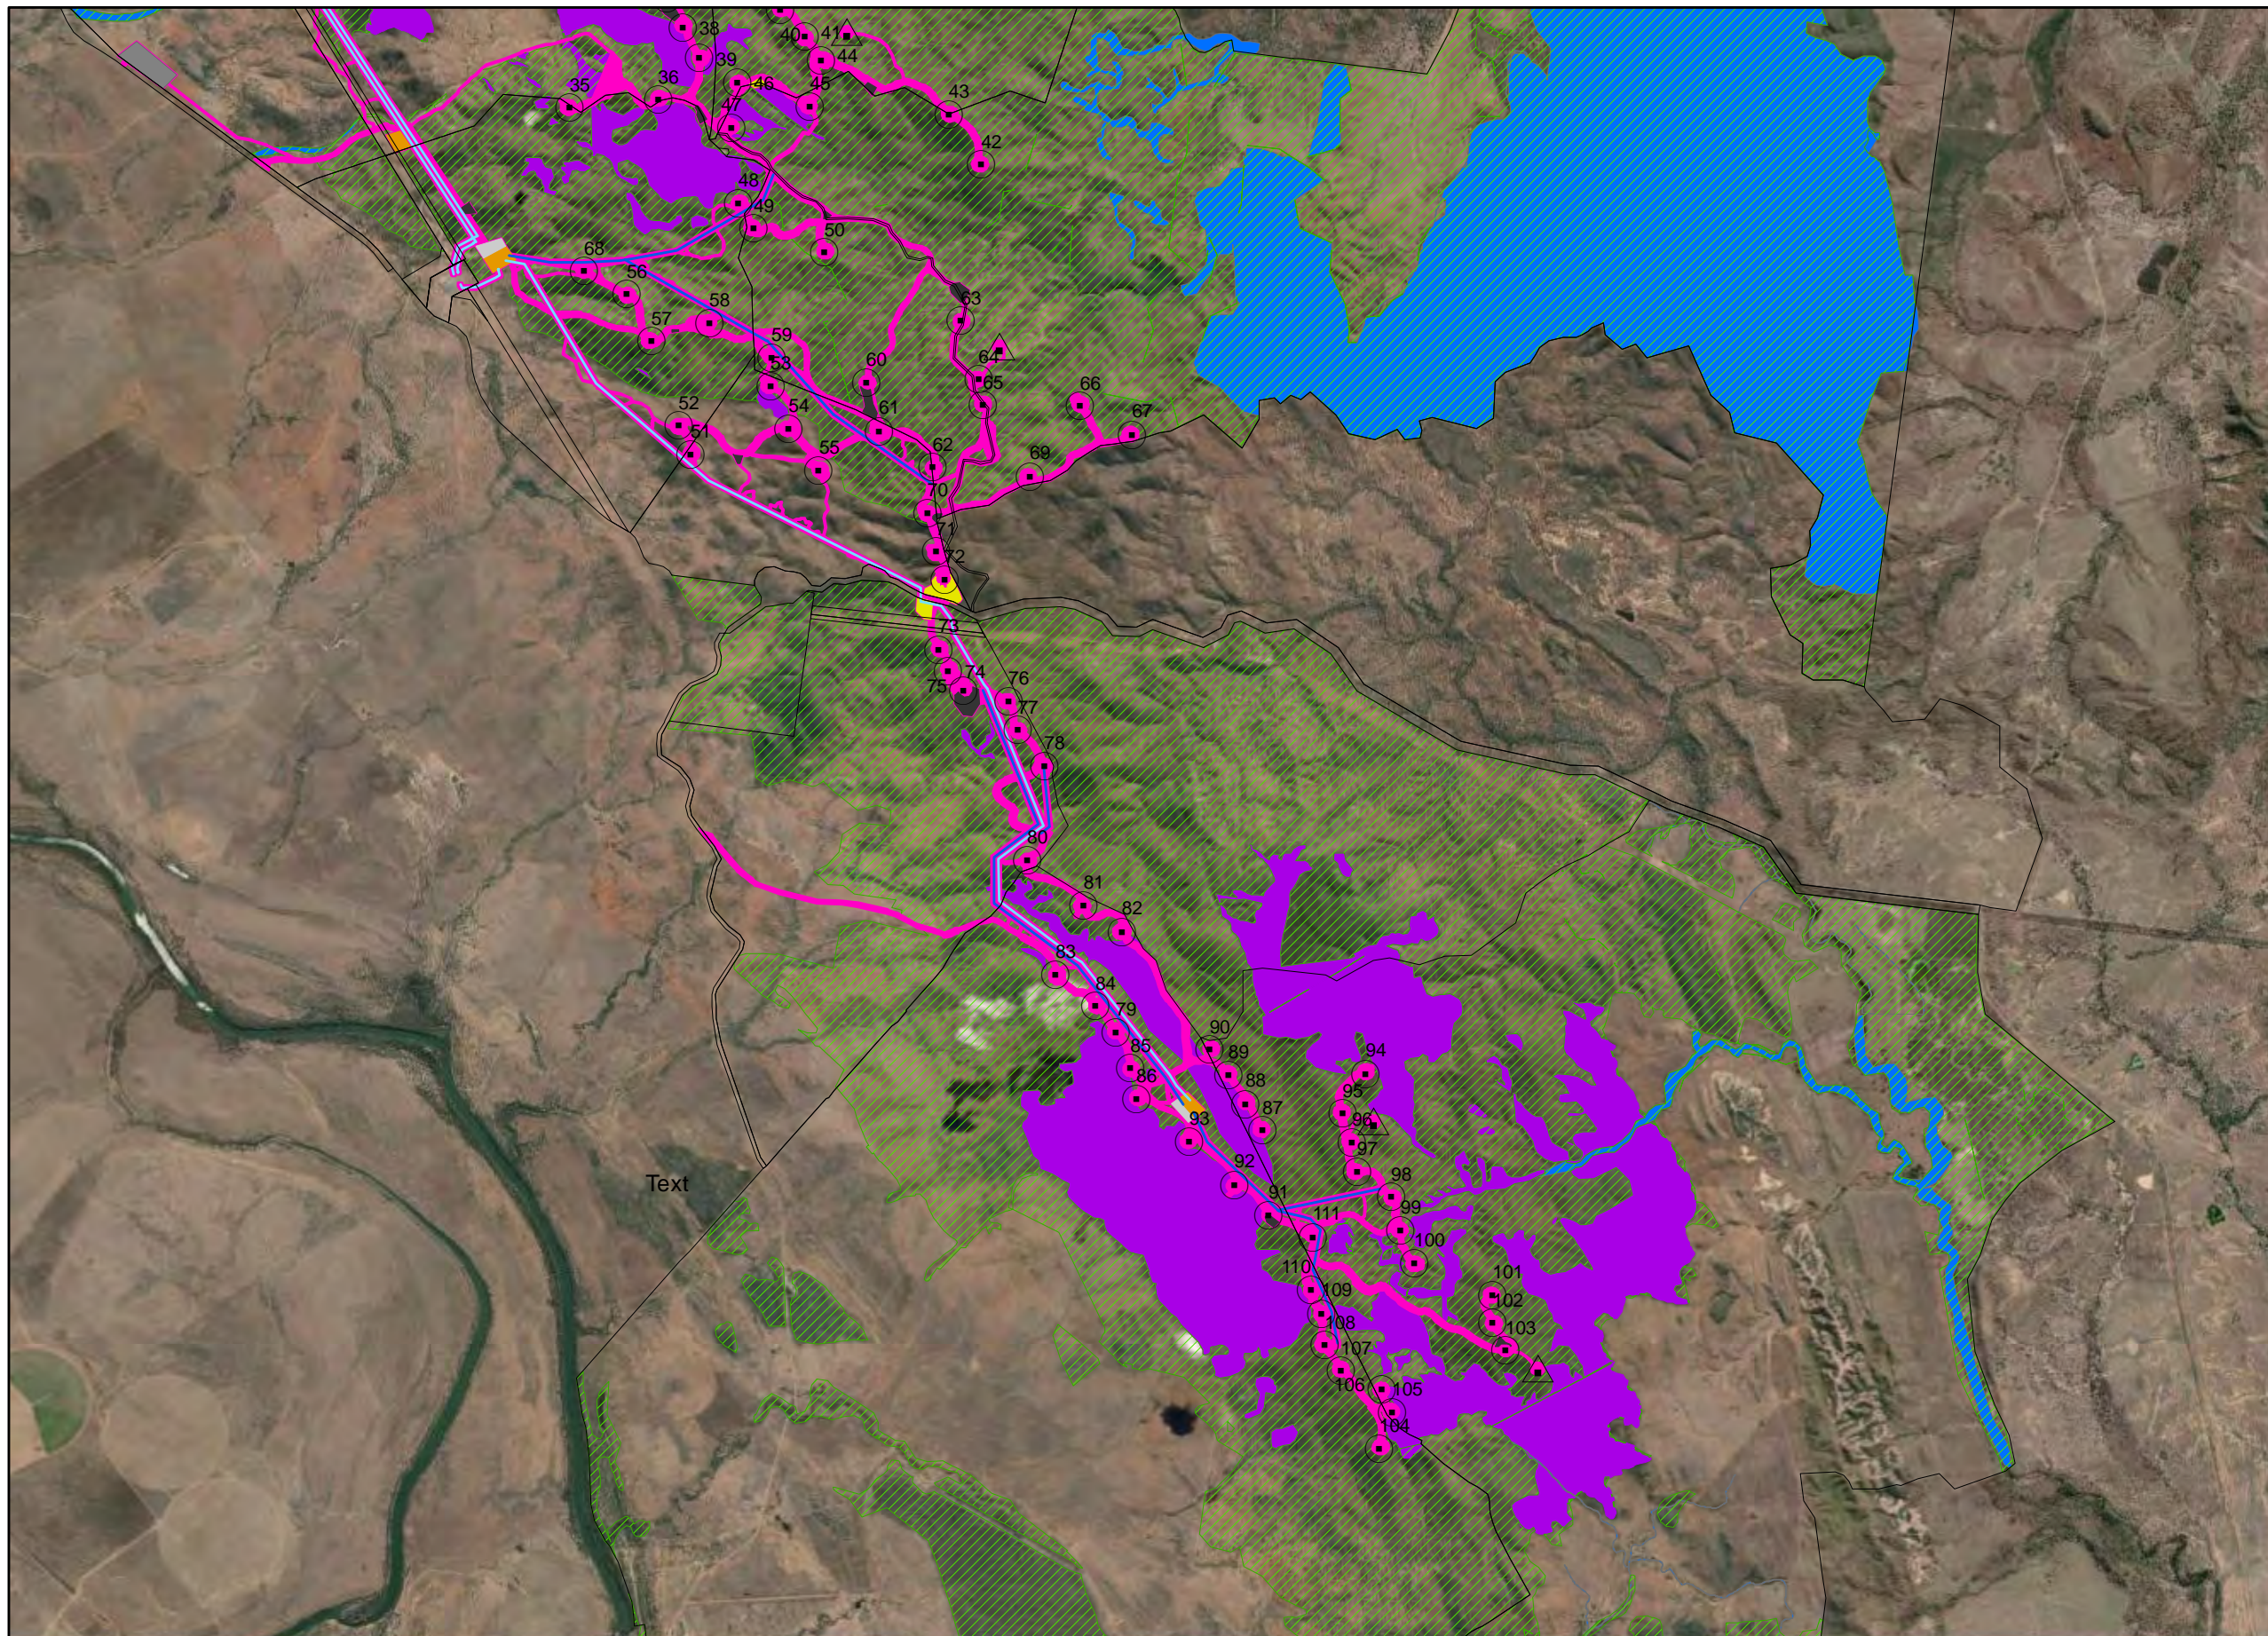
- Permanent masts
 - Turbines
 - Medium voltage overheadlines
 - High voltage voltage overheadlines
 - Accommodation camp
 - Site offices and workshop
 - Substations
 - Temporary construction compounds
 - Temporary laydown areas
 - Project Footprint
 - Project area
- Environmental Significant Areas**
- Koala Habitat (Max. 1513Ha clearing permitted)
 - Greater Glider and Squatter Pigeon Habitat (Max.17.83Ha clearing permitted)
 - RE within watercourses (Max.60.49ha clearing permitted)
 - SEVT/ RE11.4.1 (Max. 45.22Ha clearing permitted)
 - Of Concern RE11.11.10 (Max. 4.57ha clearing permitted)
 - RE 11.2.31/11.3.3/11.3.27/11.3.21 (Max 0.93Ha clearing permitted)
