# Crudine Ridge Wind Farm Aboriginal Heritage Management Plan

November 2017  
Final

This Aboriginal Heritage Management Plan (AHMP) has been prepared by Julie Dibden, NSW Archaeology Pty Ltd, for CWP Renewables on behalf of Crudine Ridge Wind Farm Pty Ltd (The Proponent). The document forms a component of the Crudine Ridge Wind Farm (CRWF; the Project) Environmental Management Strategy (EMS).

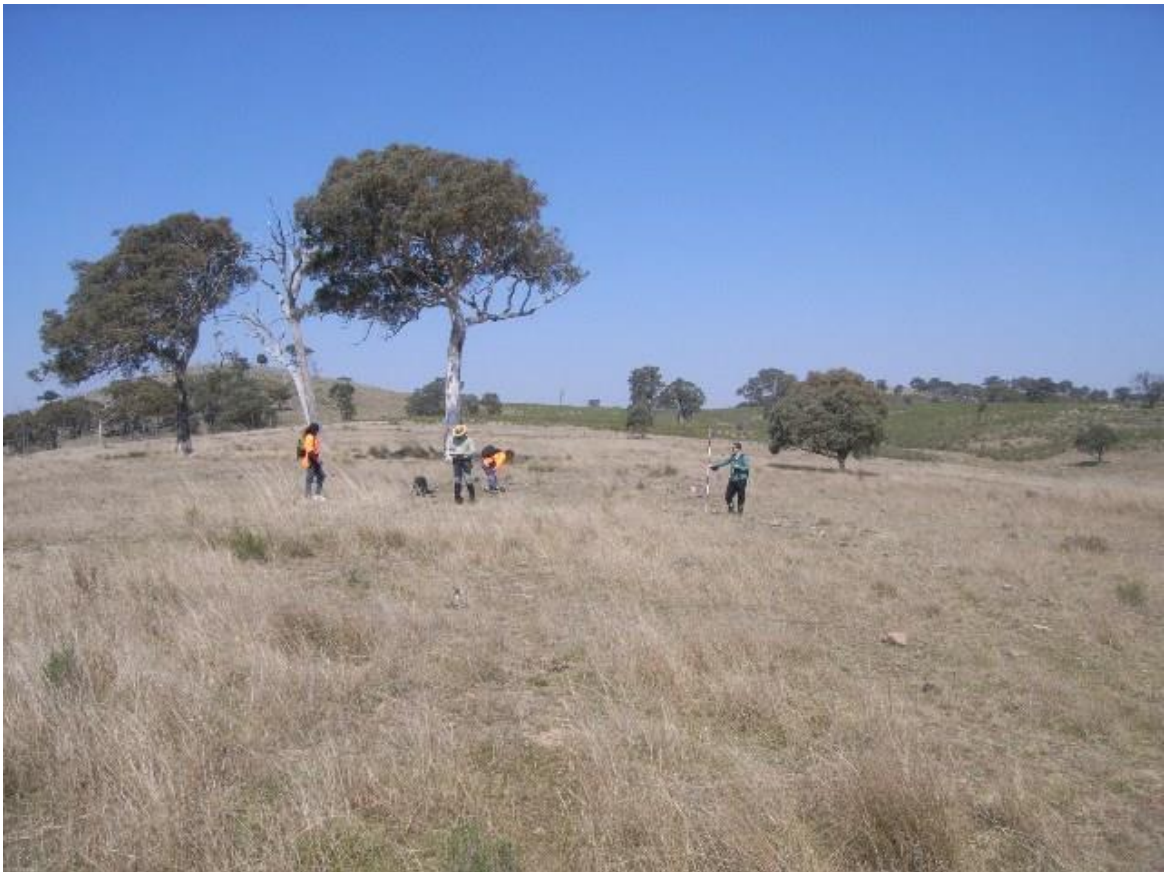
- Tuff flaked piece: 72mm x 50mm x 13mm;
- Tuff flaked piece: 51mm x 40mm x 15mm;
- Tuff broken flake; distal with hinge termination: 40mm x 28mm x 6mm.

Photograph: 19<sup>th</sup> September 2011; CRWF SU1/L1 taken facing to 180°.

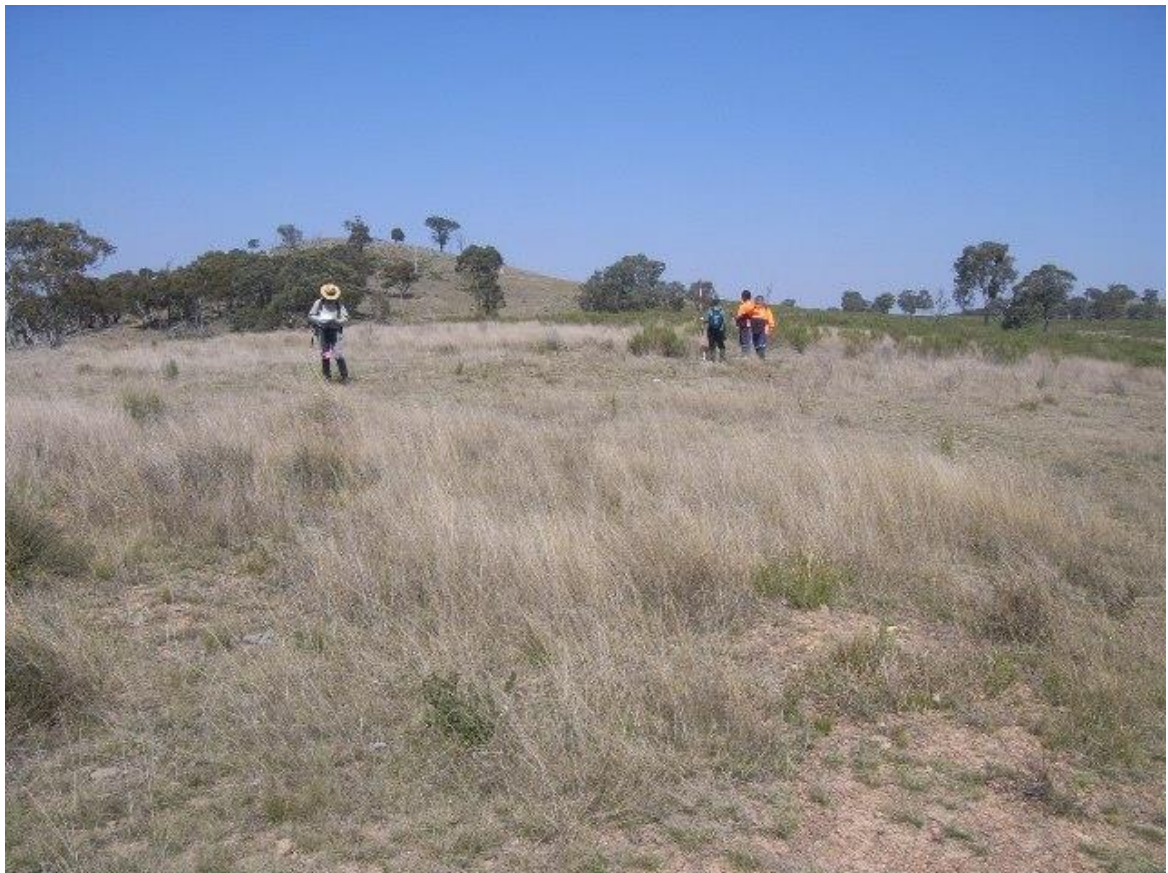
- Tuff broken flake; long. break: 62mm x 29mm x 11mm;
- Tuff broken flake; medial: 26mm x 25mm x 9mm;
- Tuff flake: 22mm x 30mm x 11mm;
- Quartzite core - amorphous: 60mm x 48mm x 40mm.

Photograph: 19<sup>th</sup> September 2011; CRWF SU1/L2 taken facing to 180°.

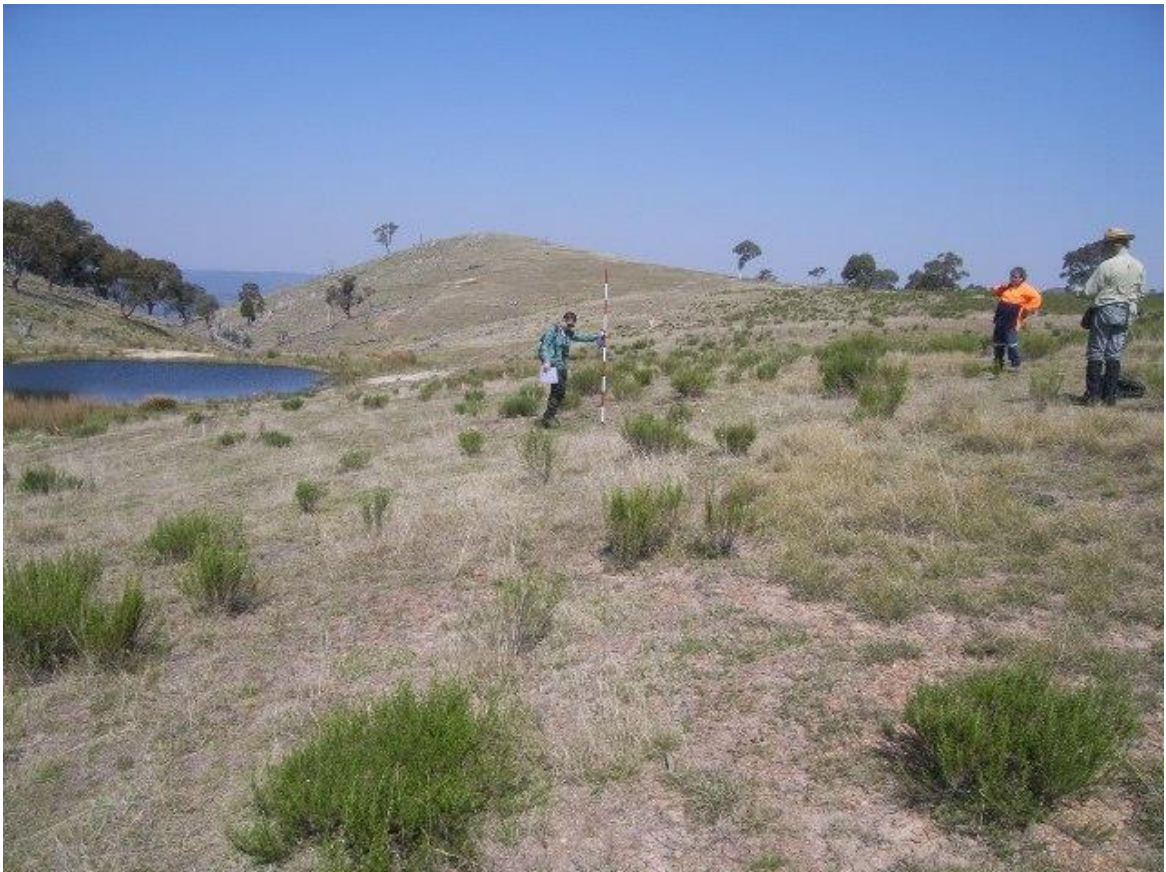
CRWF SU2/L1

Aboriginal object locale ID: CRWF Survey Unit 2/Locale 1 (CRWF SU2/L1)

Photograph: 19<sup>th</sup> September 2011; North end of CRWF SU2/L1; facing to 180°.

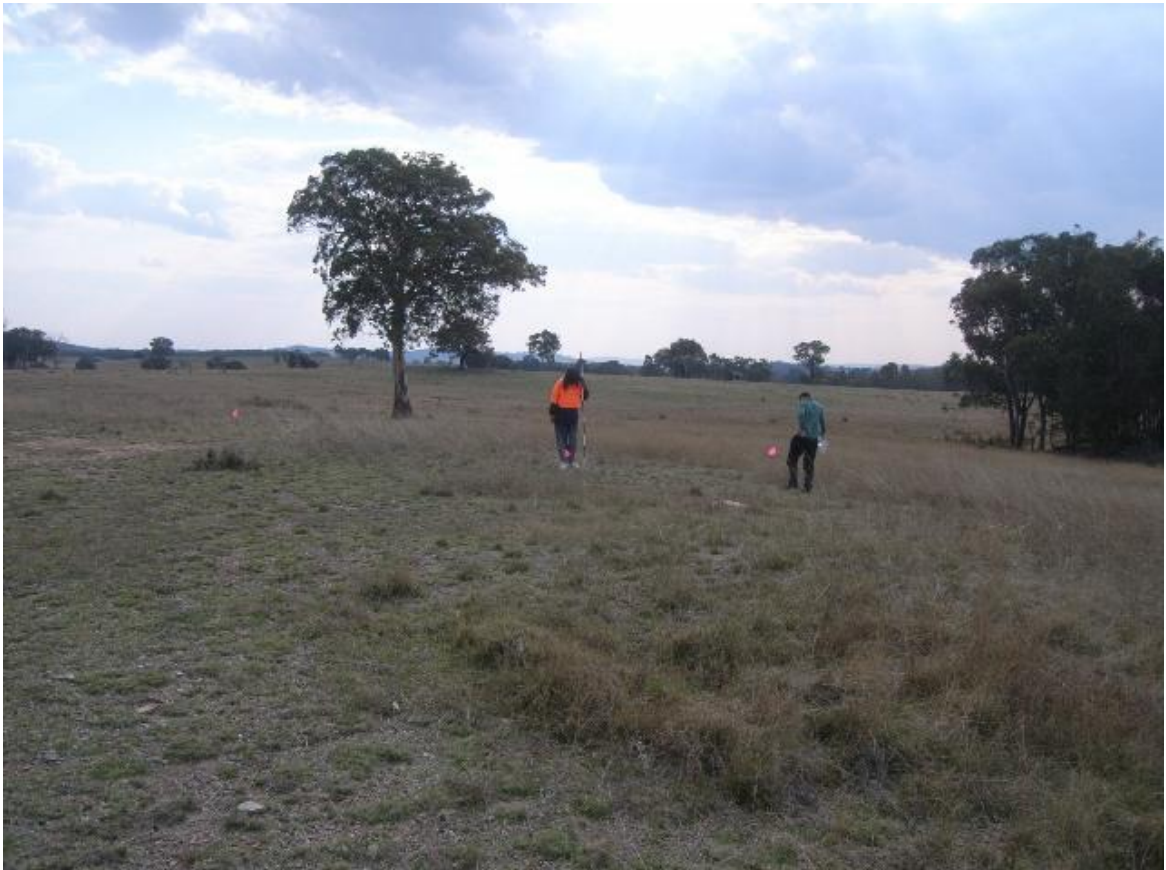
- Tuff core fragment; 3 neg. scars: 45mm x 35mm x 25mm;
- Tuff core fragment; 7 microblade scars: 45mm x 32mm x 30mm.

Photograph: 19<sup>th</sup> September 2011; CRWF SU3/L1 taken facing to 270°.

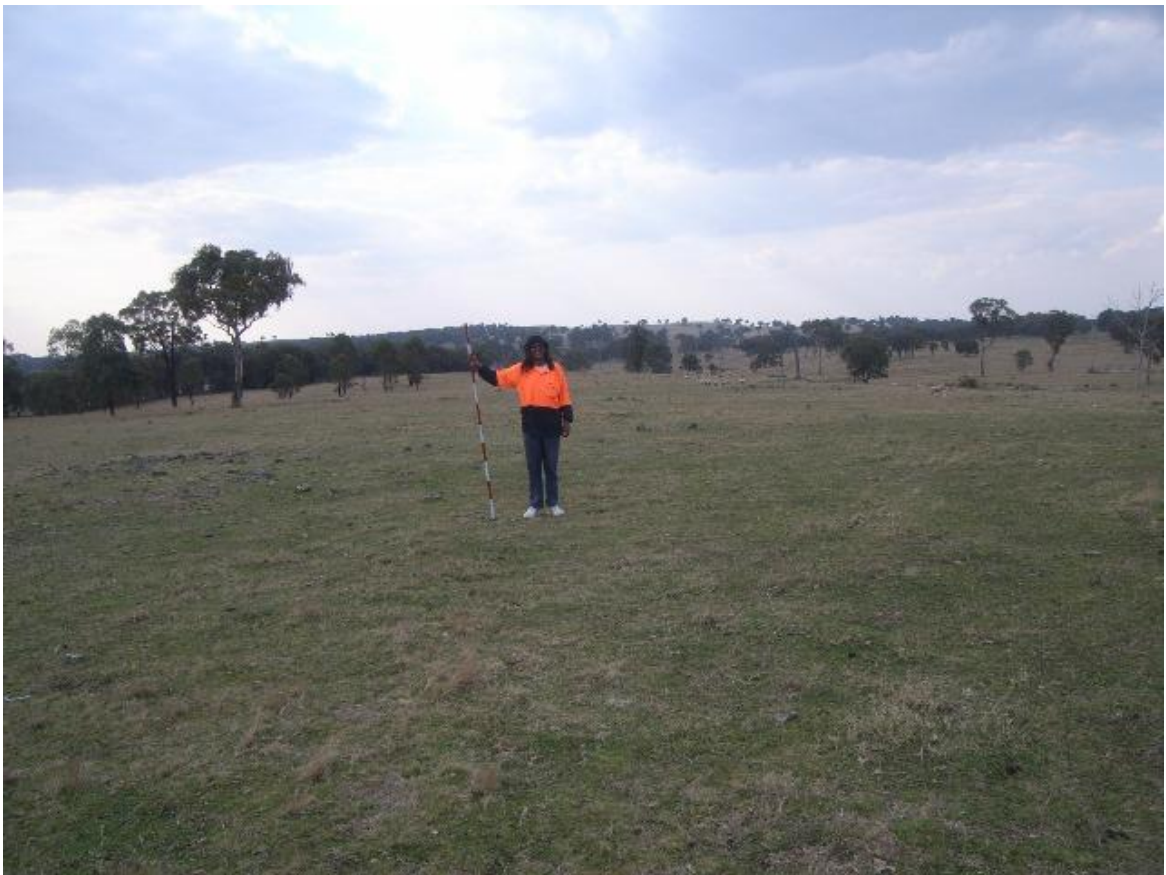
Aboriginal object locale ID: CRWF Survey Unit 3/Locale 2 (CRWF SU3/L2)  
Grid reference(GDA): Zone 55: E743718 N6344986  
Description: This locale is situated in Survey Unit 3, on a crest of a broad, undulating plateau landform. The aspect is open and gradient is very gentle (0-1°). The site is in a cleared paddock used for sheep grazing. Three stone artefacts were recorded in an area measuring approximately 20 x 20 metres (400 sq m):

- Tuff flaked piece: 34mm x 27mm x 18mm;
- Tuff flaked piece: 35mm x 26mm x 14mm;
- ?Chert core fragment: 36mm x 20mm x 15mm.

Photograph: 19<sup>th</sup> September 2011; CRWF SU3/L2 taken facing to north.

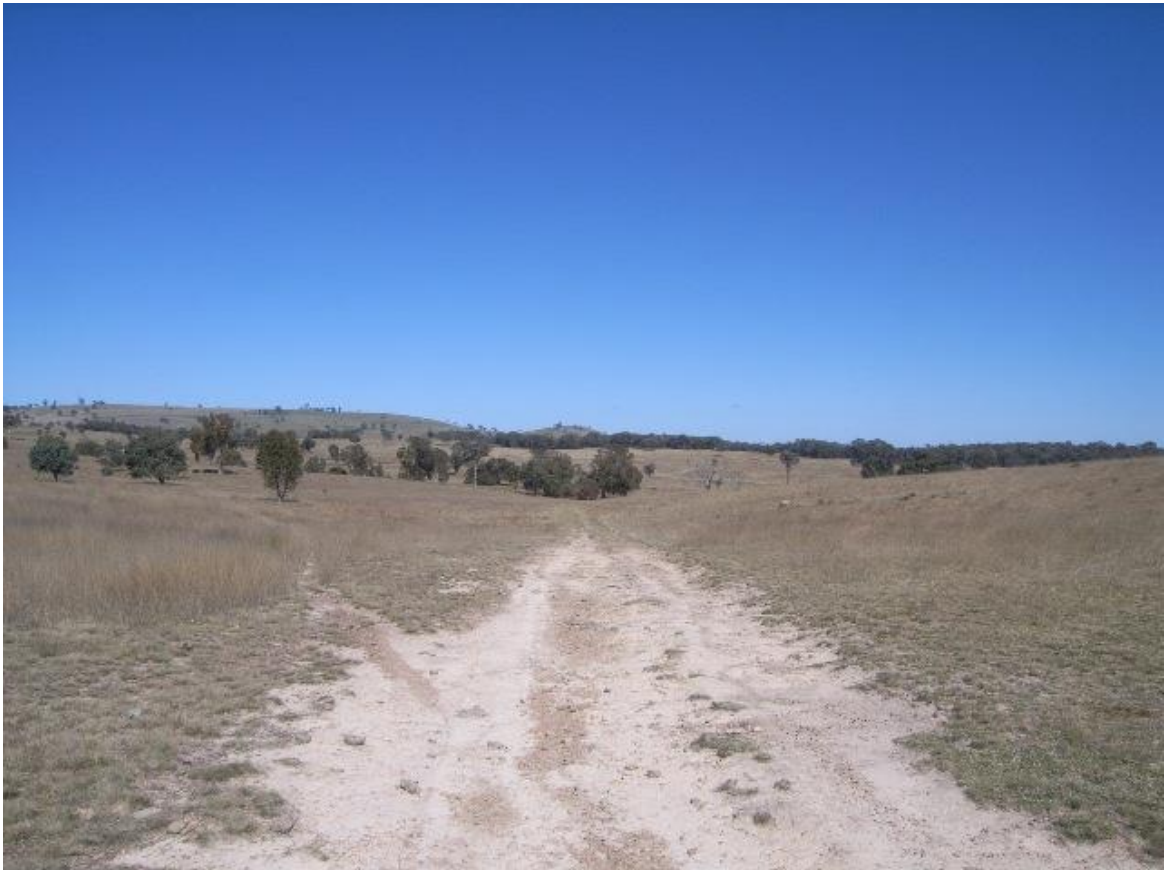
Aboriginal object locale ID: CRWF Survey Unit 3/Locale 3 (CRWF SU3/L3)  
Grid reference(GDA): Zone 55: E743303 N6344743  
Description: This locale is situated in Survey Unit 3, on a crest on a broad, undulating plateau landform. The aspect is westerly and gradient is gentle (3°). The site is in a cleared paddock used for sheep grazing. Two stone artefacts were recorded in an area measuring approximately 10 x 5 metres (50 sq m):

- Tuff flaked piece: 29mm x 26mm x 18mm;
- Tuff flaked piece: 38mm x 31mm x 16mm.

Photograph: 21<sup>st</sup> September 2011; CRWF SU3/L3 taken facing to 240°.

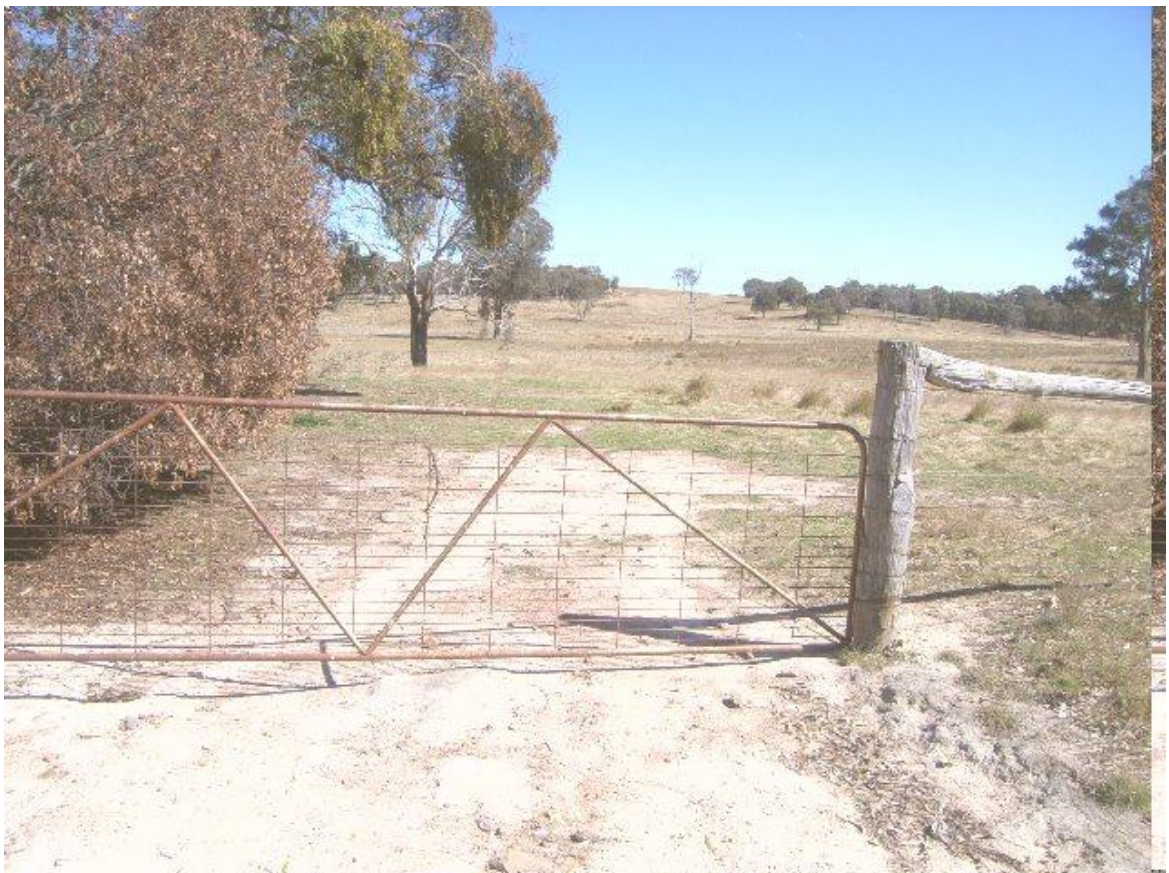
- Tuff flaked piece: 32mm x 27mm x 13mm;
- Tuff flaked piece: 32mm x 21mm x 6mm;
- Quartz (milky) flake fragment: 12mm x 5mm x 3mm;
- Tuff flaked piece; 29mm x 22mm x 8mm.

Photograph: 21<sup>st</sup> September 2011; CRWF SU3/L4 taken facing to 280°.

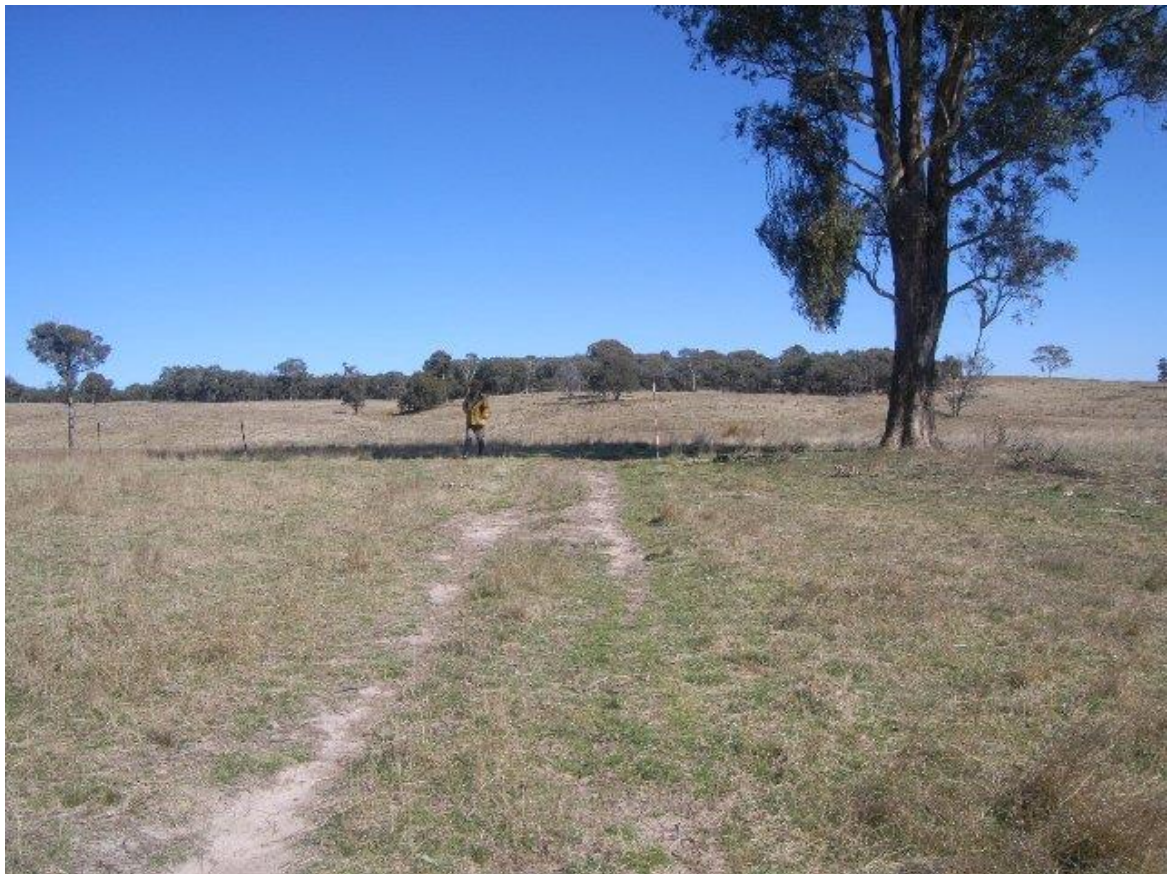
Aboriginal object locale ID: CRWF Survey Unit 3/Locale 5 (CRWF SU3/L5)  
Grid reference(GDA): Zone 55: E742930 N6344713  
Description: This locale is situated in Survey Unit 3, on a basal simple slope on a broad, undulating plateau landform. The aspect is northerly and gradient is very gentle (1°). The site is a cleared paddock used for sheep grazing. Three stone artefacts were recorded in an area measuring approximately 4 x 2 metres (8 sq m):

- Quartz flake fragment; 30mm x 15mm x 8mm;
- Tuff flaked piece: 75mm x 72mm x 24mm;
- Tuff flaked piece: 45mm x 25mm x 19mm.

Photograph: 21<sup>st</sup> September 2011; CRWF SU3/L5 taken facing to 280°.

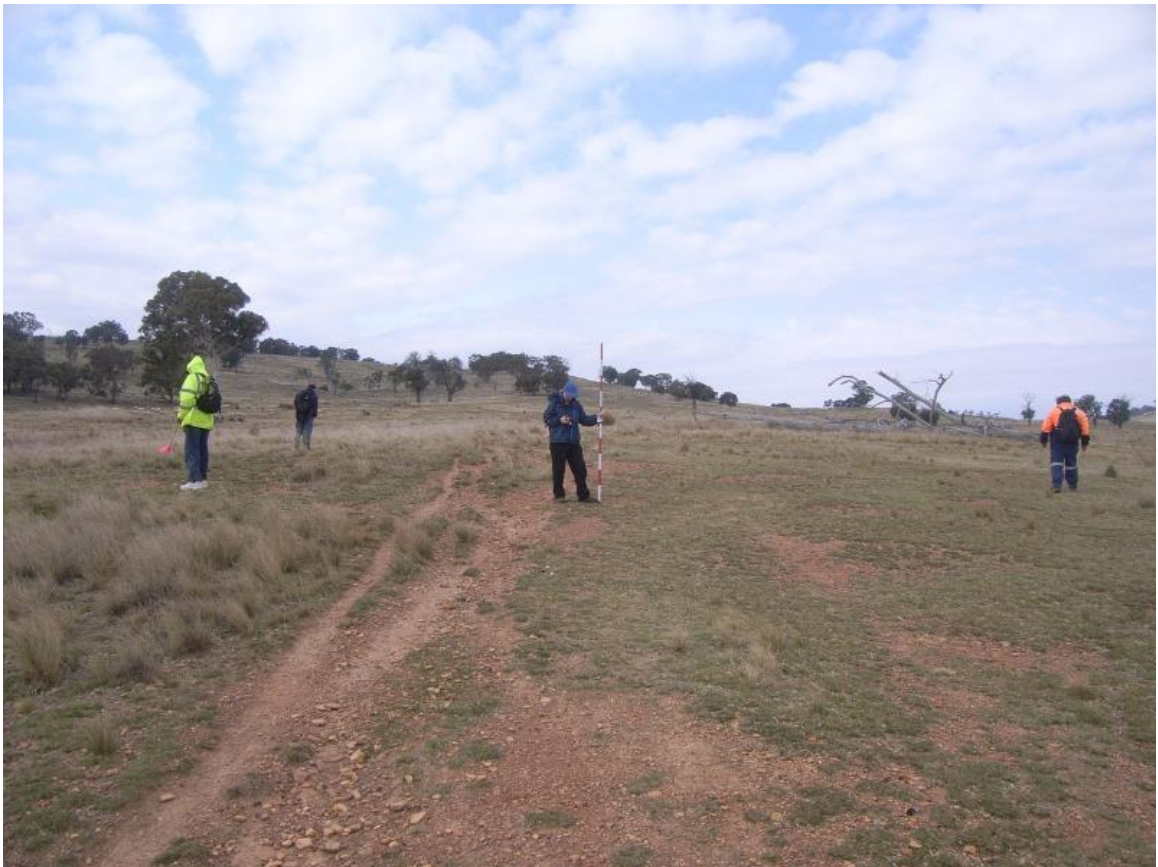
Aboriginal object locale ID: CRWF Survey Unit 4/Locale 1 (CRWF SU4/L1)  
Grid reference(GDA): Zone 55: E742809 N6344220  
Description: This locale is situated in Survey Unit 4, on a simple slope of a broad, undulating plateau landform. The aspect is northerly and gradient is gentle (3°). The site is in a cleared paddock used for sheep grazing. Three stone artefacts were recorded in an area measuring approximately 2 x 2 metres (4 sq m):

- Tuff flake: 29mm x 18mm x 8mm;
- Tuff flaked piece: 26mm x 16mm x 10mm;
- Tuff flake: 17mm x 12mm x 7mm.

Photograph: 20<sup>th</sup> September 2011; CRWF SU4/L1 taken facing to 170°.

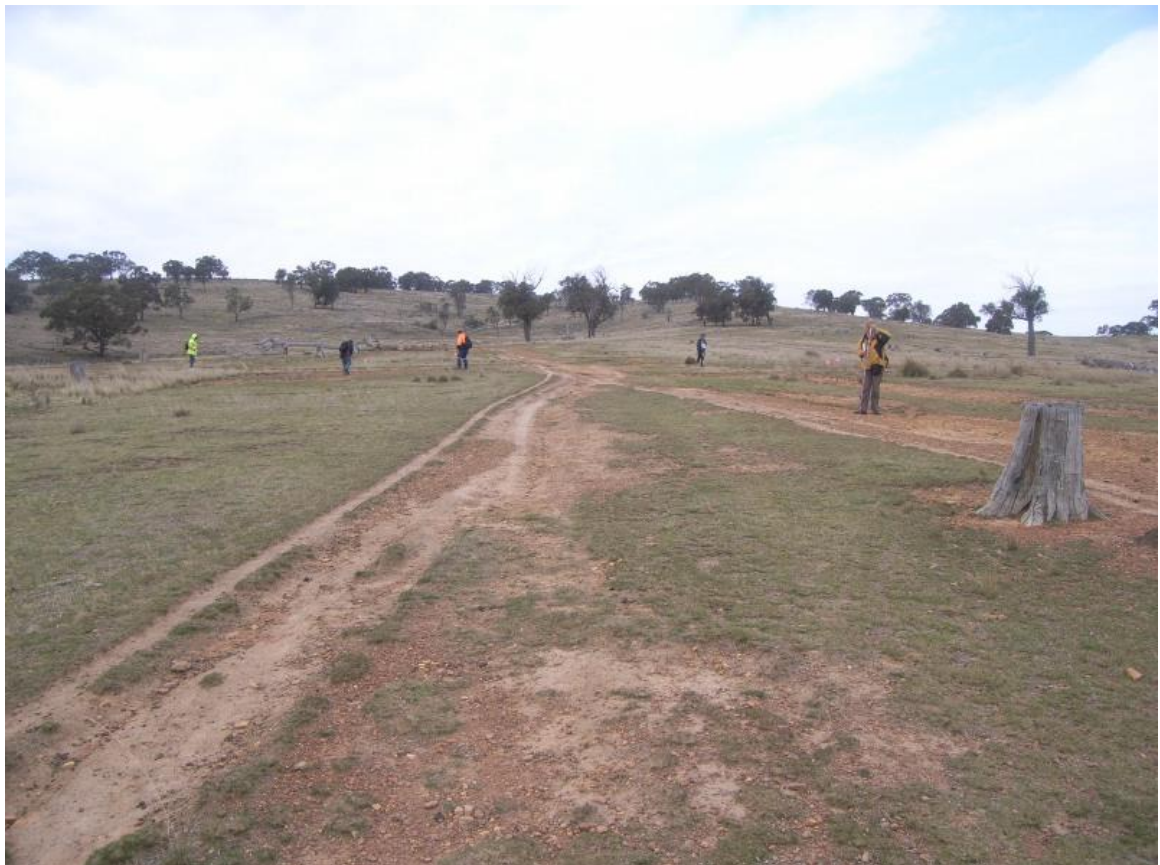
Aboriginal object locale ID: CRWF Survey Unit 4/Locale 2 (CRWF SU4/L2)  
Grid reference(GDA): Zone 55: E742812 N6344095 (NW end)  
Description: This locale is situated in Survey Unit 4, on a simple slope of a broad, undulating plateau landform. The aspect is northerly and gradient is gentle (3°). The site is in a cleared paddock used for sheep grazing. Four stone artefacts were recorded in an area measuring approximately 30 x 30 metres (900 sq m):

- Tuff flaked piece; 23mm x 13mm x 6mm;
- Tuff flake portion: medial; 12mm x 9mm x 4mm;
- Tuff flaked piece; 19mm x 9mm x 9mm;
- Tuff broken retouched artefact; retouched from ventral; proximal portion of a *Bondi point*; 19mm x 8mm x 4mm.

Photograph: 20<sup>th</sup> September 2011; CRWF SU4/L2 taken facing to 150°.

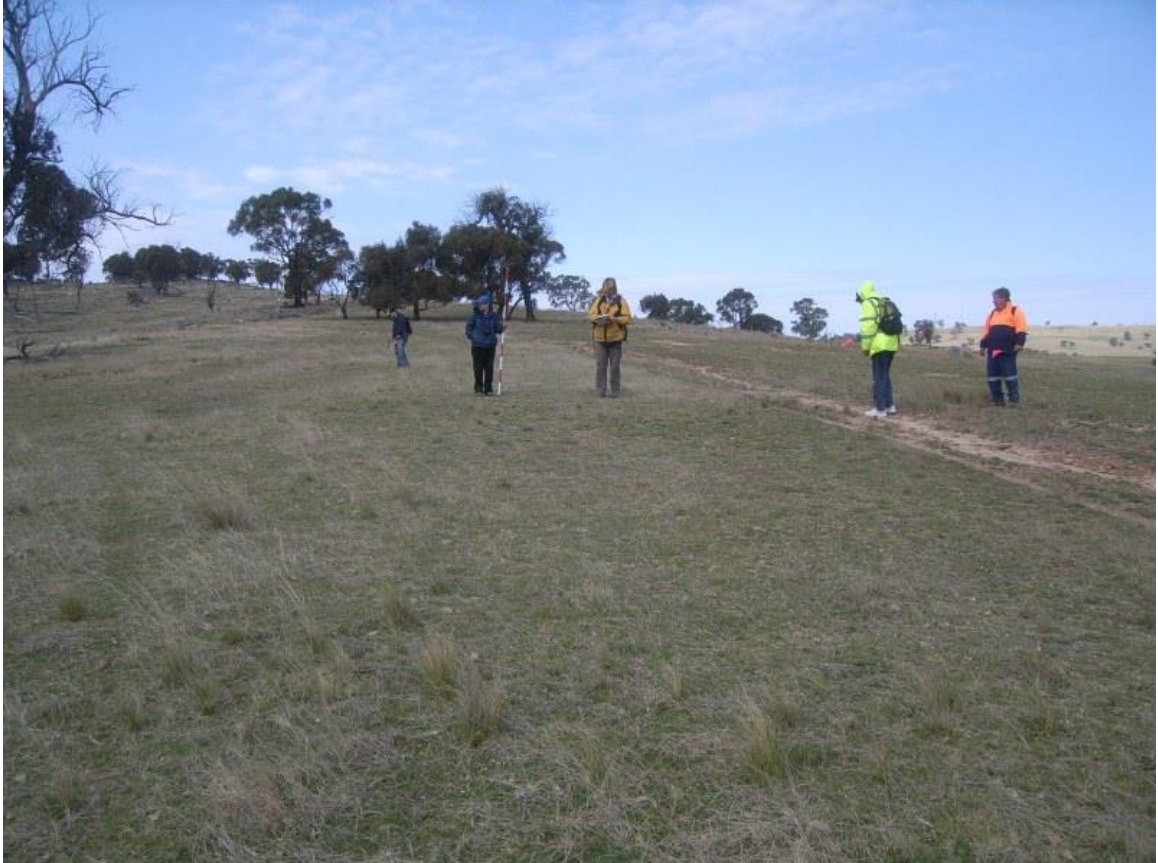
Aboriginal object locale ID: CRWF Survey Unit 4/Locale 3 (CRWF SU4/L3)  
Grid reference(GDA): Zone 55: E742836 N6343932  
Description: This locale is situated in Survey Unit 4, on a simple slope of a broad, undulating plateau landform. The aspect is northerly and gradient gentle (3°). The site is in a cleared paddock used for sheep grazing. One stone artefact was recorded:  
○ Tuff retouched artefact: 42mm x 21mm x 13mm.

Photograph: 20<sup>th</sup> September 2011; CRWF SU4/L3 taken facing to 180°.

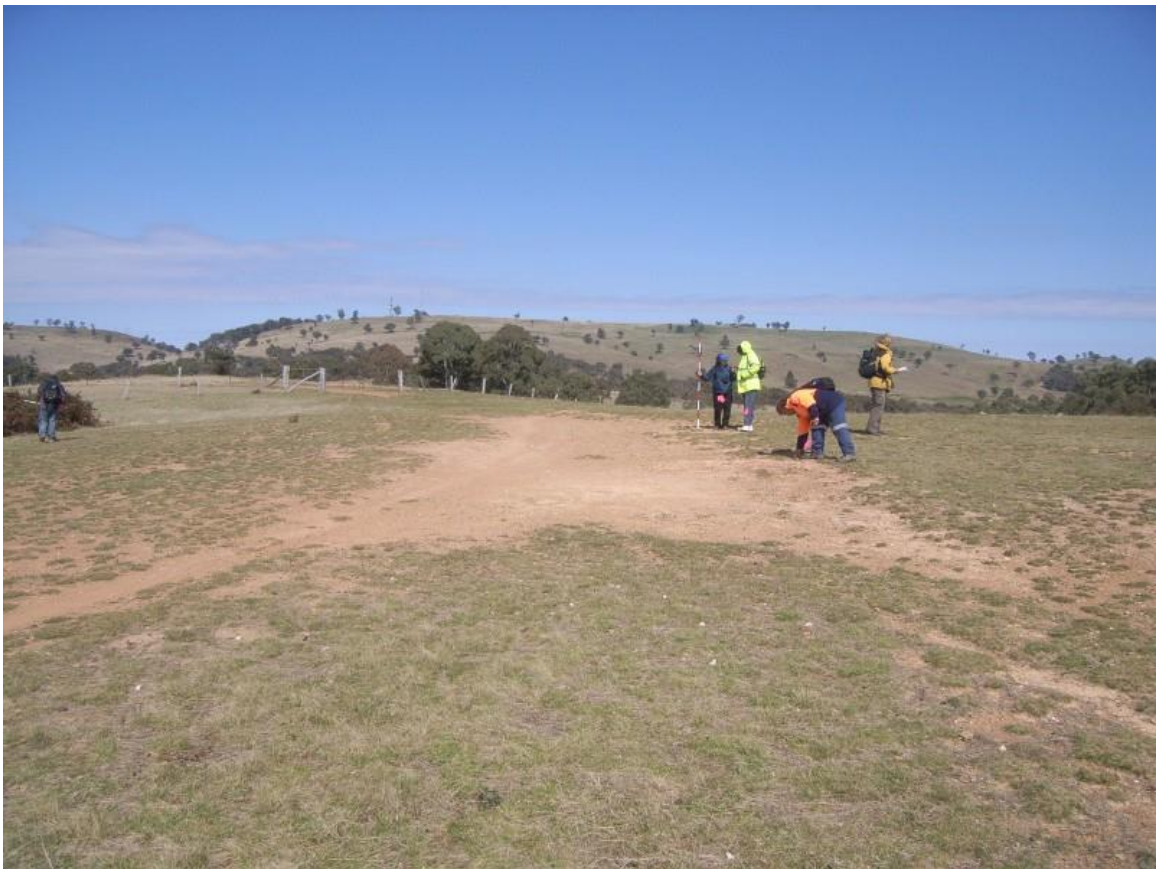
- Tuff flake fragment; 41mm x 24mm x 12mm;
- Tuff flake; 18mm x 17mm x 6mm;
- Tuff flaked piece: 26mm x 25mm x 15mm.

Photograph: 20<sup>th</sup> September 2011; CRWF SU5/L1 taken facing to 230°.

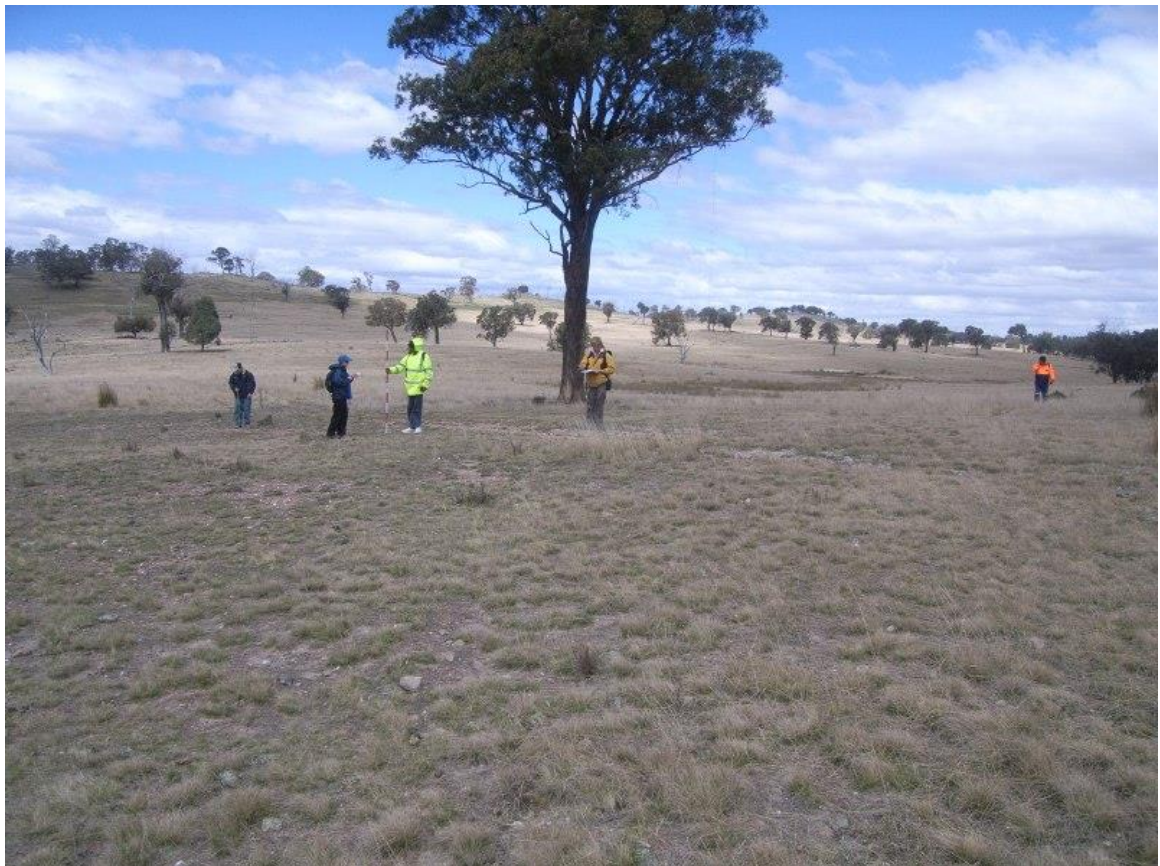
- Tuff flake; 25mm x 40mm x 8mm;
- Tuff flake; 26mm x 30mm x 10mm;
- Quartz flake; 21mm x 12mm x 8mm;
- Tuff flake fragment; long. snap: 33mm x 40mm x 9mm
- Tuff flake; 33mm x 35mm x 8mm;
- Tuff flake fragment; 11mm x 33mm x 10mm.

Photograph: 20<sup>th</sup> September 2011; CRWF SU6/L1 taken facing to 170°.

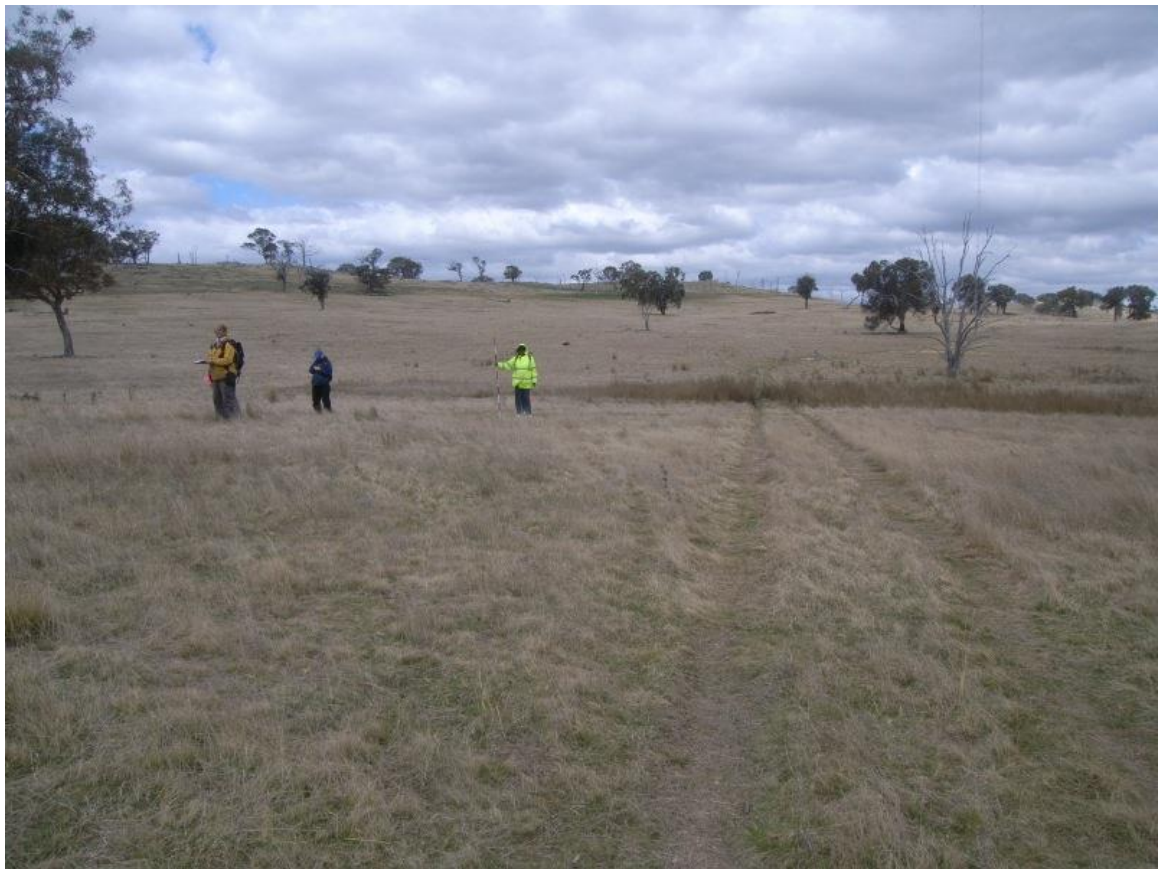
- Tuff flaked piece; 70mm x 38mm x 20mm;
- Tuff flake; 20mm x 15mm x 6mm;
- Quartz (translucent)flaked piece; 18mm x 17mm x 12mm;

Photograph: 20<sup>th</sup> September 2011; CRWF SU6/L2 taken facing to 150°.

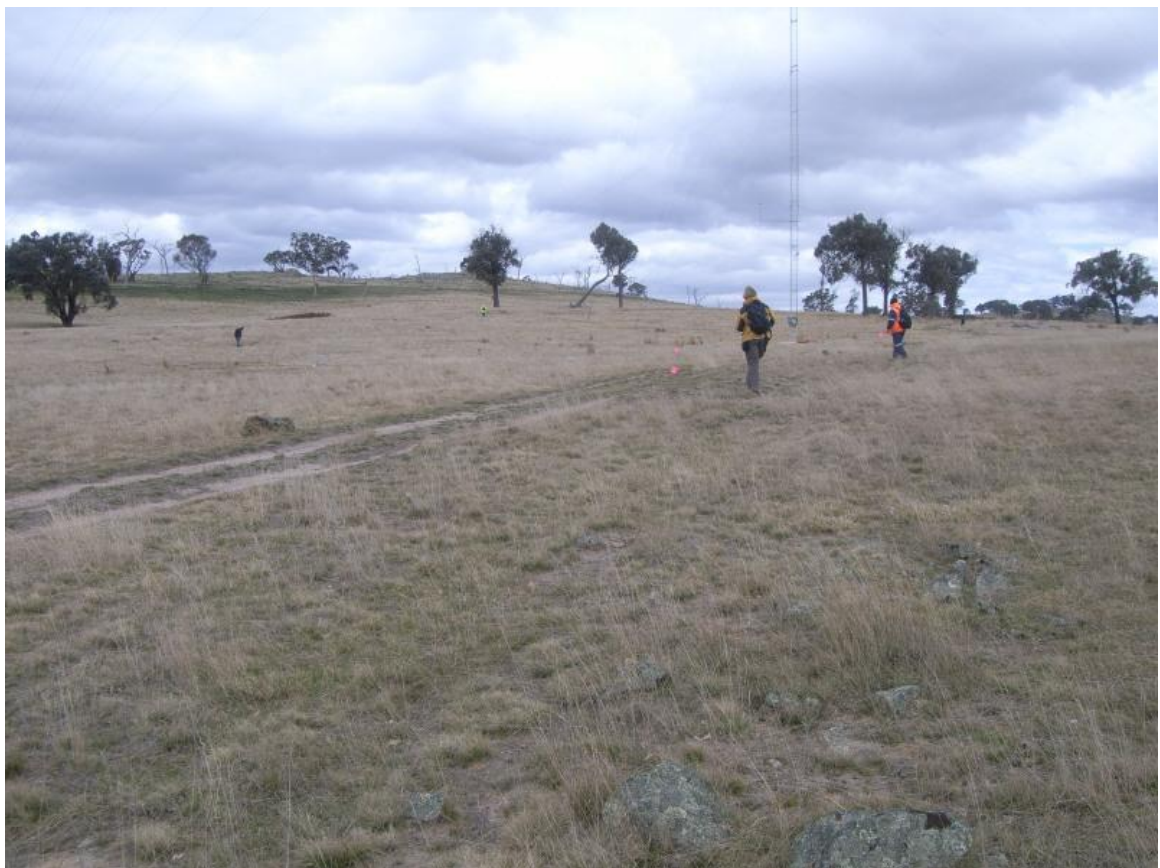
- Tuff flake; 42mm x 61mm x 11mm;
- Tuff flake fragment; distal; 20mm x 21mm x 4mm;
- Tuff flake fragment; 9mm x 13mm x 2mm;
- Tuff flake fragment; 20mm x 21mm x 5mm;
- Quartz (milky)flake; 24mm x 16mm x 5mm;
- Tuff flake fragment; 21mm x 11mm x 5mm;
- Chert flaked piece; 22mm x 19mm x 6mm;
- Tuff flake fragment; distal; 23mm x 39mm x 13mm;
- Tuff flake fragment; proximal; 16mm x 30mm x 6mm;
- Tuff flaked piece; 30mm x 35mm x 9mm.

Photograph: 20<sup>th</sup> September 2011; CRWF SU6/L3 taken facing to 170°.

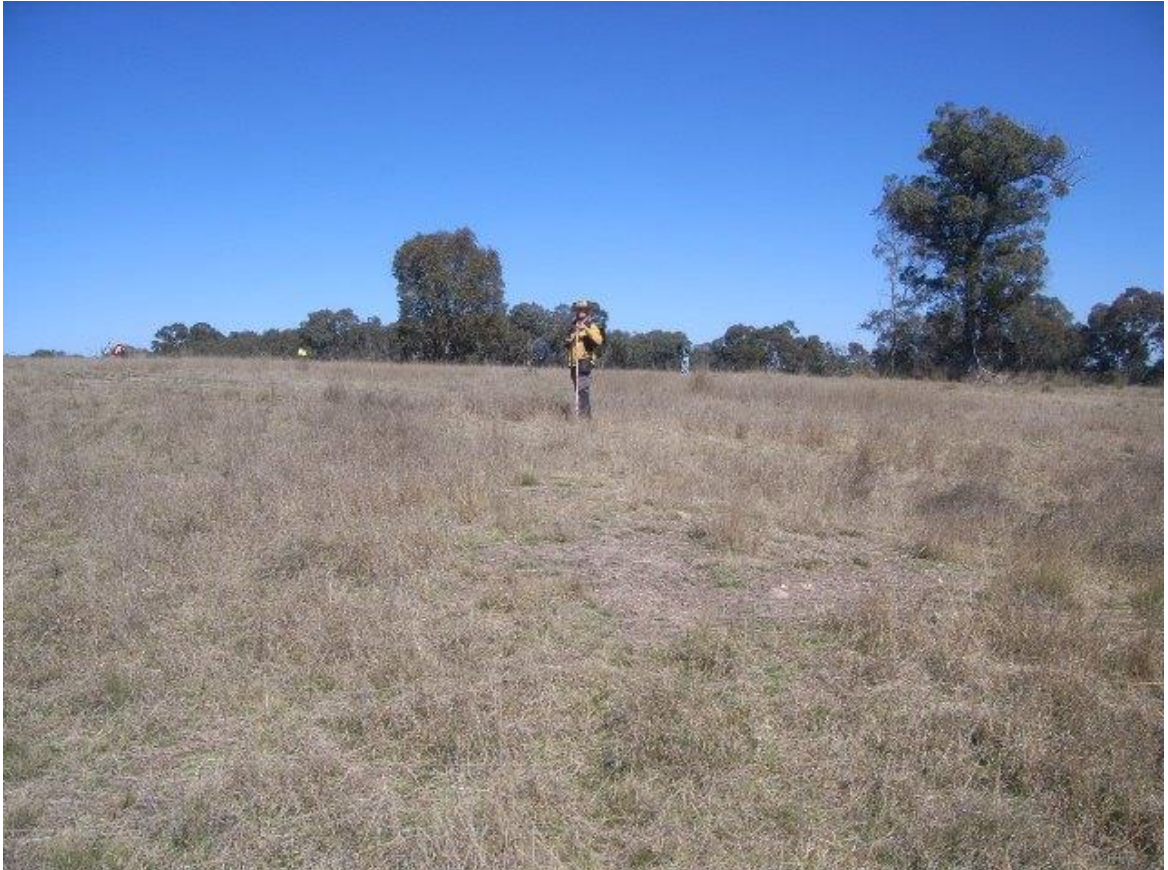
21<sup>st</sup> September 2011; CRWF SU6/L5 taken facing to 230°.

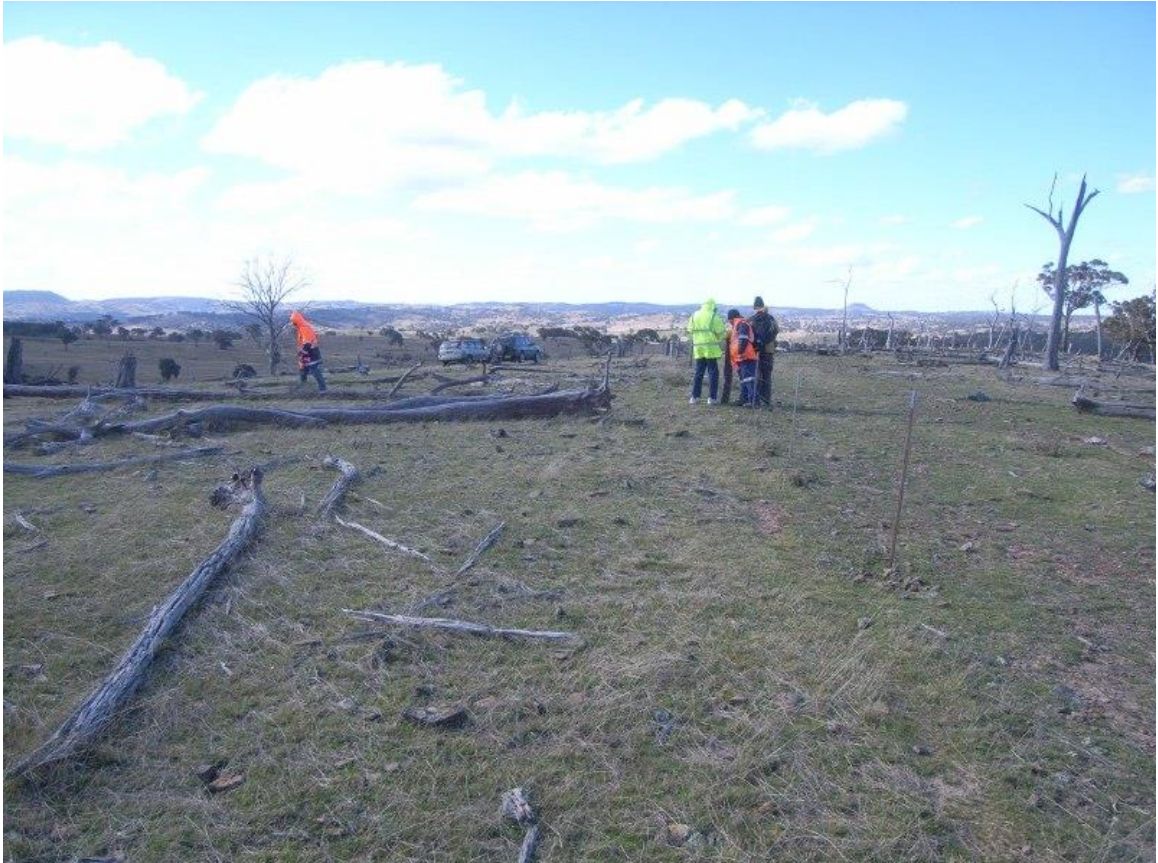
- Tuff blade flake; 71mm x 19mm x 9mm.

Photograph: 20<sup>th</sup> September 2011; CRWF SU7/L1 taken facing to the north.

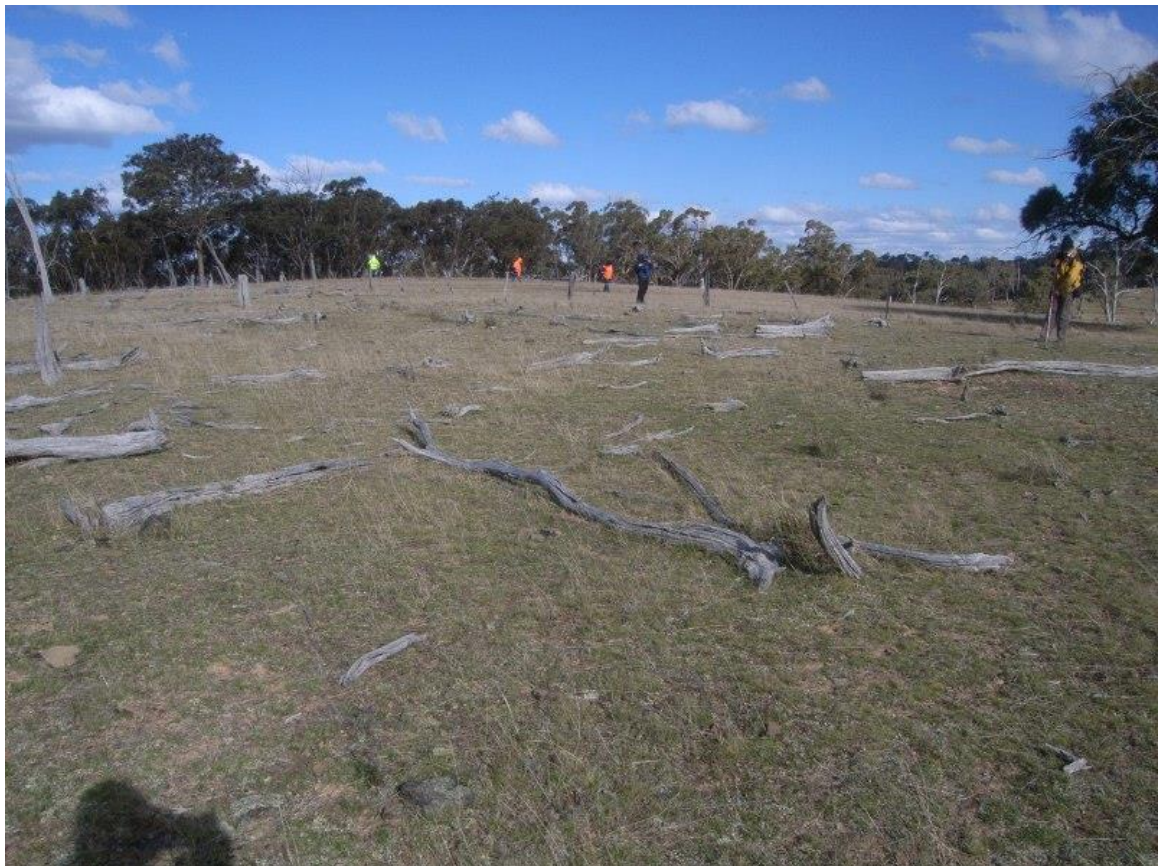
Aboriginal object locale ID: CRWF Survey Unit 7/Locale 2 (CRWF SU7/L2)  
 Grid reference(GDA): Zone 55: E744270 N6347436  
 Description: This locale is situated in Survey Unit 7, on a crest of a broad, undulating plateau landform. The aspect is open and gradient very gentle (1-2°). The site is a cleared paddock used for sheep grazing. Seven stone artefacts were recorded in an area measuring approximately 40 x 40 metres (1,600 sq m):

- Quartz (milky)flake; 19mm x 11mm x 6mm;
- Tuff flake with terrestrial cortex; 55mm x 15mm x 7mm;
- Chert flake; 22mm x 51mm x 11mm;
- Chert retouched artefact; 42mm x 17mm x 7mm;
- Chert flaked piece; 25mm x 42mm x 8mm;
- Tuff broken retouched artefact; *Bondi point*; proximal portion; 36mm x 15mm x 5mm.

Photograph: 20<sup>th</sup> September 2011; CRWF SU7/L2 taken facing to 130°.

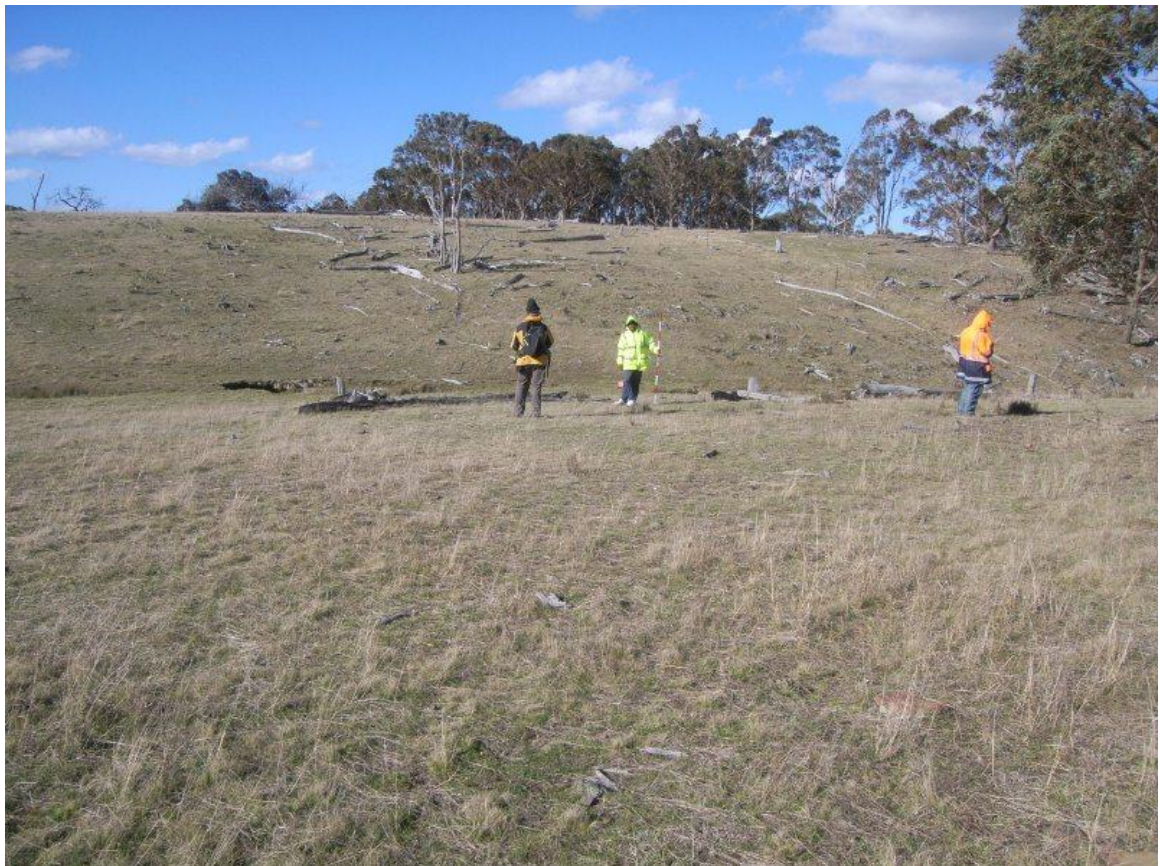
- Tuff flake; 54mm x 48mm x 14mm;
- Tuff flake; 28mm x 20mm x 4mm;
- Tuff flaked piece; 43mm x 19mm x 14mm;
- Chert blade core; 49mm x 25mm x 26mm;
- Tuff flake fragment; 23mm x 16mm x 4mm.

Photograph: 20<sup>th</sup> September 2011; CRWF SU7/L3 taken facing to 30°.

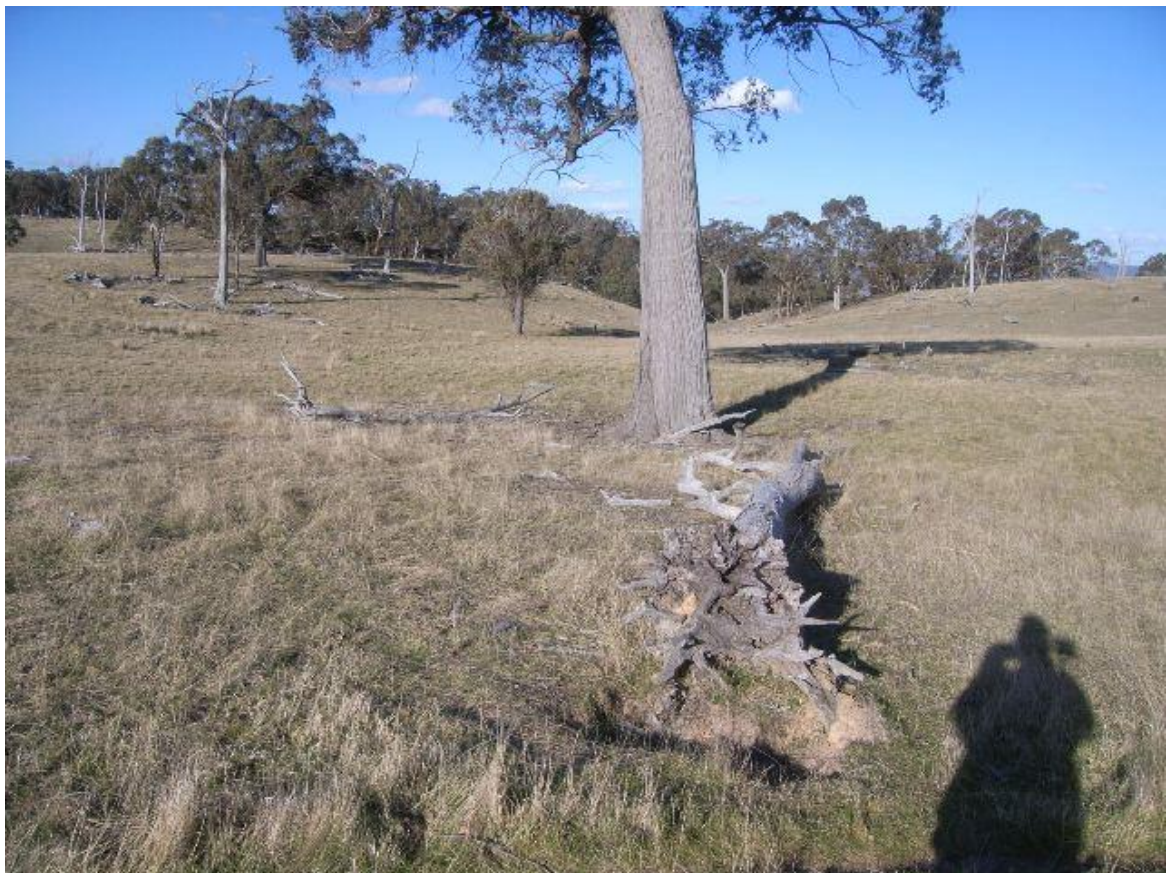
- Tuff core (amorphous); 2 scars: 82mm x 68mm x 65mm;
- Chert (banded) flaked piece with usewear; 3 notches along one margin, each of which is c. 2cm wide; 70mm x 55mm x 30mm.

Photograph: 20<sup>th</sup> September 2011; CRWF SU7/L5 taken facing to 70°.
