# Crudine Ridge Wind Farm Aboriginal Heritage Management Plan

November 2017  
Final

This Aboriginal Heritage Management Plan (AHMP) has been prepared by Julie Dibden, NSW Archaeology Pty Ltd, for CWP Renewables on behalf of Crudine Ridge Wind Farm Pty Ltd (The Proponent). The document forms a component of the Crudine Ridge Wind Farm (CRWF; the Project) Environmental Management Strategy (EMS).

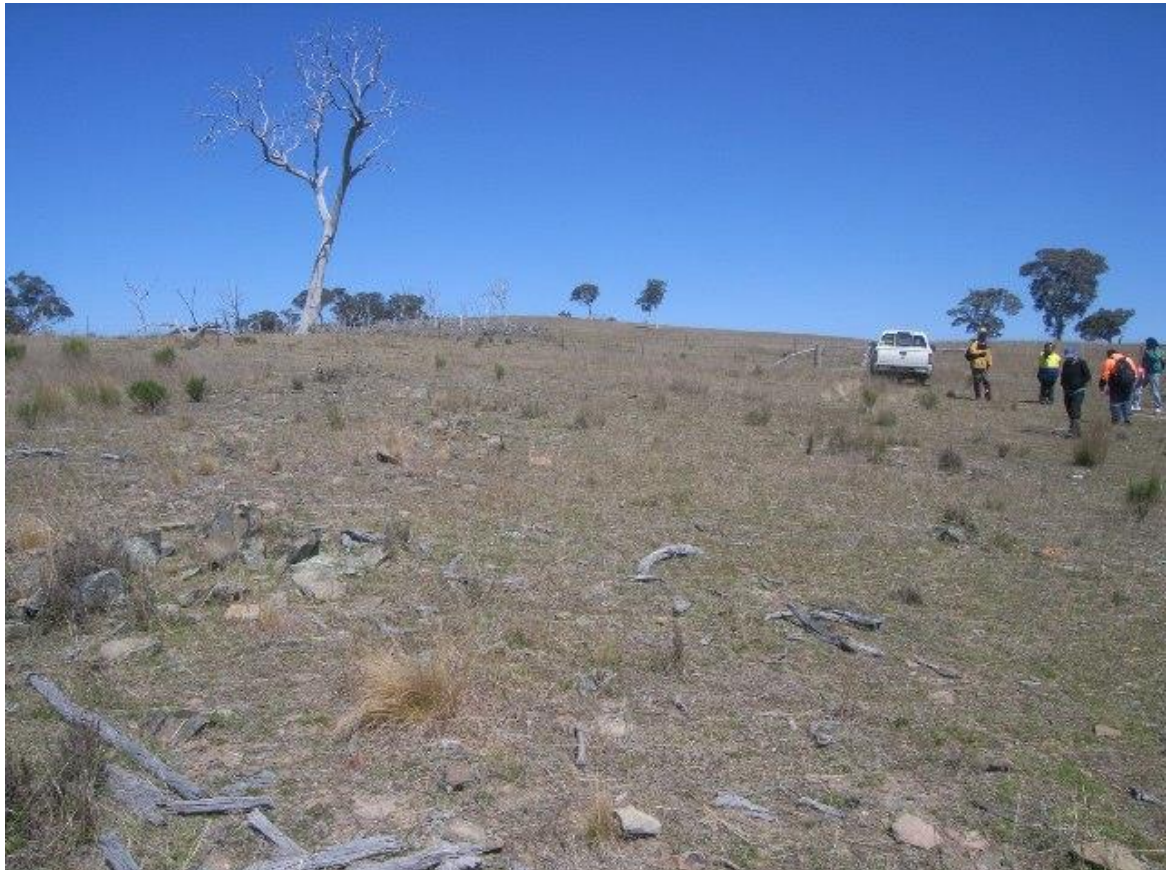
Aboriginal object locale ID: CRWF Survey Unit 7/Locale 6 (CRWF SU7/L6)  
Grid reference(GDA): Zone 55: E744702 N6348674  
Description: This locale is situated in Survey Unit 7, on a crest of a broad, undulating plateau landform. The aspect is to the north and gradient very gentle (2°). The site is in a cleared paddock used for sheep grazing. One stone artefact was recorded:  
○ Chert flaked piece; 35mm x 19mm x 16mm.

Photograph: 21<sup>st</sup> September 2011; CRWF SU7/L6 taken facing to 190°.

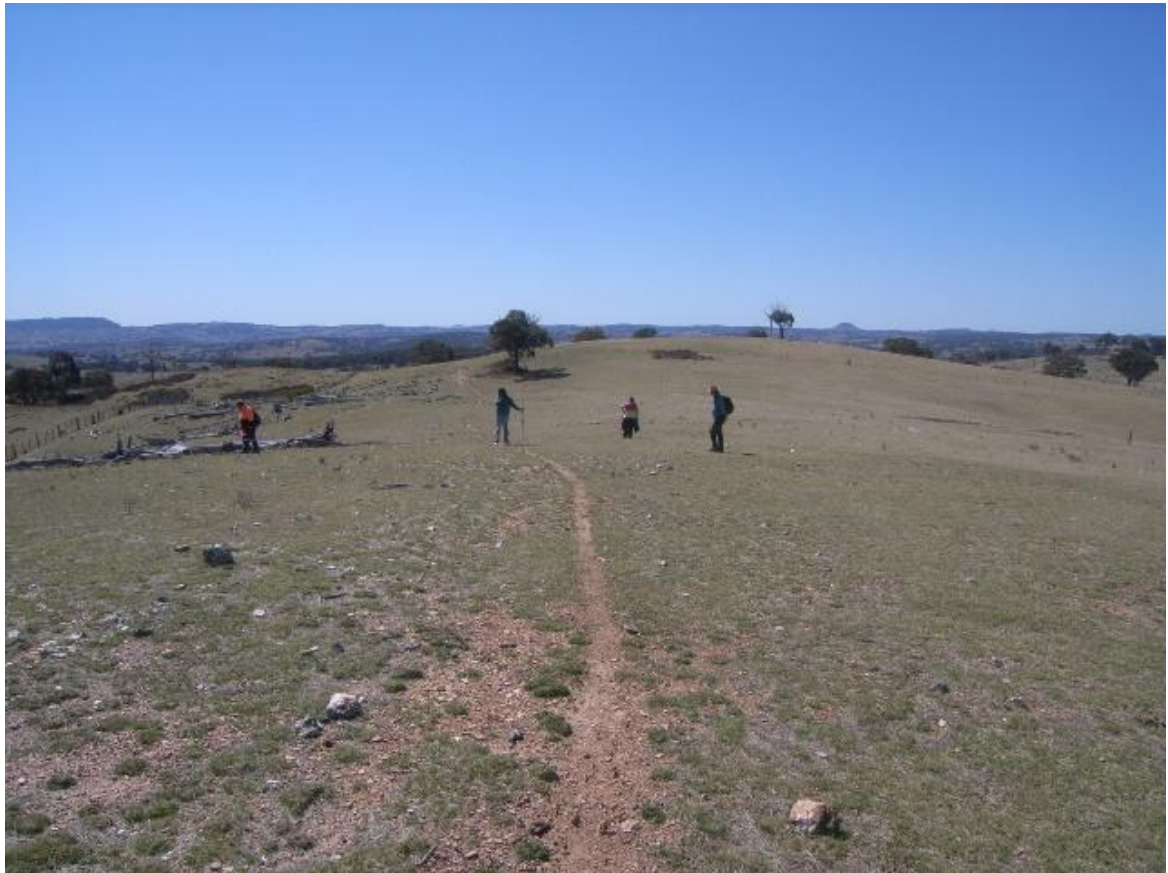
Aboriginal object locale ID: CRWF Survey Unit 8/Locale 1 (CRWF SU8/L1)  
Grid reference(GDA): Zone 55: E743822 N6347354  
Description: This locale is situated in Survey Unit 8, on a crest of a broad, undulating plateau landform. The aspect is northerly and gradient very gentle (2°). The site is in a cleared paddock used for sheep grazing. One stone artefact was recorded:  
○ Tuff proximal flake portion: 20mm x 48mm x 30mm.

Photograph: 21<sup>st</sup> September 2011; CRWF SU8/L1 taken facing to the north.

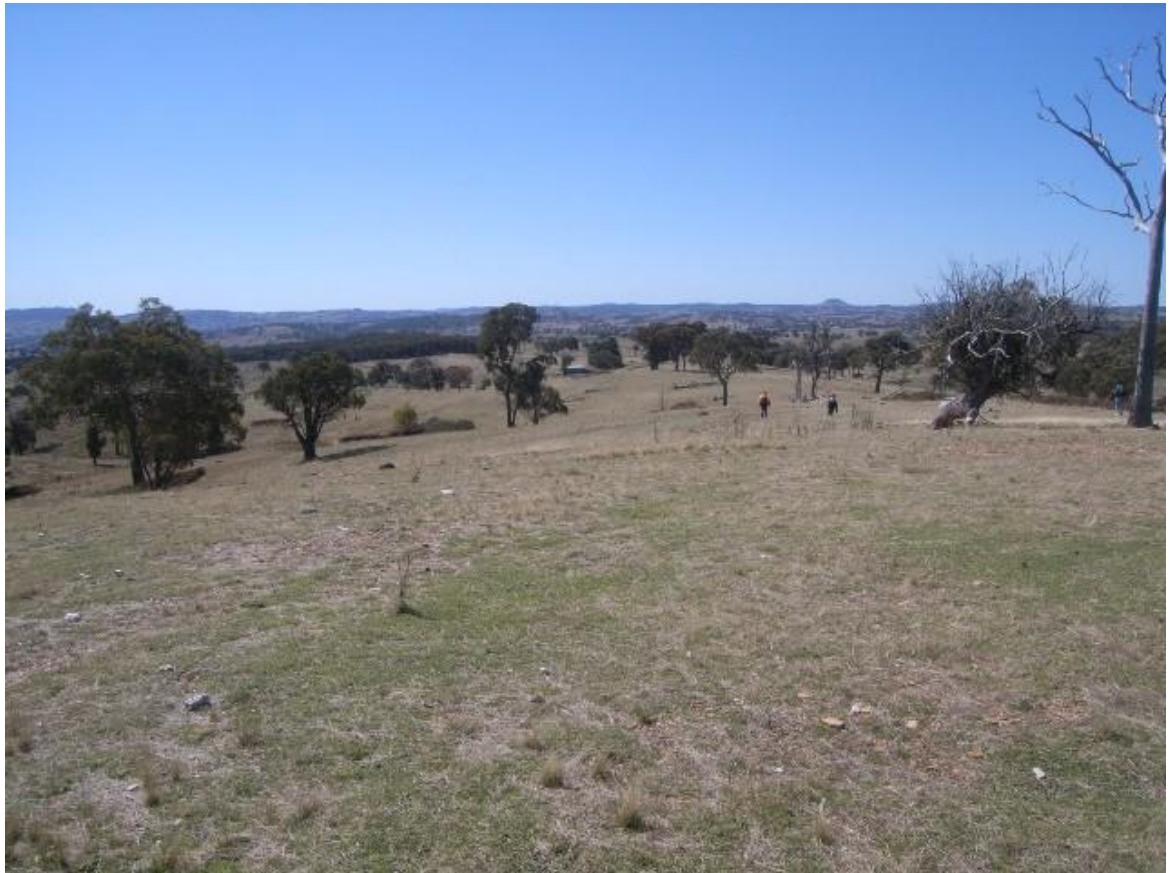
Aboriginal object locale ID: CRWF Survey Unit 8/Locale 2 (CRWF SU8/L2)  
Grid reference(GDA): Zone 55: E744053 N6347984  
Description: This locale is situated in Survey Unit 8, on a crest of a broad, undulating plateau landform. The aspect is northerly and gradient gentle (3°). The site is in a cleared paddock used for sheep grazing. One stone artefact was recorded:  
○ Tuff flaked piece: 51mm x 29mm x 8mm.

Photograph: 21<sup>st</sup> September 2011; CRWF SU8/L2 taken facing to the north.

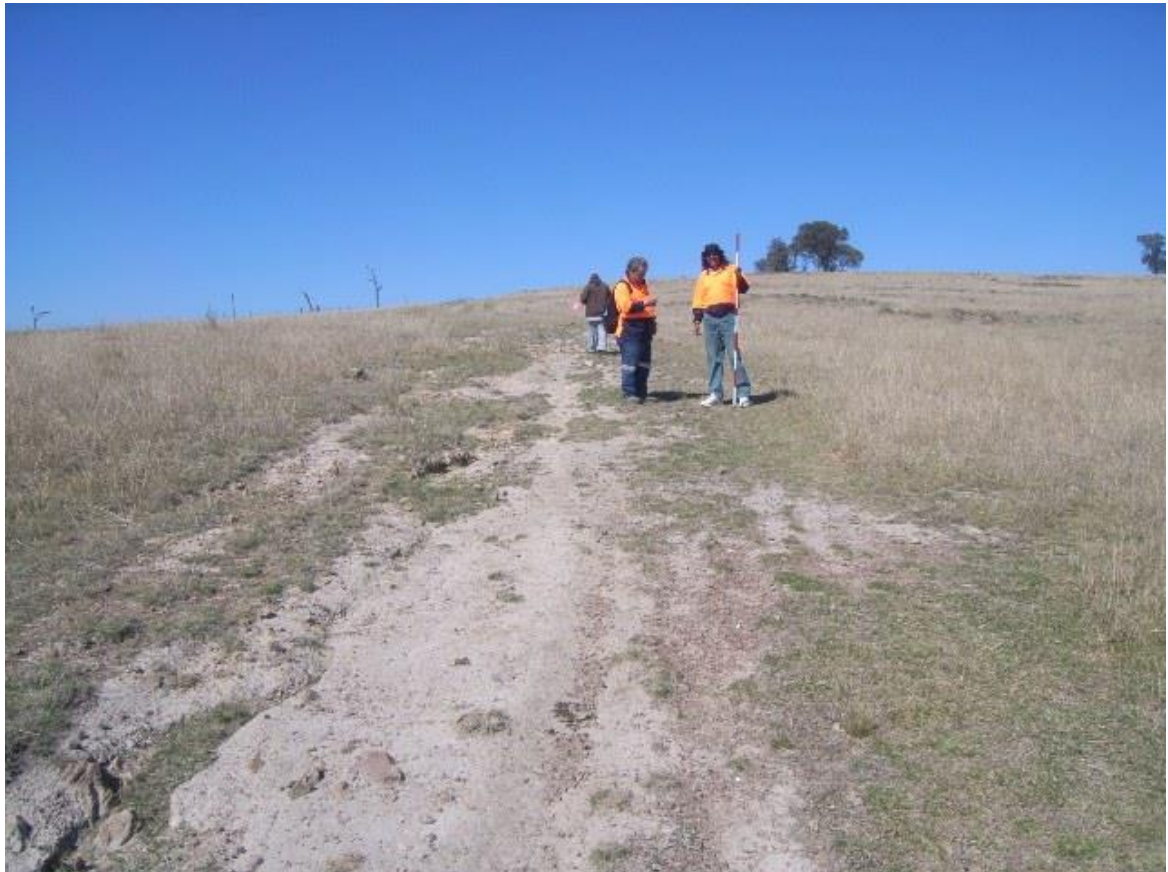
- Tuff proximal flake portion; 37mm x 32mm x 9mm.

Photograph: 22<sup>nd</sup> September 2011; CRWF SU9/L1 taken facing to 180°.

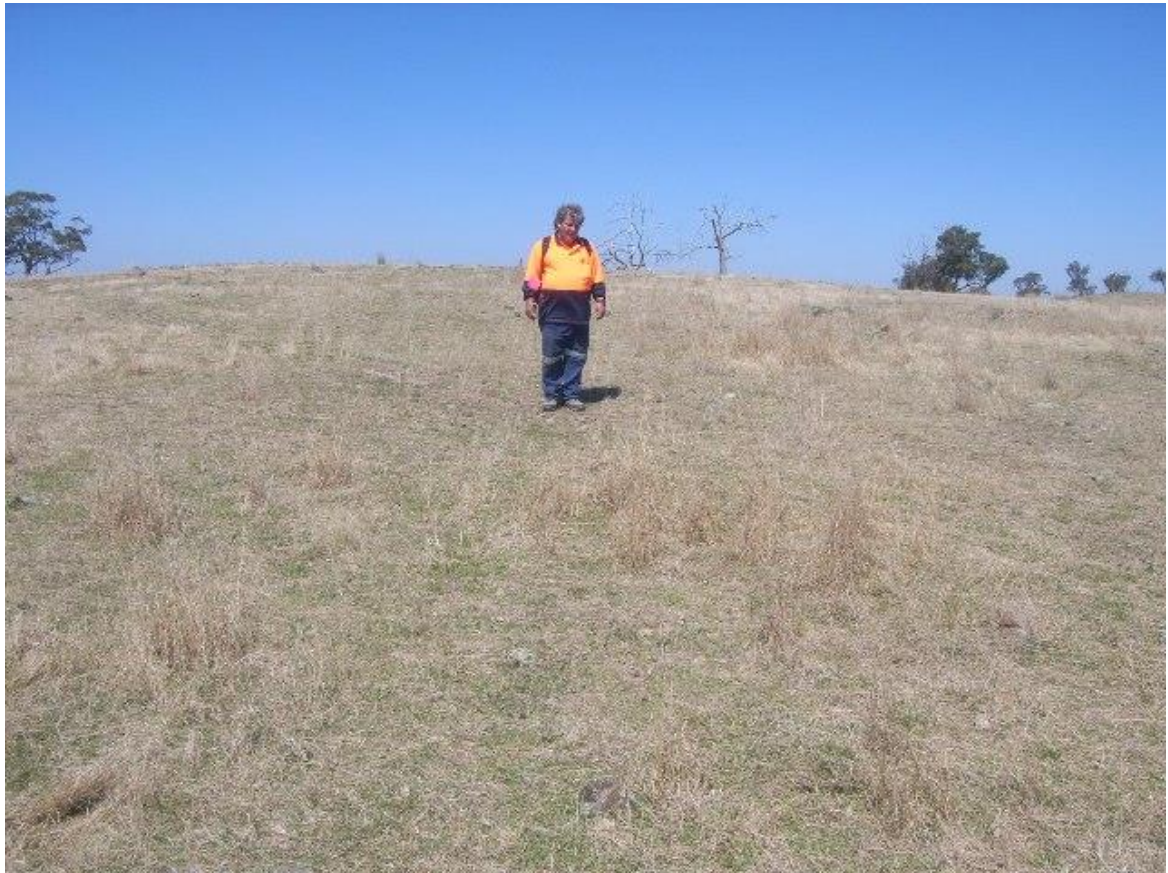
Aboriginal object locale ID: CRWF Survey Unit 9/Locale 2 (CRWF SU9/L2)  
Grid reference(GDA): Zone 55: E750955 N6355239  
Description: This locale is situated in Survey Unit 9, on a crest of a broad, undulating plateau landform. The aspect is northerly and gradient gentle (4°). The site is in a cleared paddock used for sheep grazing. One stone artefact was recorded on bare earth:  
○ Tuff proximal flake portion; 30mm x 25mm x 10mm.

Photograph: 22<sup>nd</sup> September 2011; CRWF SU9/L2 taken facing to 150°.

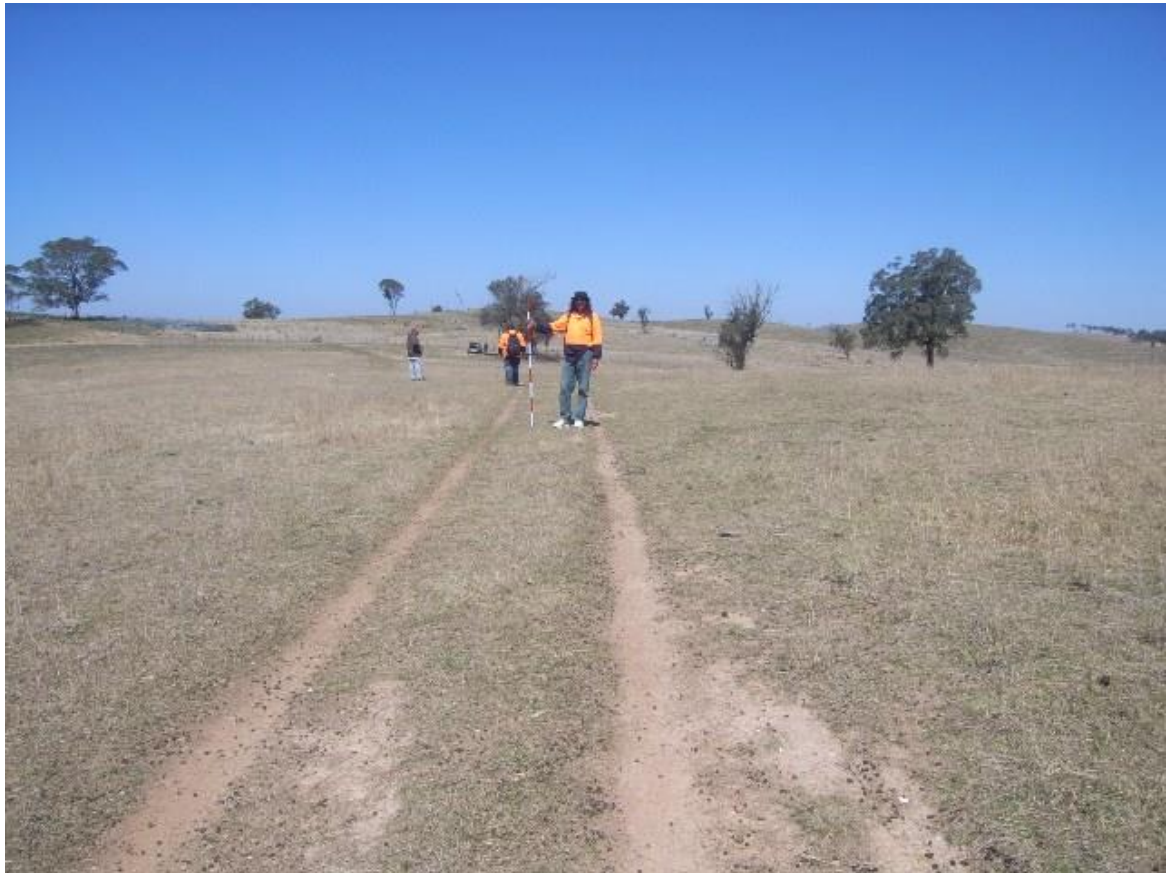
Aboriginal object locale ID: CRWF Survey Unit 9/Locale 3 (CRWF SU9/L3)  
Grid reference(GDA): Zone 55: E750357 N6354009  
Description: This locale is situated in Survey Unit 9, on a crest of a broad, undulating plateau landform. The aspect is open and gradient very gentle (1°). The site is in a cleared paddock used for sheep grazing. One stone artefact was recorded on a track:  
○ Tuff flaked piece; 40mm x 35mm x 17mm.

Photograph: 22<sup>nd</sup> September 2011; CRWF SU9/L3 taken facing to 150°.

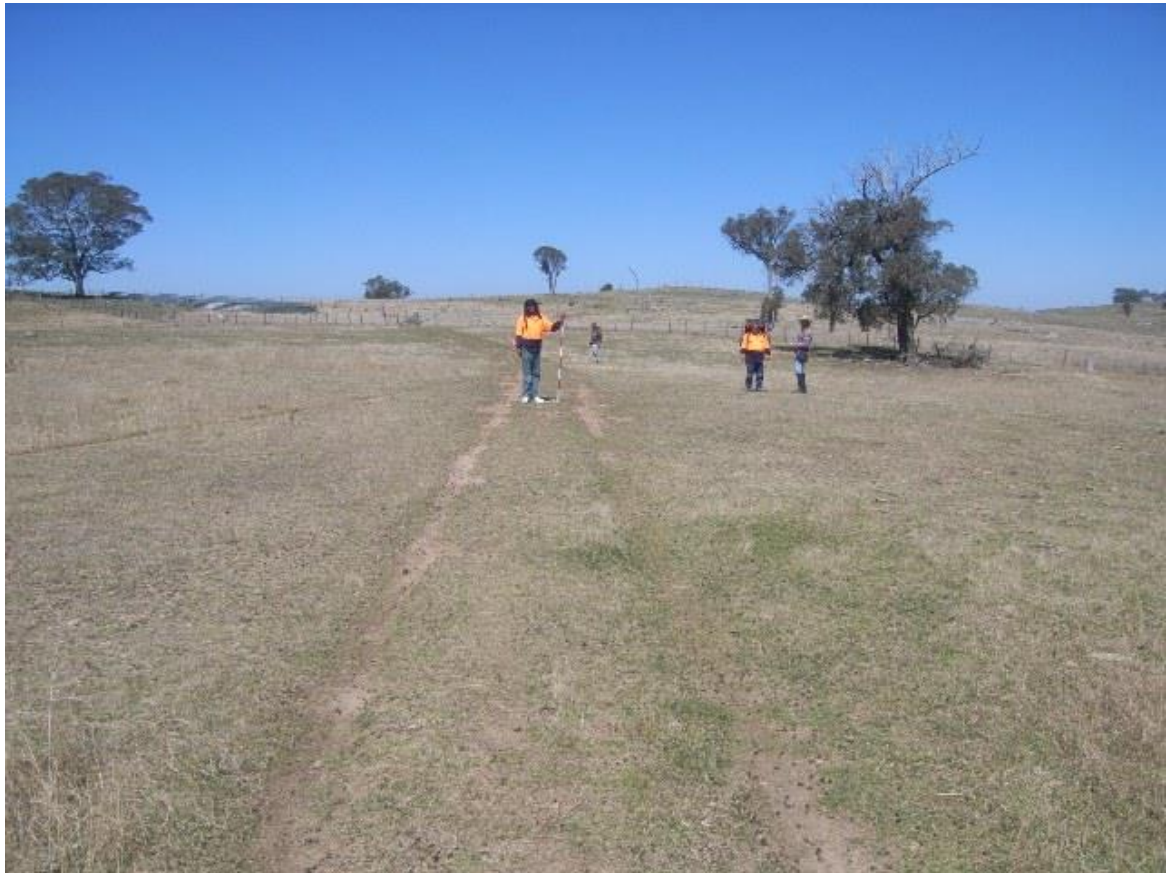
- Tuff flake fragment; 20mm x 17mm x 6mm.

Photograph: 22<sup>nd</sup> September 2011; CRWF SU9/L4 taken facing to 150°.

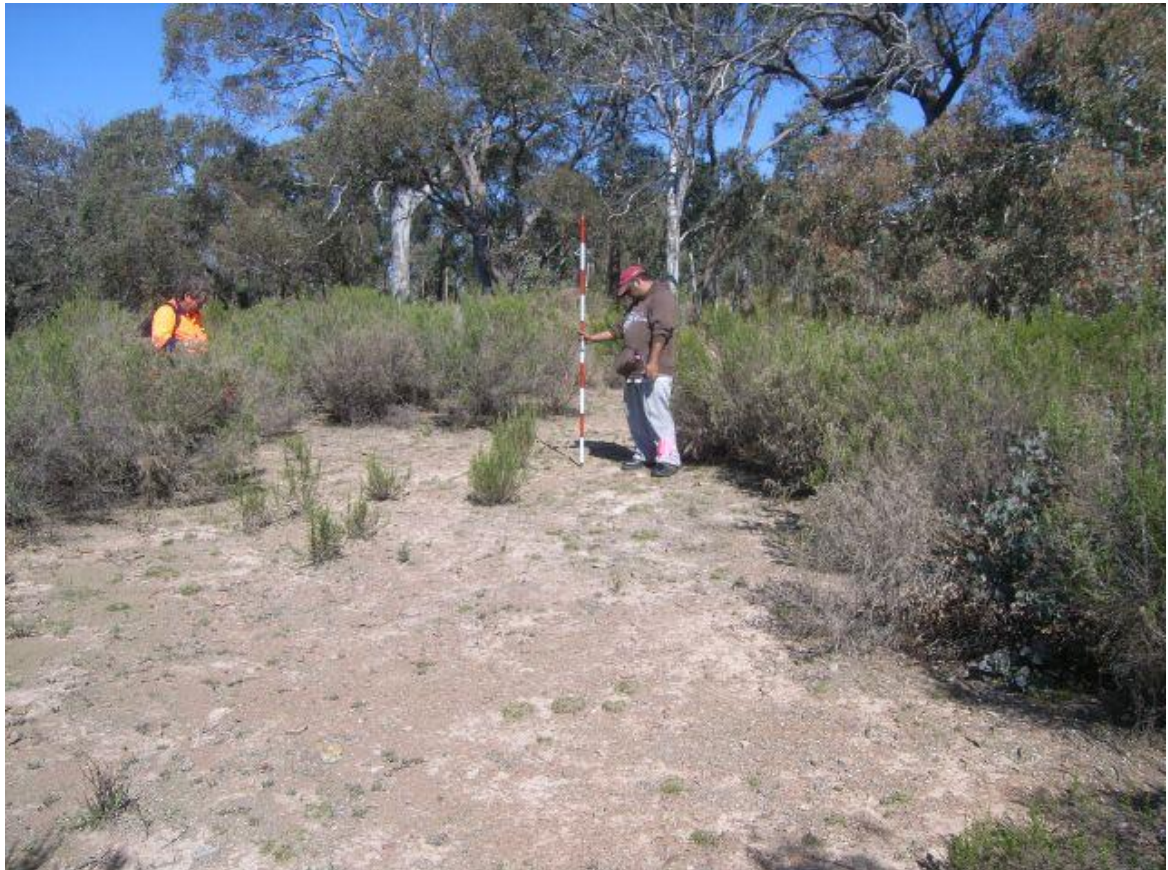
- Tuff flake; 35mm x 25mm x 14mm.

Photograph: 22<sup>nd</sup> September 2011; CRWF SU10/L1 taken facing to 120°.

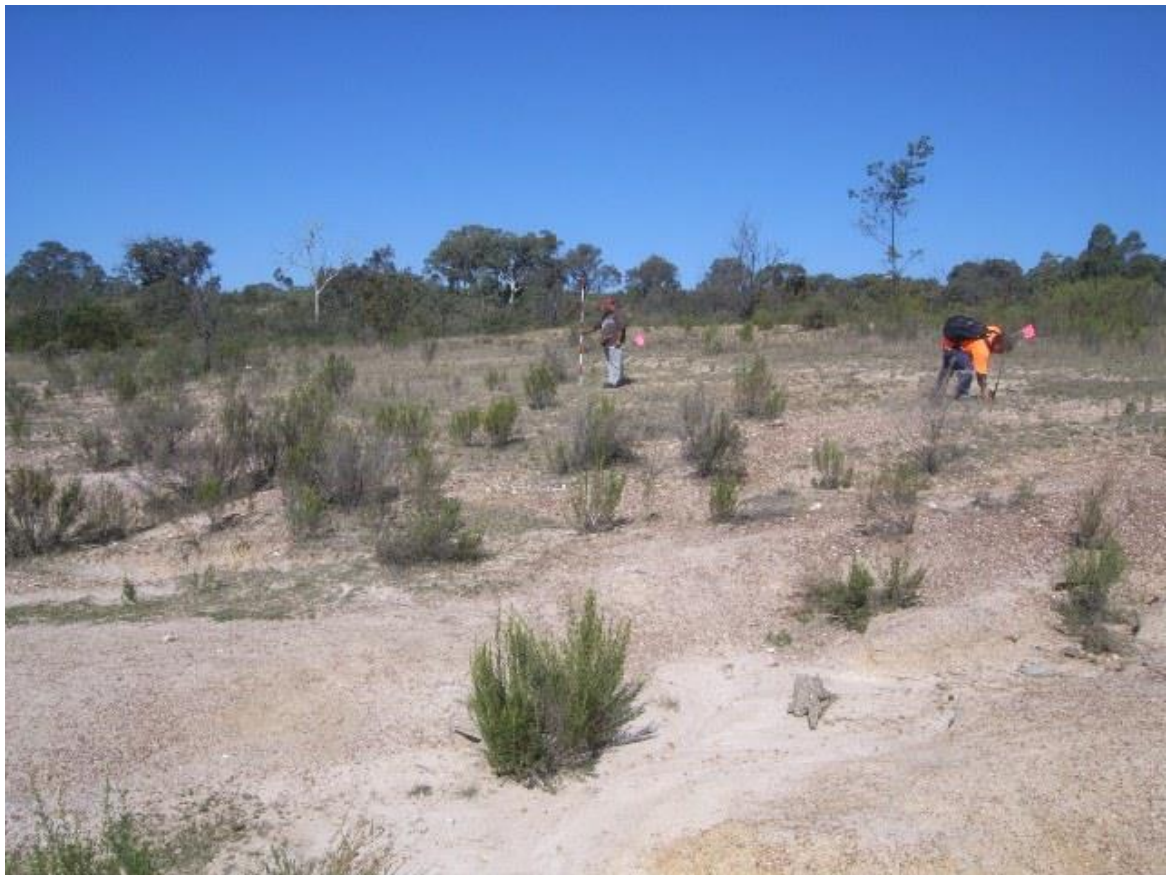
- Tuff flaked piece; 25mm x 32mm x 17mm;
- Tuff core; 2 scars; 25mm x 60mm x 32mm;

Photograph: 22<sup>nd</sup> September 2011; CRWF SU10/L2 taken facing to 90°.

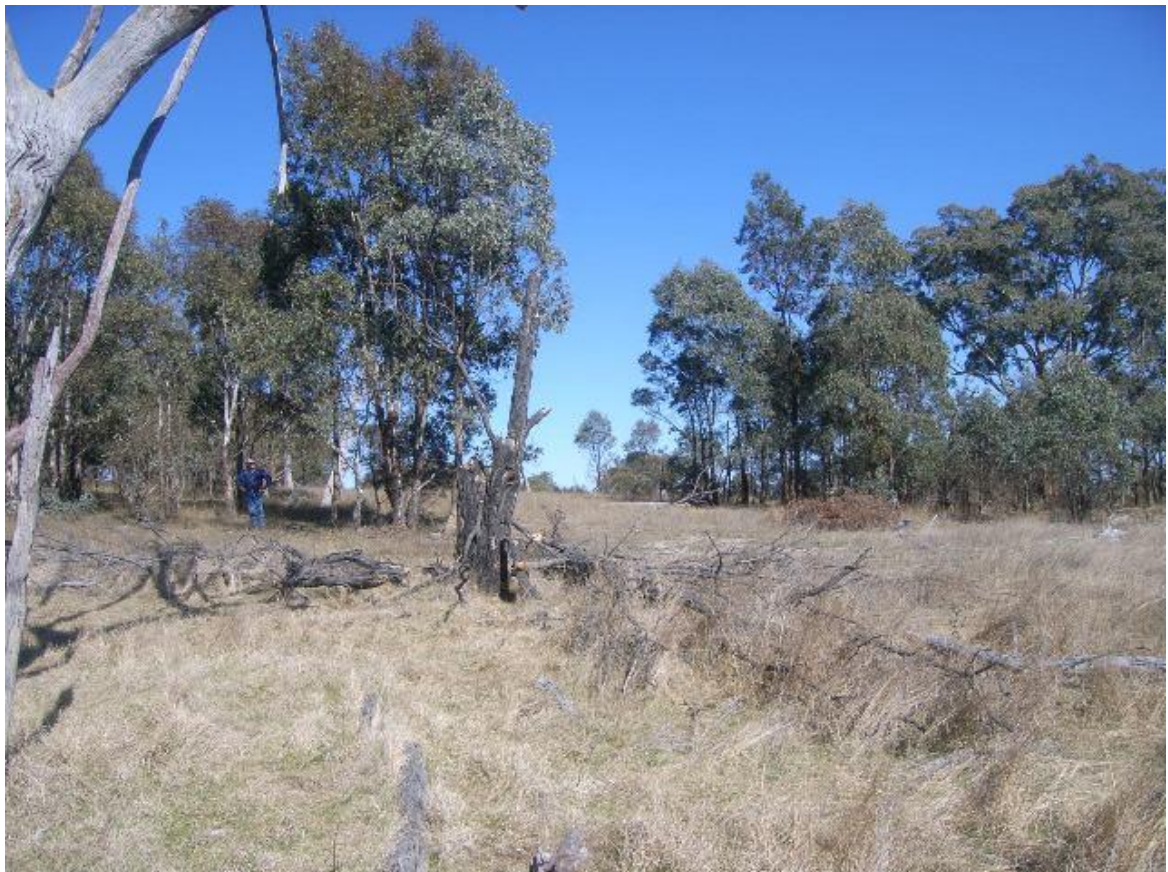
- Uncertain material: flaked piece with terrestrial cortex; 45mm x 45mm x 20mm;
- Tuff flake fragment; 20mm x 30mm x 4mm;
- Tuff flake; 38mm x 18mm x 6mm;
- Chert retouched artefact; *Bondi point*; 20mm x 8mm x 4mm.

Photograph: 23<sup>rd</sup> September 2011; CRWF SU12/L1 taken facing to 240°.

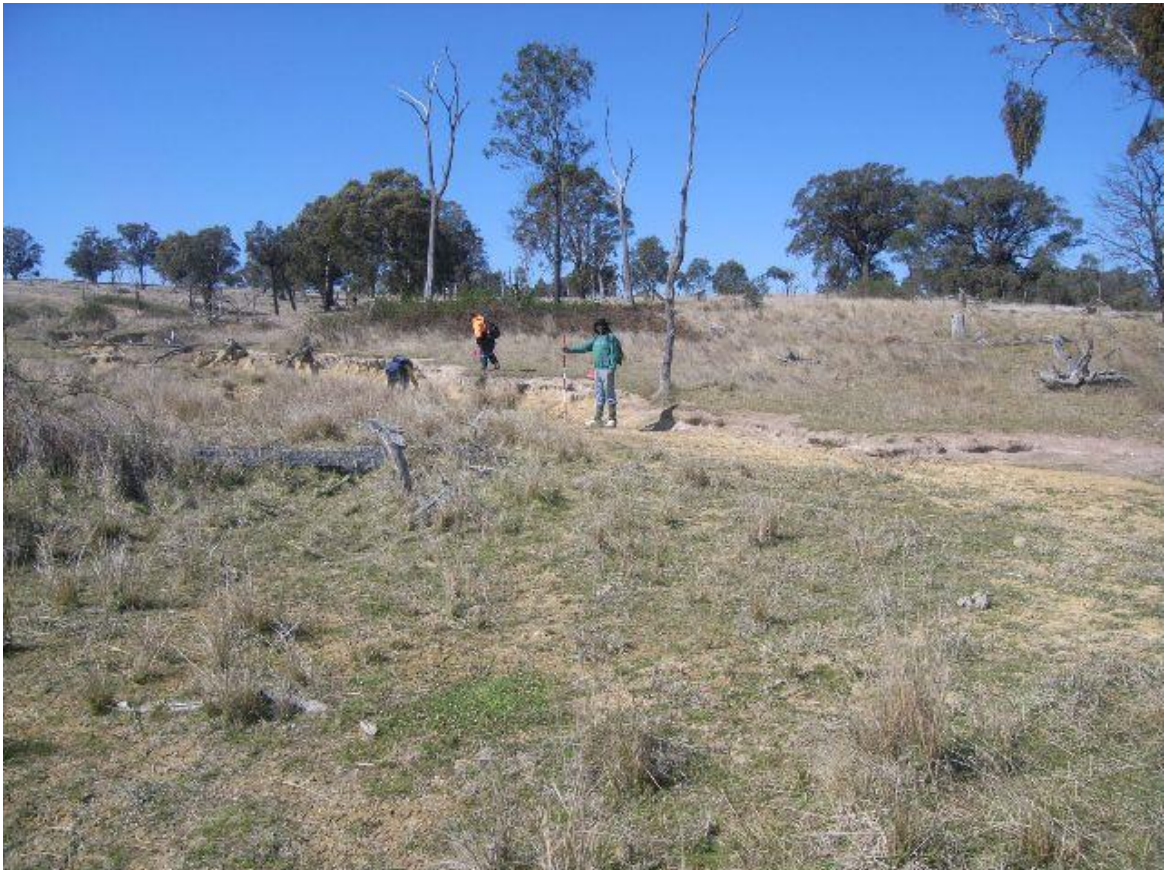
- Tuff flake; 60mm x 28mm x 11mm;
- Tuff flaked piece; 50mm x 22mm x 12mm.

Photograph: 23<sup>rd</sup> September 2011; CRWF SU12/L2 taken facing to 150°.

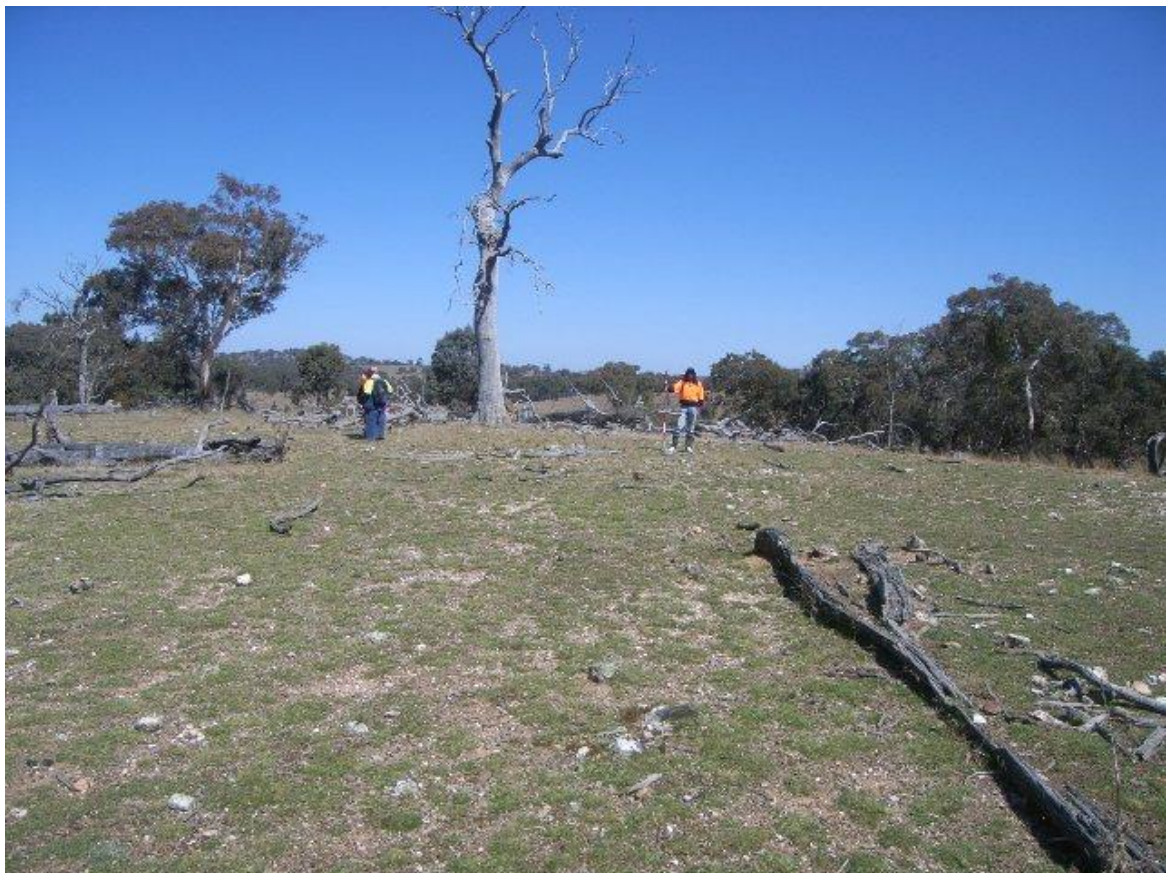
- Tuff flake fragment with usewear; terrestrial cortex; 55mm x 28mm x 18mm;
- Chert flake; 25mm x 42mm x 12mm;
- Tuff flaked piece; terrestrial cortex : 35mm x 17mm x 12mm.

Photograph: 23<sup>rd</sup> September 2011; CRWF SU13/L1 taken facing to 240°.

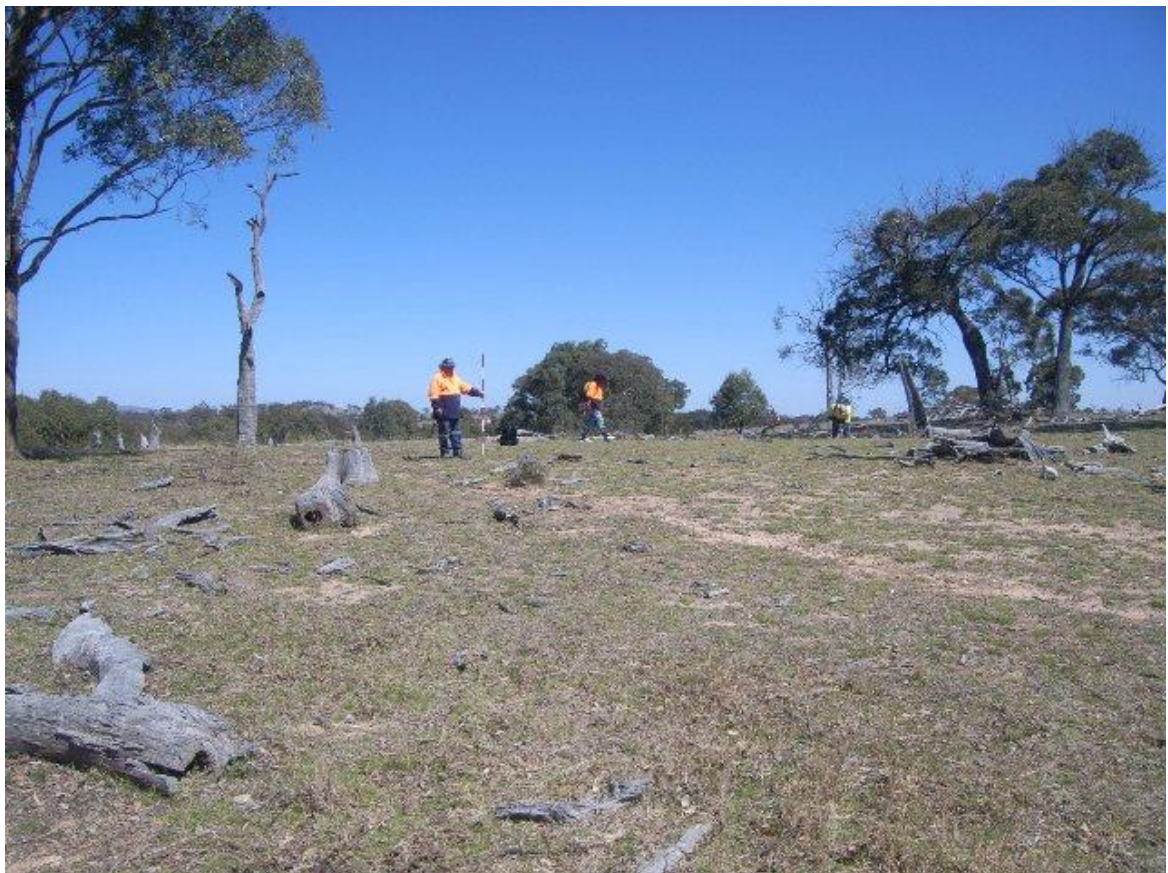
- Tuff flake fragment; 12mm x 21mm x 4mm;
- Tuff flake; 25mm x 22mm x 10mm;
- Tuff flake; 25mm x 37mm x 11mm;
- Tuff flake fragment; 25mm x 30mm x 10mm;
- Tuff flake with usewear and terrestrial cortex; 28mm x 30mm x 12mm;
- Tuff flake; 18mm x 24mm x 6mm;
- Tuff flake; 16mm x 28mm x 4mm;
- Chert (banded) flake fragment with usewear; 30mm x 23mm x 8mm;
- Tuff flake; 11mm x 18mm x 3mm;
- Silcrete (very fine grained) flake; 15mm x 25mm x 7mm.

Photograph: 23<sup>rd</sup> September 2011; CRWF SU13/L2 taken facing to 230°.

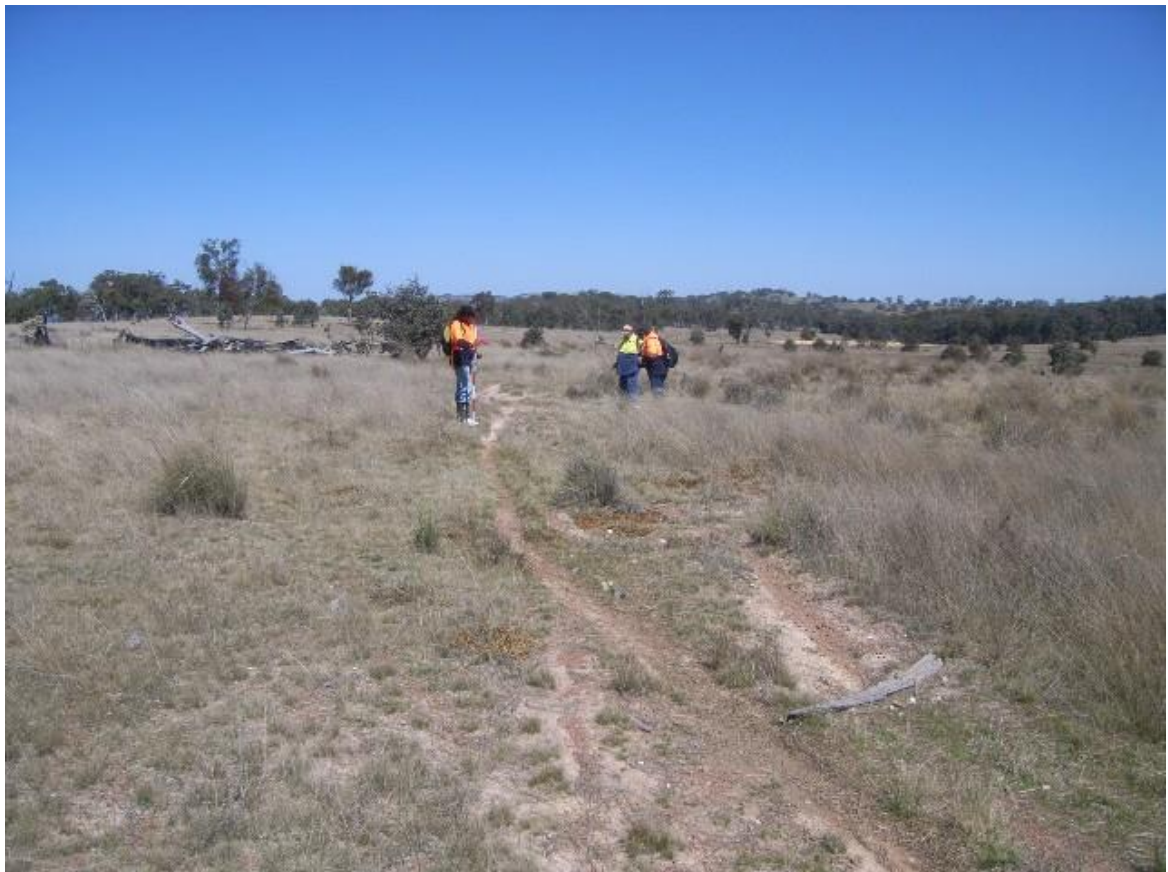
- Tuff proximal flake portion; 30mm x 35mm x 8mm;
- Tuff flake: 32mm x 33mm x 11mm.

Photograph: 23<sup>rd</sup> September 2011; CRWF SU13/L3 taken facing to 230°.

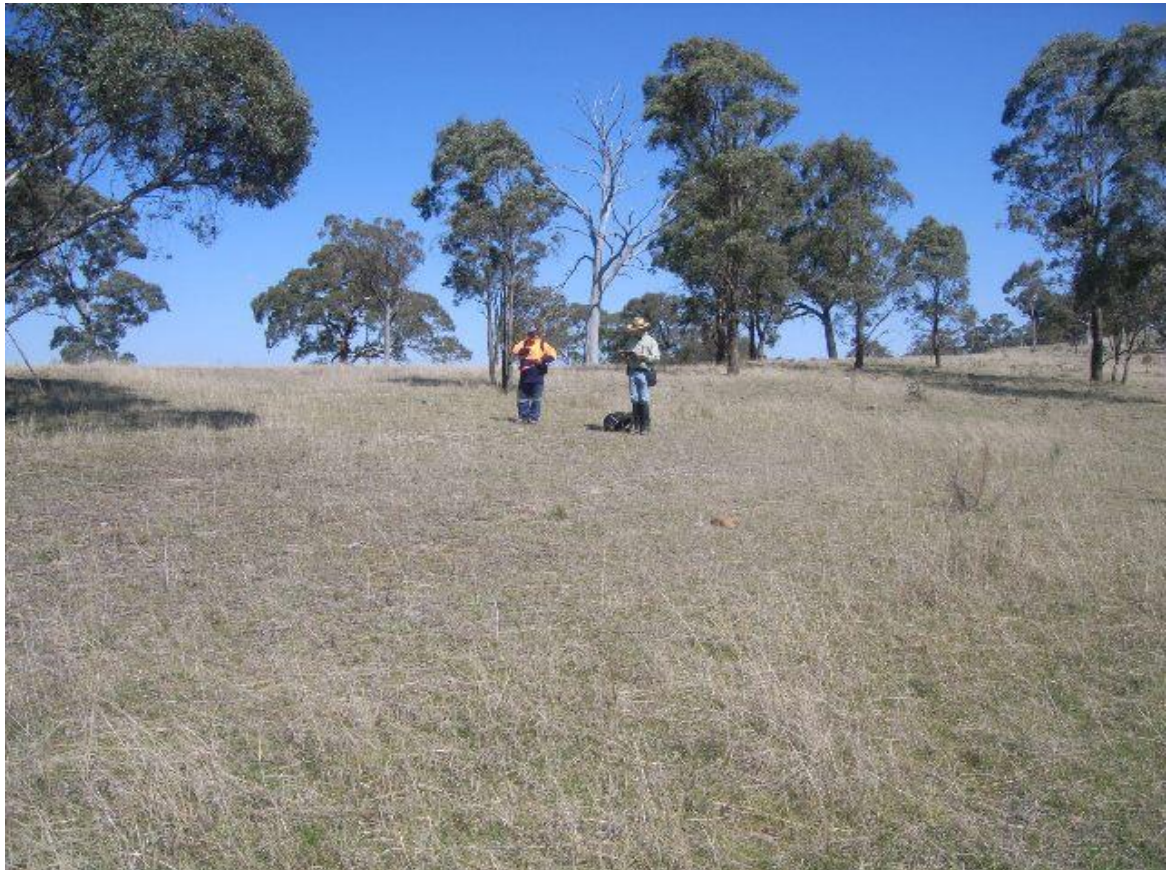
- Tuff flake; 50mm x 40mm x 15mm.

Photograph: 23<sup>rd</sup> September 2011; CRWF SU14/L1 taken facing to  $150^{\circ}$ .

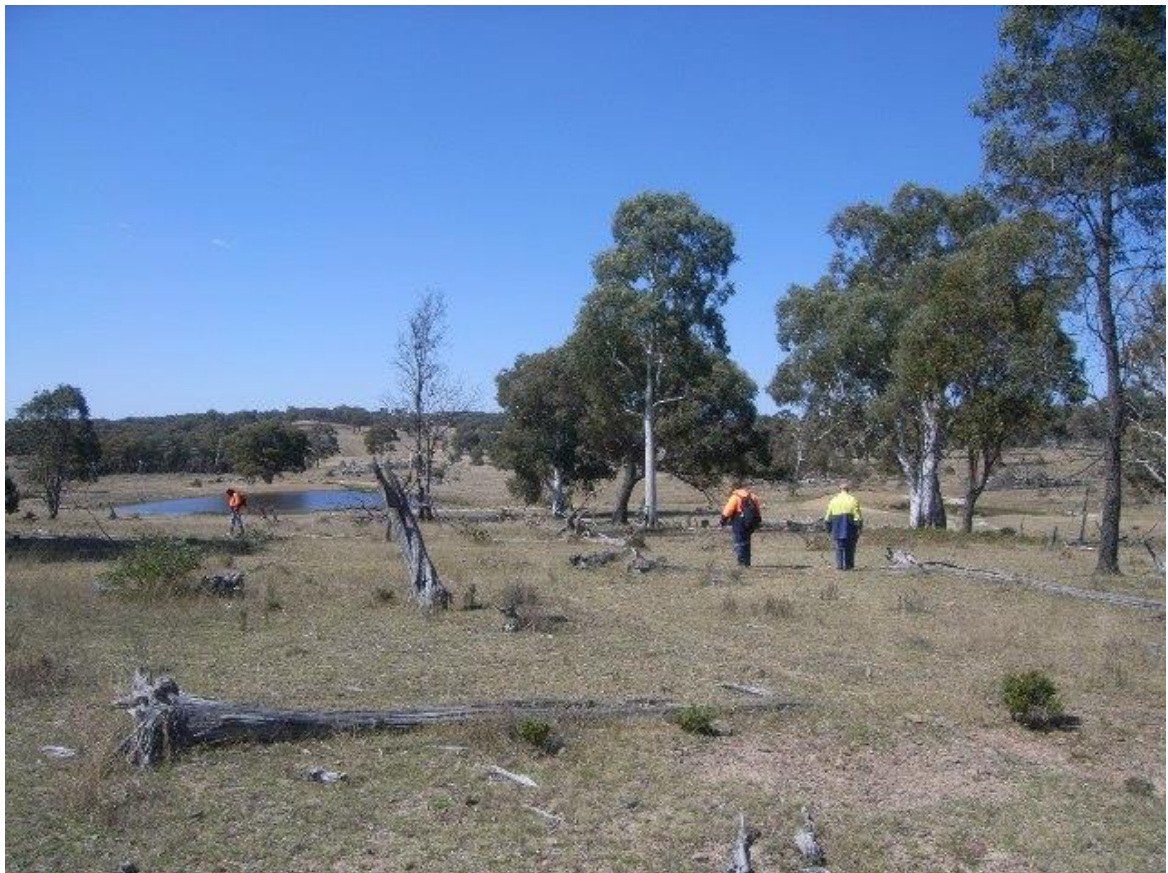
- Chert flake; 23mm x 35mm x 8mm;
- Tuff flake: 25mm x 28mm x 6mm.

Photograph: 23<sup>rd</sup> September 2011; CRWF SU14/L2 taken facing to 110°.

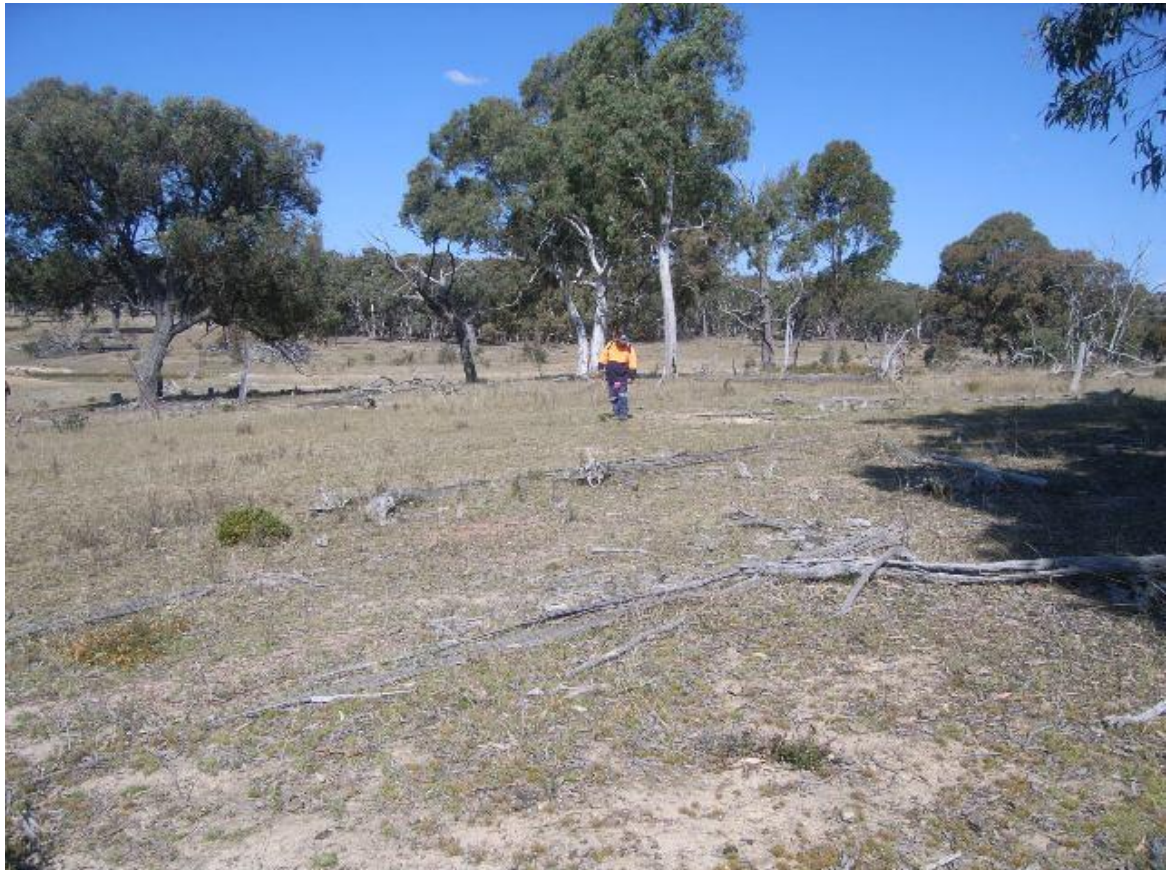
Aboriginal object locale ID: CRWF Survey Unit 14/Locale 3 (CRWF SU14/L3)  
Grid reference(GDA): Zone 55: E746665 N6349665  
Description: This locale is situated in Survey Unit 14, on a crest of a broad, undulating plateau landform. The aspect is westerly and gradient very gentle (1°). The site is in paddock used for sheep grazing. One stone artefact was recorded on bare earth:  
○ Tuff flake; 30mm x 40mm x 9mm.

Photograph: 23<sup>rd</sup> September 2011; CRWF SU14/L3 taken facing to 60°.

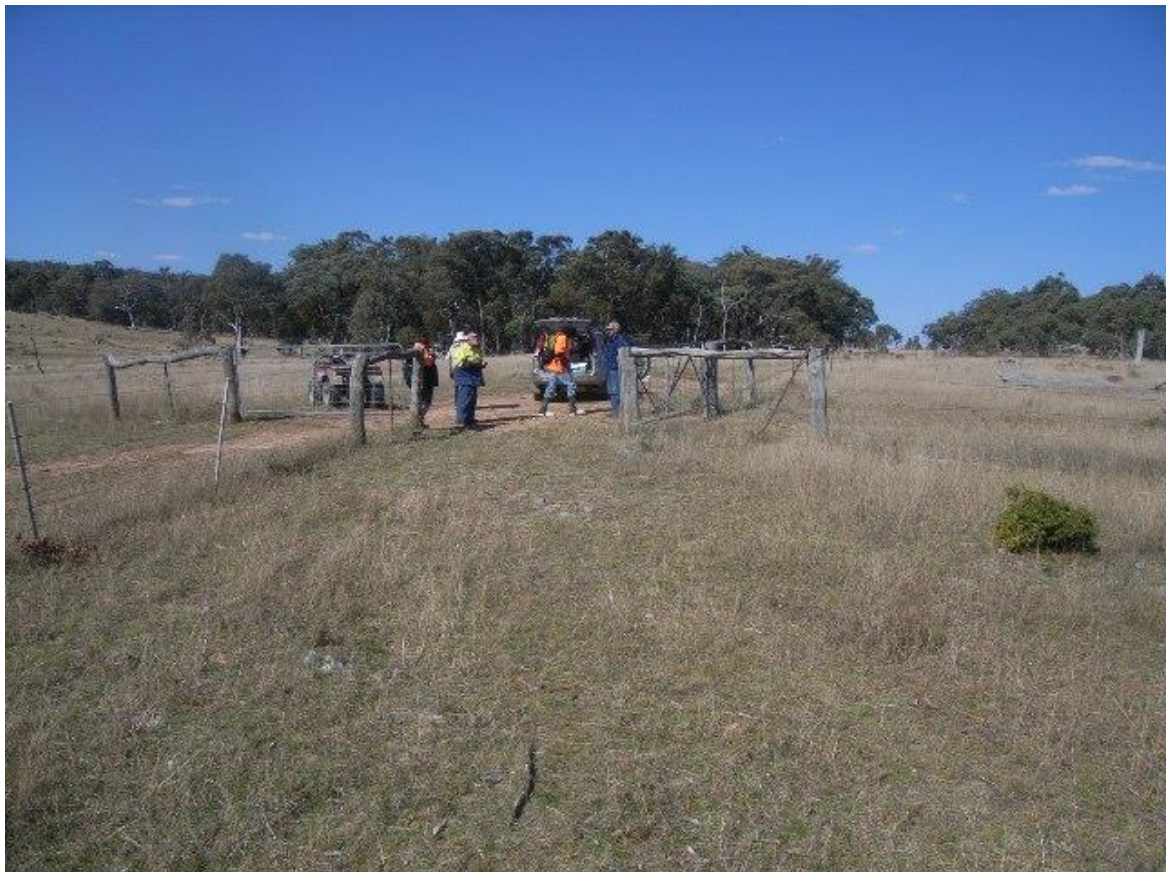
- Tuff flake fragment; 40mm x 23mm x 10mm;
- Quartz flake; 32mm x 25mm x 10mm;
- Tuff flake: 25mm x 8mm x 5mm;
- Tuff flake: 23mm x 15mm x 6mm;
- Tuff flake fragment: 14mm x 18mm x 3mm ;
- Tuff flake: 16mm x 11mm x 3mm;
- Tuff flaked piece: 45mm x 28mm x 10mm;
- Tuff flake: 40mm x 30mm x 15mm;
- Tuff flake fragment: 14mm x 22mm x 5mm;
- Tuff flake fragment: 15mm x 25mm x 5mm;
- Tuff flake fragment: 38mm x 18mm x 14mm;
- Tuff flake: 12mm x 26mm x 6mm;
- Tuff flake: 37mm x 20mm x 8mm;
- Tuff flaked piece: 25mm x 33mm x 12mm.

Photograph: 23<sup>rd</sup> September 2011; CRWF SU14/L4 taken facing to 60°.

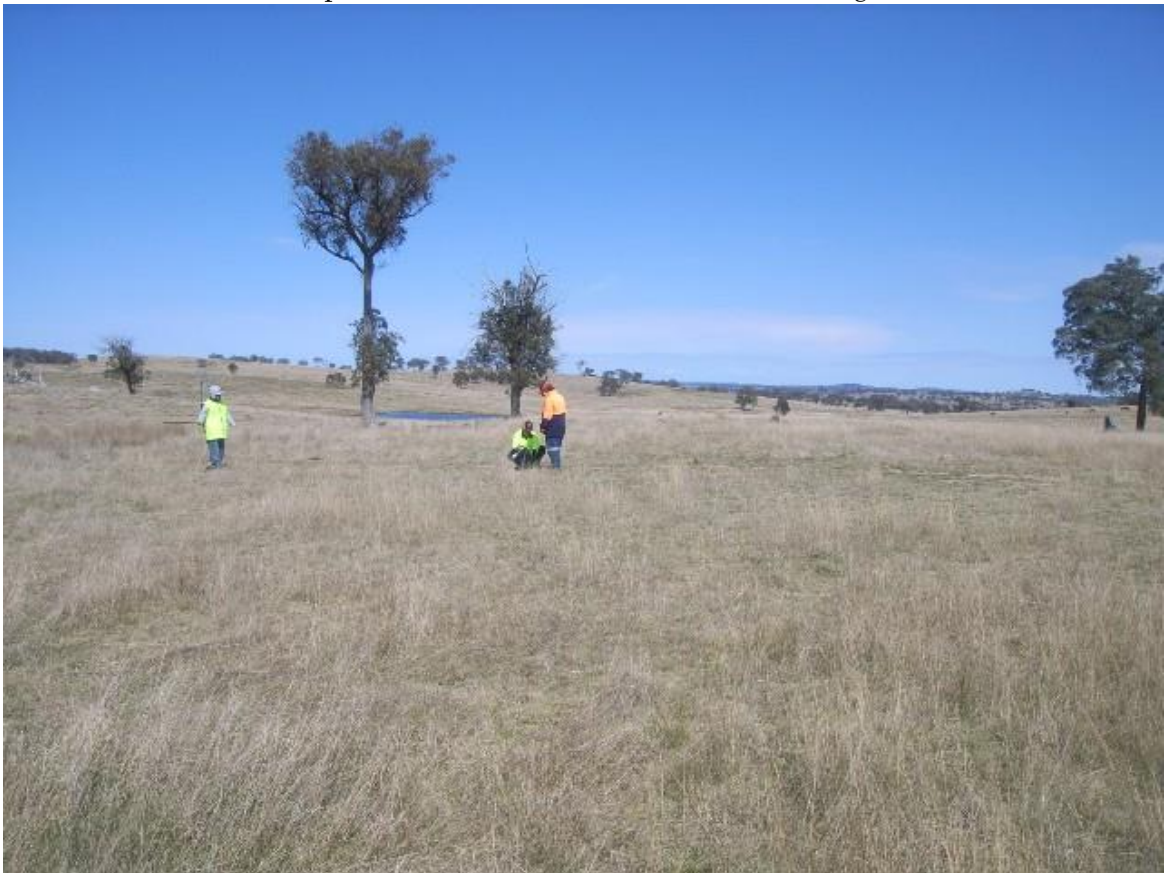
- Tuff flake; 33mm x 30mm x 15mm;
- Tuff core fragment; 71mm x 20mm x 14mm;
- Tuff proximal flake portion; 28mm x 26mm x 9mm.

Photograph: 27<sup>th</sup> September 2011; CRWF SU17/L1 taken facing to 230°.

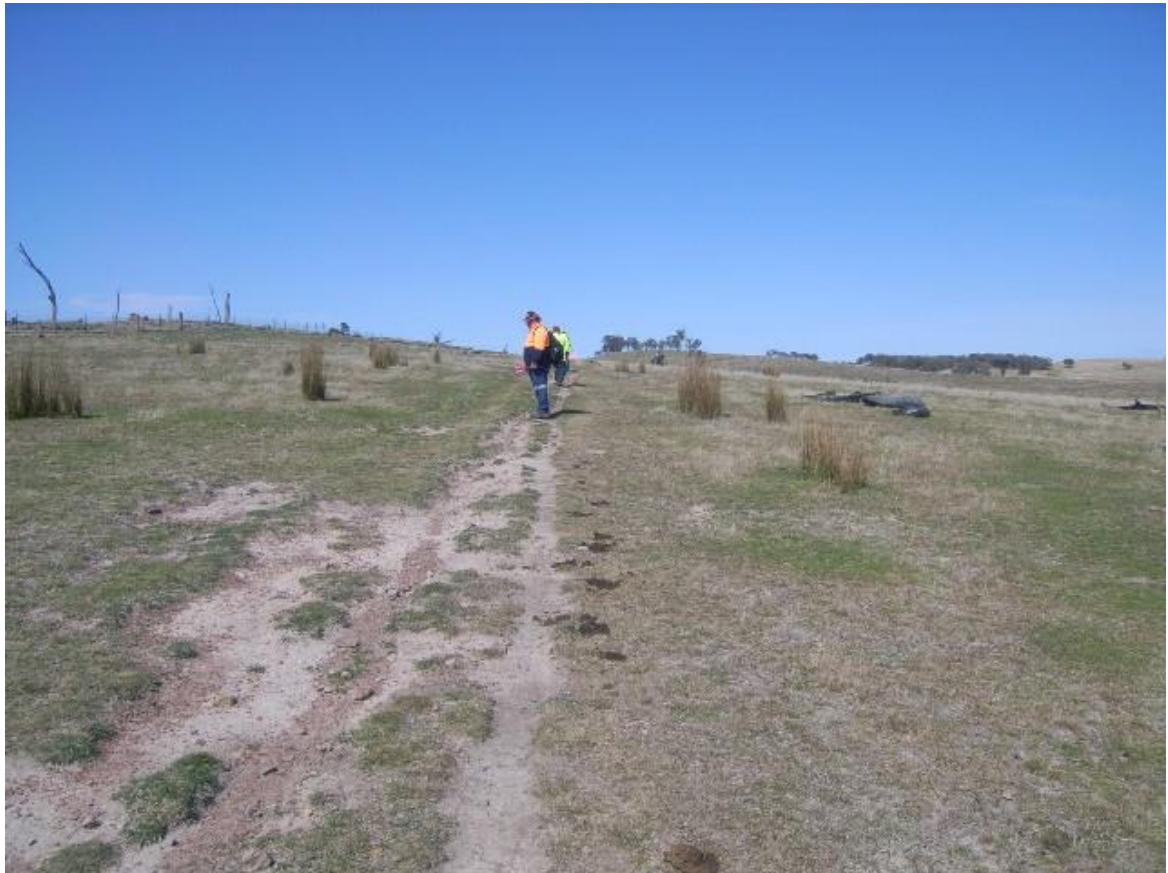
Aboriginal object locale ID: CRWF Survey Unit 17/Locale 2 (CRWF SU17/L2)  
Grid reference(GDA): Zone 55: E750460 N6353723  
Description: This locale is situated in Survey Unit 17 on a crest of a broad, undulating plateau landform. The aspect is to the west and gradient gentle (3°). The site is in a paddock used for sheep grazing. One stone artefact was recorded on a vehicle track:  
○ Tuff flake; 33mm x 28mm x 8mm.

Photograph: 27<sup>th</sup> September 2011; CRWF SU17/L2 taken facing to 180°.
