# Crudine Ridge Wind Farm Aboriginal Heritage Management Plan

November 2017  
Final

This Aboriginal Heritage Management Plan (AHMP) has been prepared by Julie Dibden, NSW Archaeology Pty Ltd, for CWP Renewables on behalf of Crudine Ridge Wind Farm Pty Ltd (The Proponent). The document forms a component of the Crudine Ridge Wind Farm (CRWF; the Project) Environmental Management Strategy (EMS).

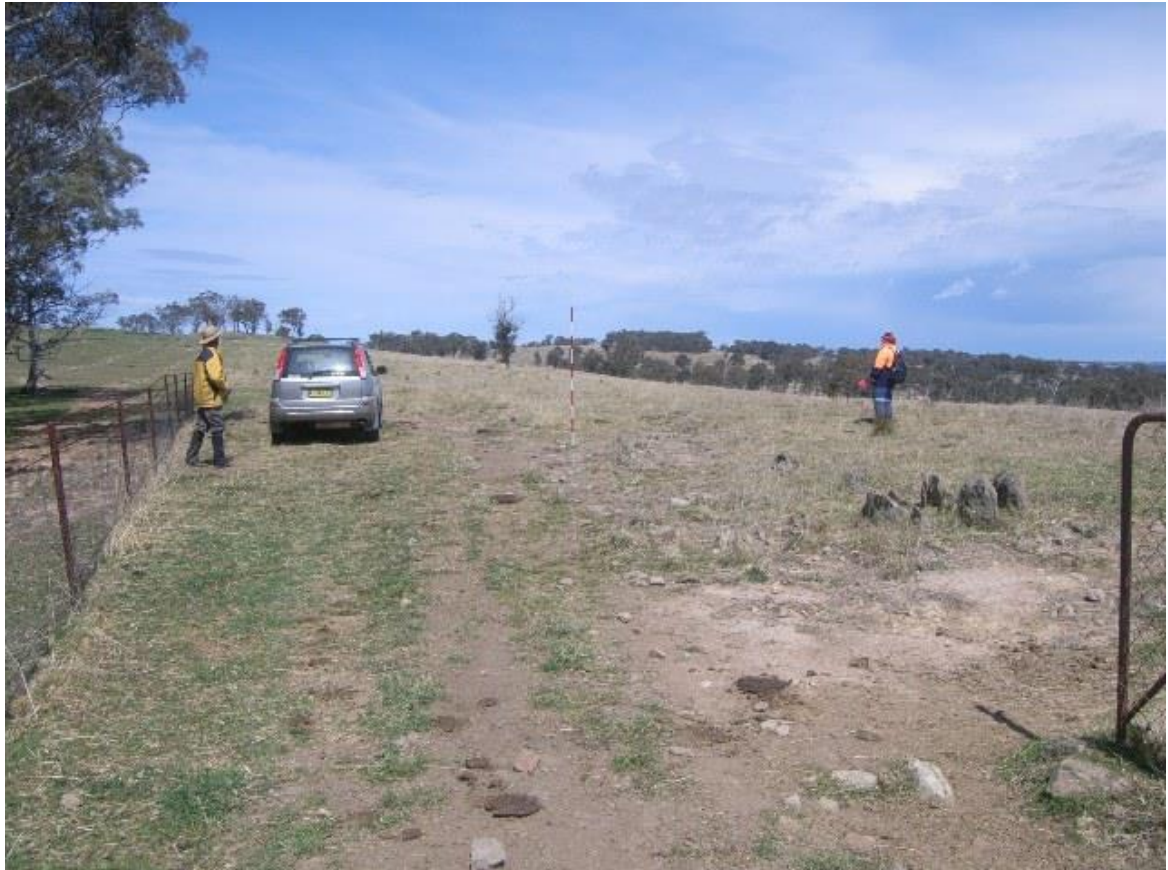
Aboriginal object locale ID: CRWF Survey Unit 17/Locale 3 (CRWF SU17/L3)  
Grid reference(GDA): Zone 55: E749878 N6352403  
Description: This locale is situated in Survey Unit 17 on a crest of a broad, undulating plateau landform. The aspect is open and gradient very gentle (0-1°). The site is in a paddock used for sheep grazing. One stone artefact was recorded on a vehicle track:

- Tuff flake; 50mm x 35mm x 18mm (broken in 2 pieces).

Photograph: 27<sup>th</sup> September 2011; CRWF SU17/L3 taken facing to 180°.

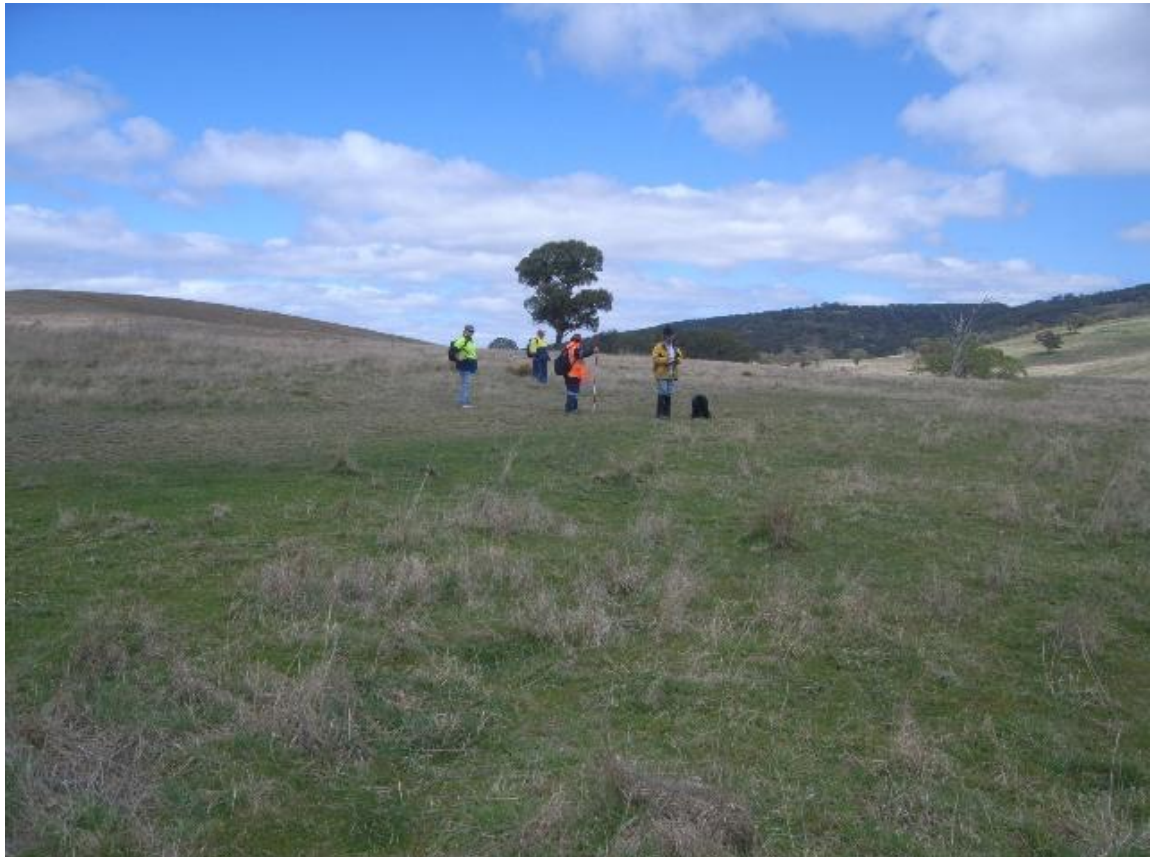
Aboriginal object locale ID: CRWF Survey Unit 18/Locale 1 (CRWF SU18/L1)  
Grid reference(GDA): Zone 55: E758305 N6356311  
Description: This locale is situated in Survey Unit 18 on a simple slope. The aspect is northerly and gradient very gentle (2°). The site is in a paddock used for sheep grazing. One stone artefact was recorded on a vehicle track:  
○ Tuff flake fragment; 45mm x 43mm x 15mm.

Photograph: 26<sup>th</sup> September 2011; CRWF SU18/L1 taken facing to 230°.

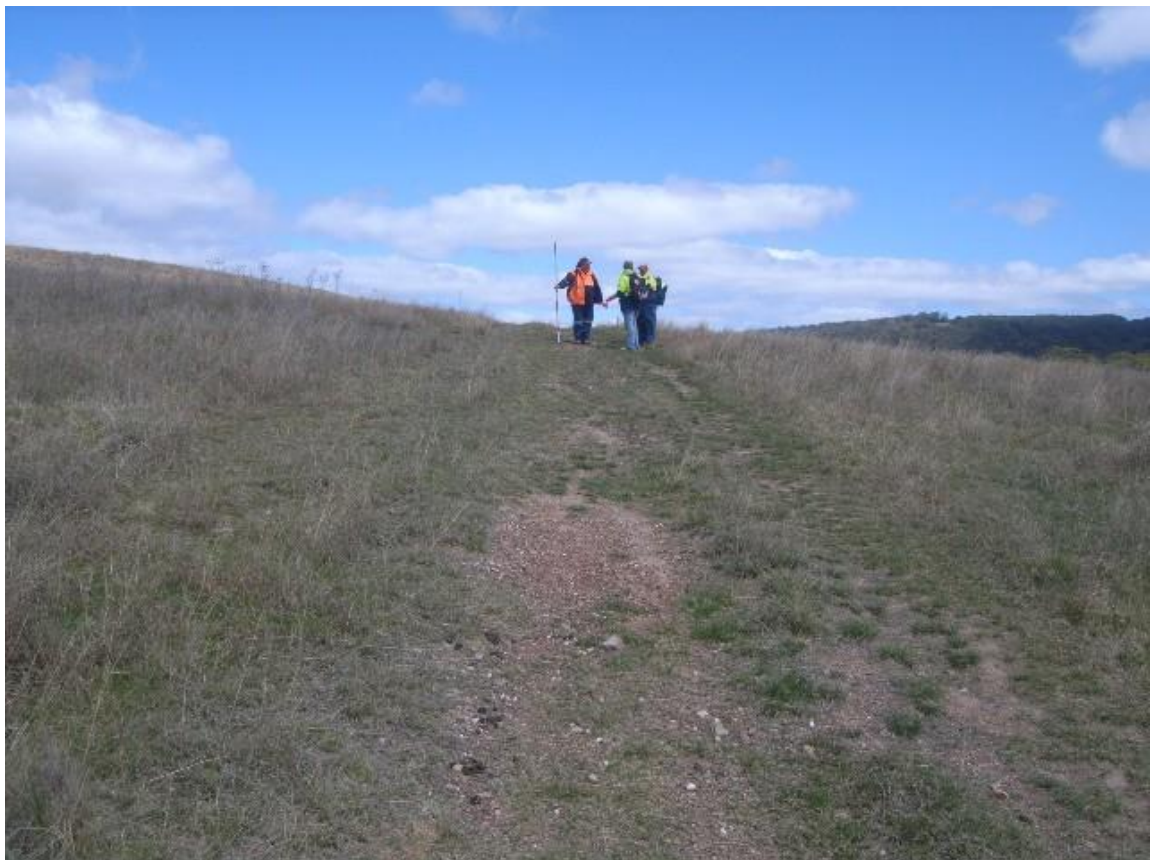
- Chert flake, 18mm x 35mm x 10mm;
- Chert flake fragment ; 18mm x 14mm x 4mm;
- Chert flake ; 22mm x 23mm x 8mm;
- Tuff flake fragment; 18mm x 34mm x 9mm.

Photograph: 26<sup>th</sup> September 2011; CRWF SU18/L2 taken facing to 230°.
