Murra Warra Wind Farm

Electric Line Clearance Management Plan (ELCMP) (2024-2025)

Electricity Safety (Electric Line Clearance) Regulations 2020

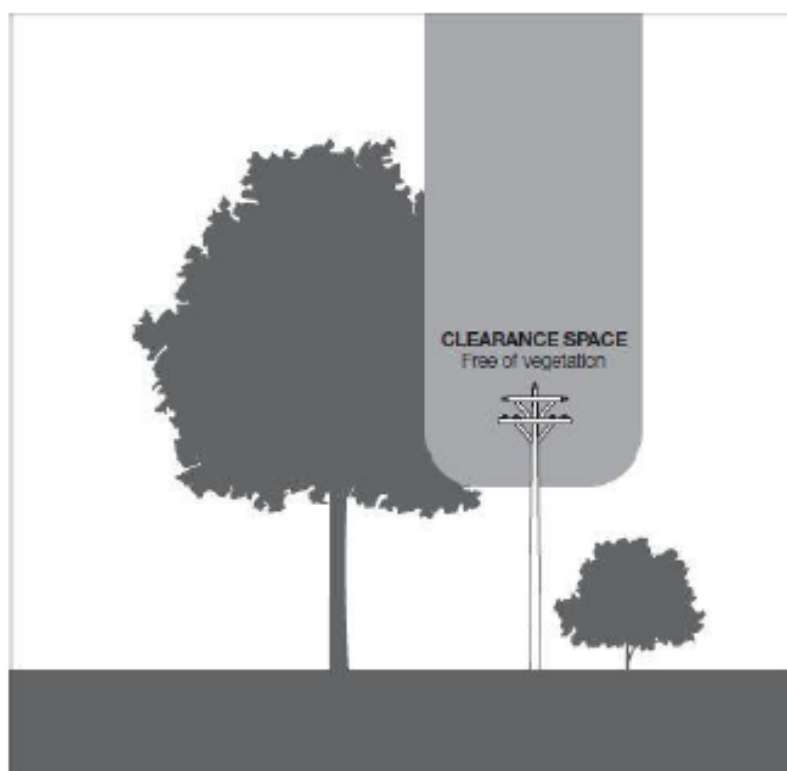
**FIGURE 5—UNINSULATED 66 000 VOLT ELECTRIC LINE
IN A LOW BUSHFIRE RISK AREA AND UNINSULATED
ELECTRIC LINE IN A HAZARDOUS BUSHFIRE RISK AREA**

Clauses 27, 28 and 29, Graphs 4, 5 and 6
