Murra Warra Wind Farm

Electric Line Clearance Management Plan (ELCMP) (2025-2026)

Electricity Safety (Electric Line Clearance) Regulations 2020

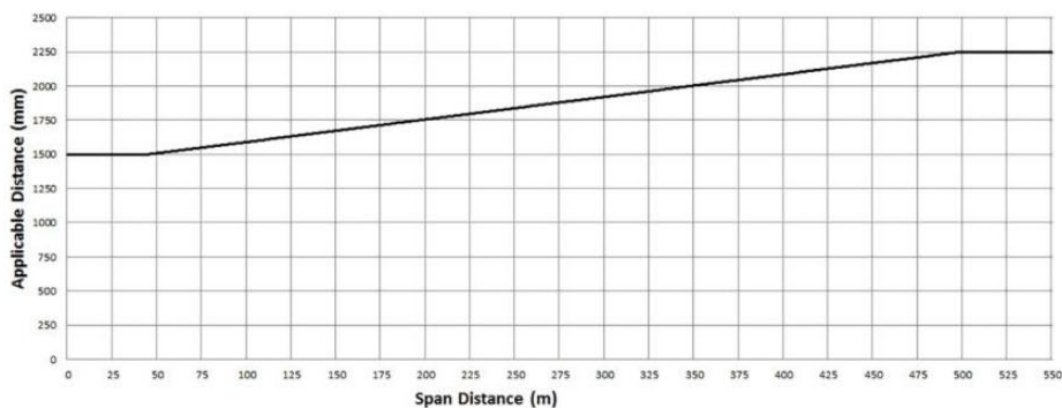
Figure C.3 – Applicable Distance by Span Length

In High Bushfire Risk Areas.

Clauses 3 and 28

- i. Sag and Sway is not included in the above figure,

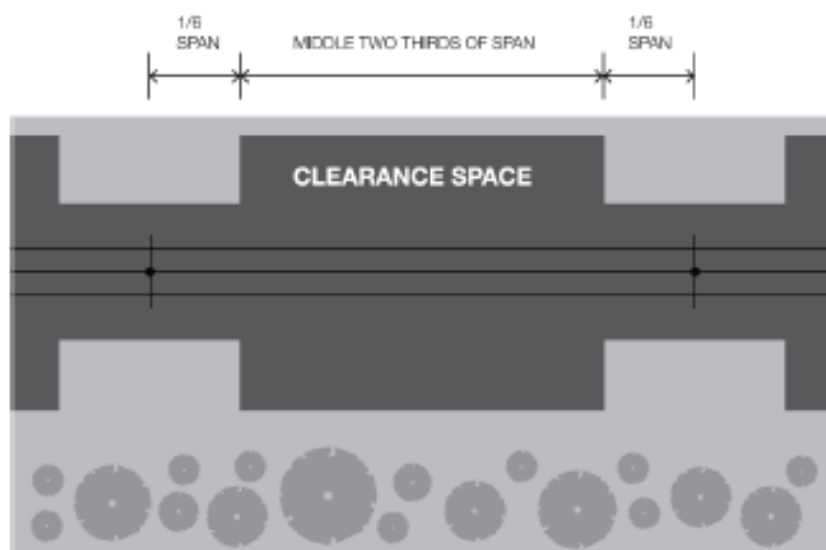
FIGURE 1—PLAN VIEW OF ELECTRIC LINES IN ALL AREAS

Clauses 24, 25, 26, 27, 28 and 29,
Graphs 1, 2, 3, 4, 5 and 6

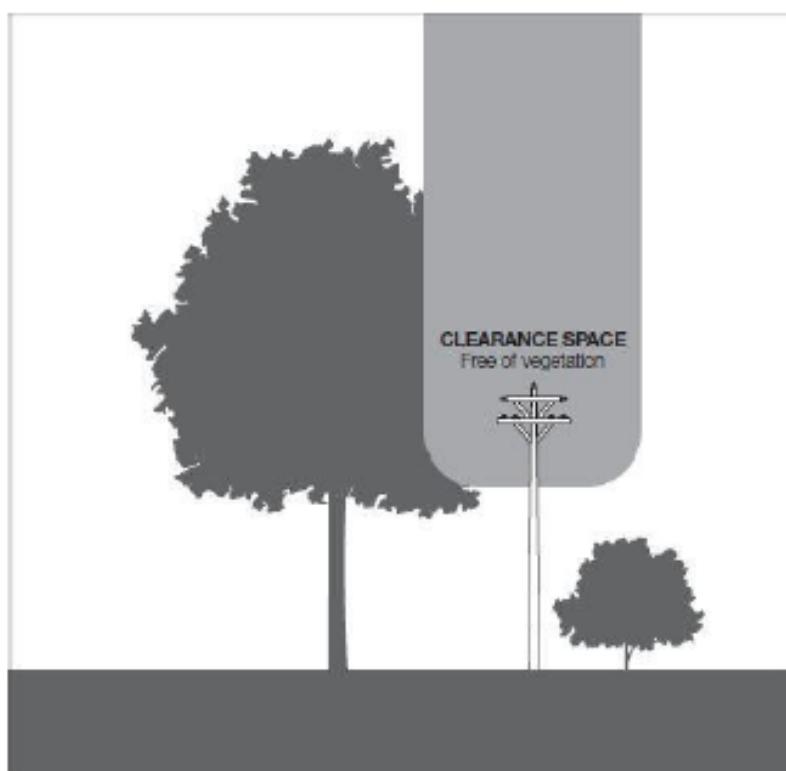
**FIGURE 5—UNINSULATED 66 000 VOLT ELECTRIC LINE
IN A LOW BUSHFIRE RISK AREA AND UNINSULATED
ELECTRIC LINE IN A HAZARDOUS BUSHFIRE RISK AREA**

Clauses 27, 28 and 29, Graphs 4, 5 and 6

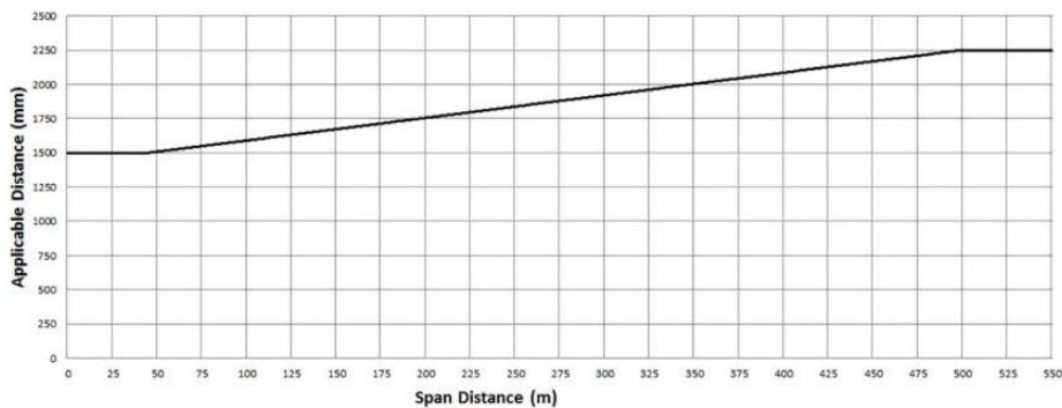
Figure C.1 – Applicable Distance by Span Length

In High Bushfire Risk Areas.

Clauses 3 and 28

- i. Sag and Sway is not included in the above figure,

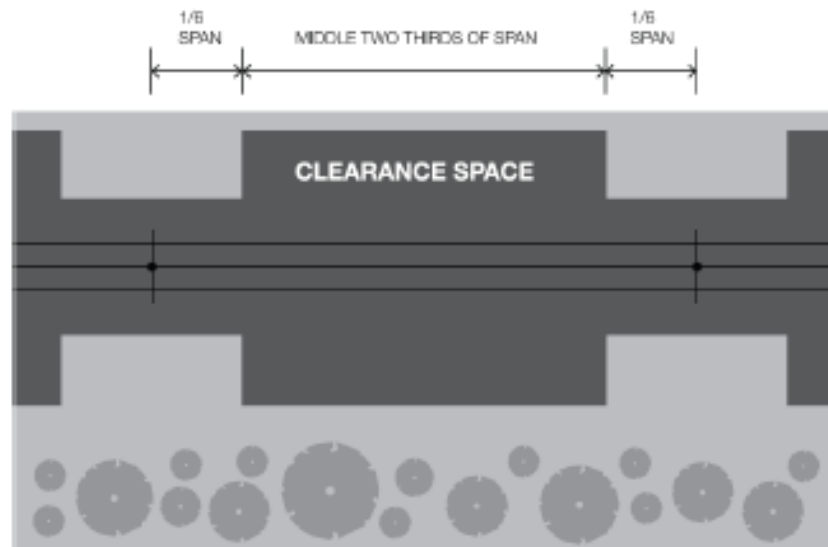
**FIGURE 1—PLAN VIEW OF ELECTRIC LINES IN ALL
AREAS**

Clauses 24, 25, 26, 27, 28 and 29,
Graphs 1, 2, 3, 4, 5 and 6

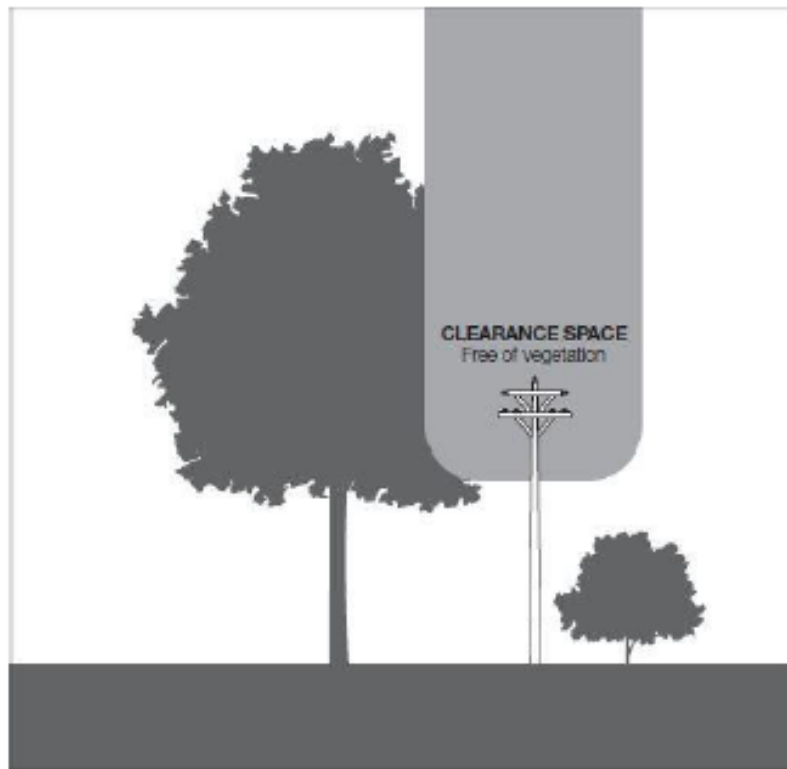
**FIGURE 5—UNINSULATED 66 000 VOLT ELECTRIC LINE
IN A LOW BUSHFIRE RISK AREA AND UNINSULATED
ELECTRIC LINE IN A HAZARDOUS BUSHFIRE RISK AREA**

Clauses 27, 28 and 29, Graphs 4, 5 and 6
