Murra Warra Wind Farm

Electric Line Clearance Management Plan (ELCMP) (2025-2026)

Electricity Safety (Electric Line Clearance) Regulations 2025

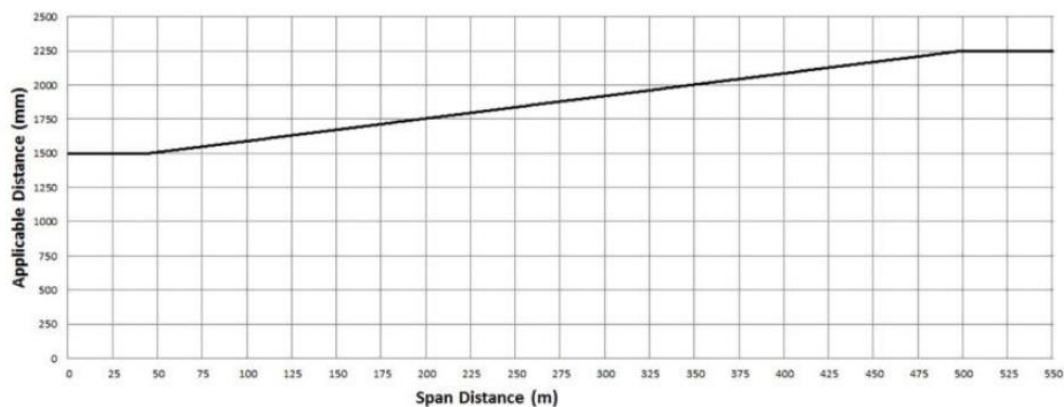
Figure C.2 – Applicable Distance by Span Length

- Applicable Distance by Span Length, and
- Minimum Distance Requirement Including Swag and Sway, in High Bushfire Risk Areas.

- Sag and Sway is not included in the above figure,

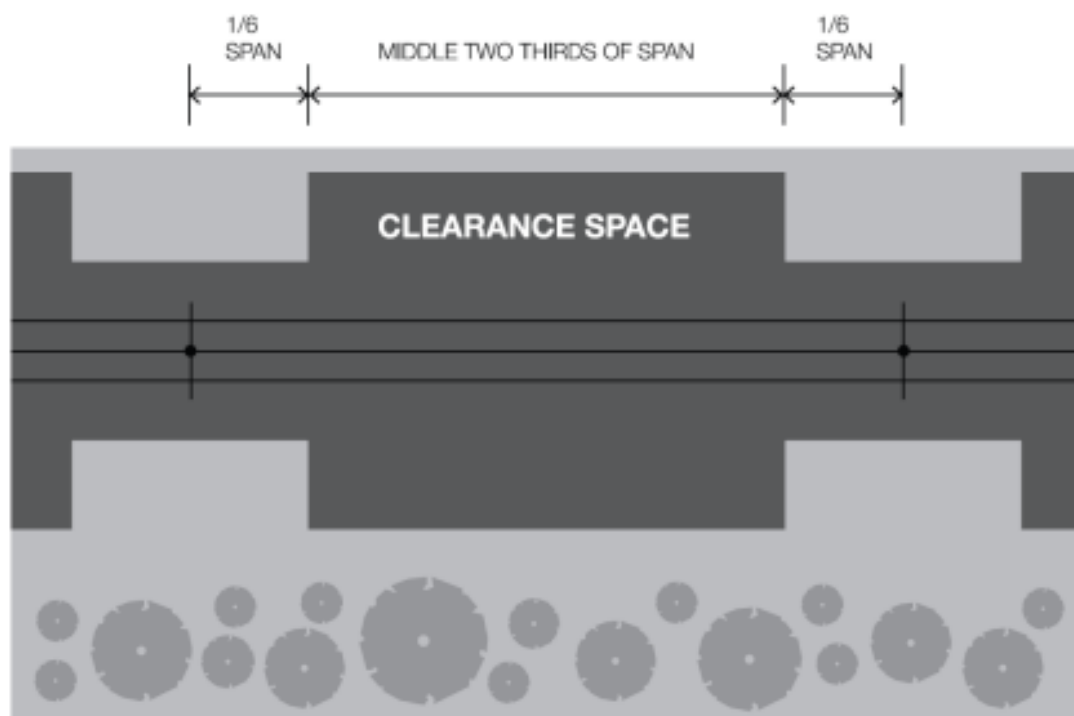
Figure 1—Plan view of electric lines in all areas

Clauses 24, 25, 26, 27, 28 and 29,
Graphs 1, 2, 3, 4, 5 and 6

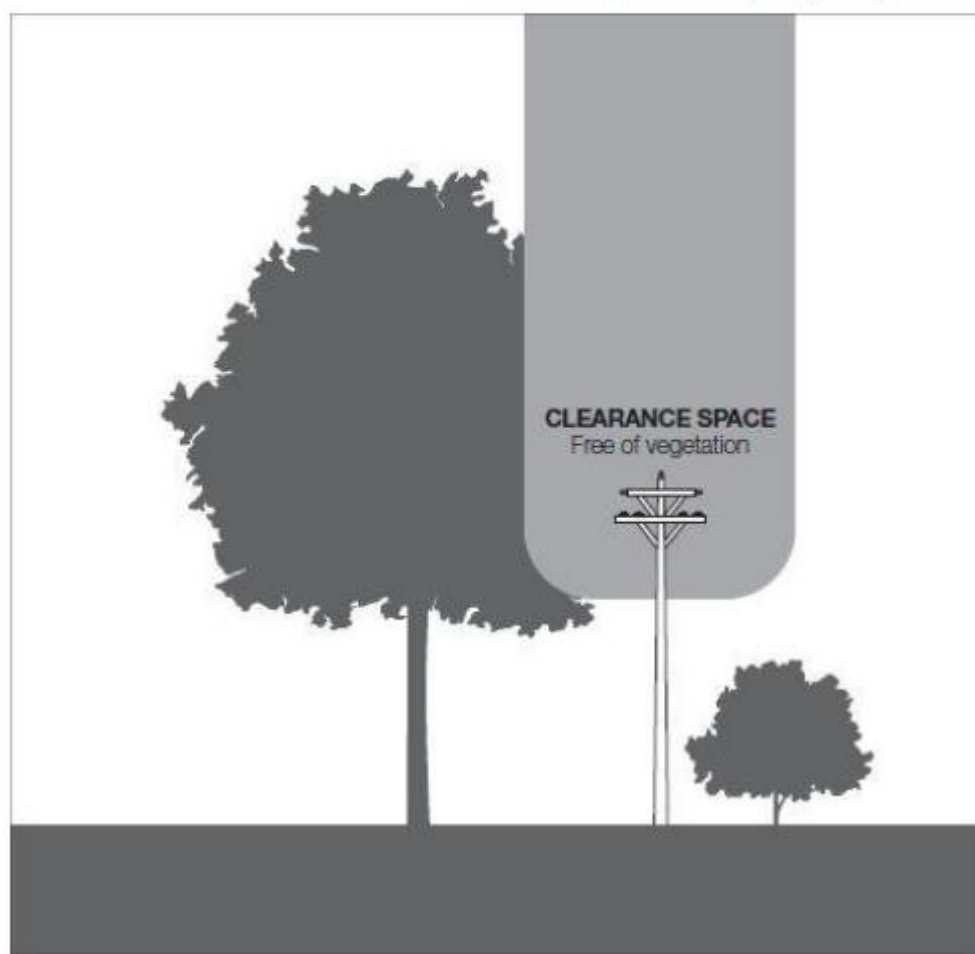
Figure 5—Uninsulated 66 000 volt electric line in a low bushfire risk area and uninsulated electric line in a hazardous bushfire risk area

Clauses 27, 28 and 29, Graphs 4, 5 and 6

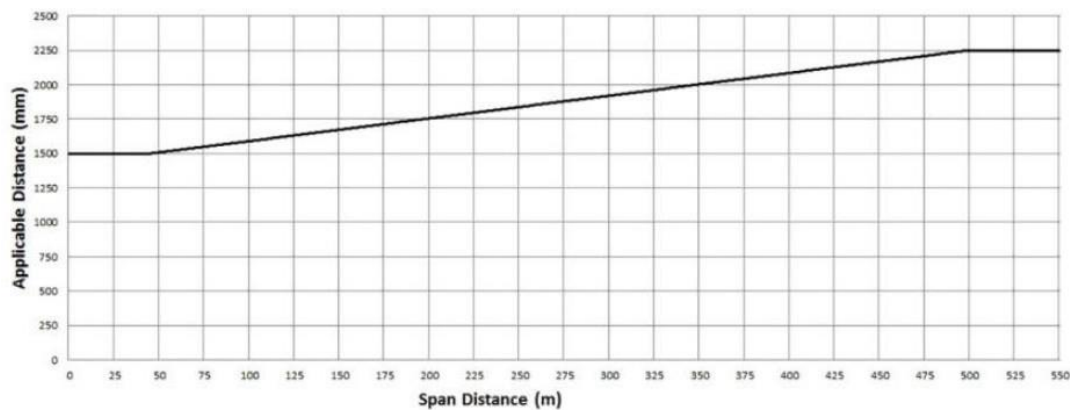
Figure C.1 – Applicable Distance by Span Length

High Bushfire Risk Areas.

- i. Sag and Sway is not included in the above figure,

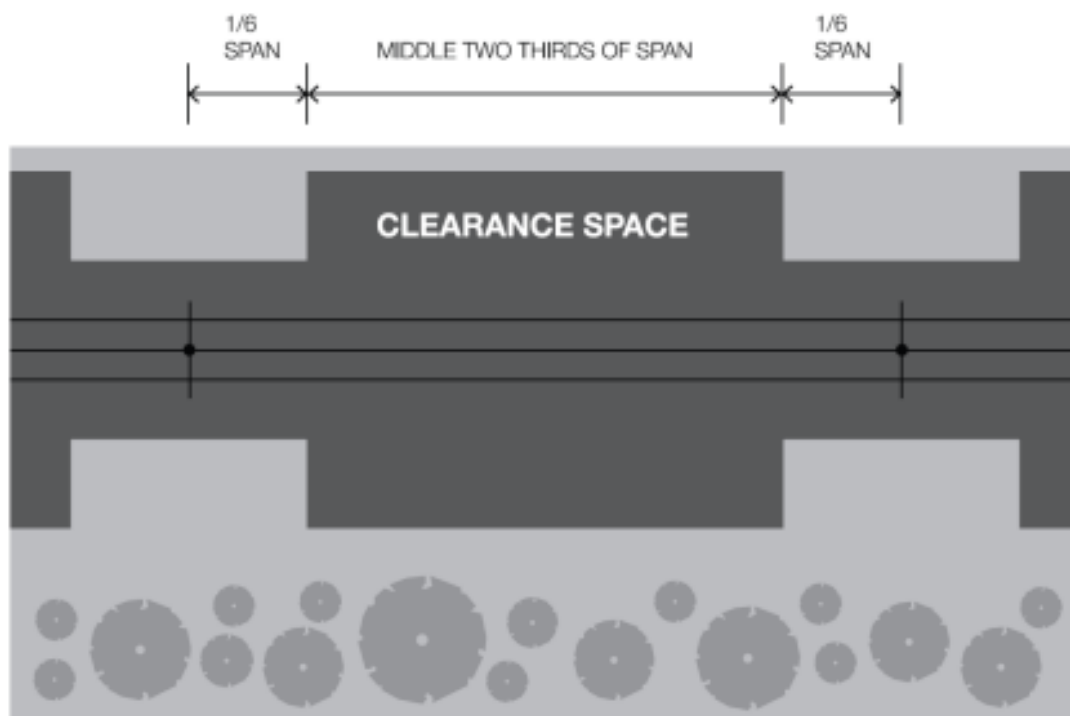
Figure 1—Plan view of electric lines in all areas

Clauses 24, 25, 26, 27, 28 and 29,
Graphs 1, 2, 3, 4, 5 and 6

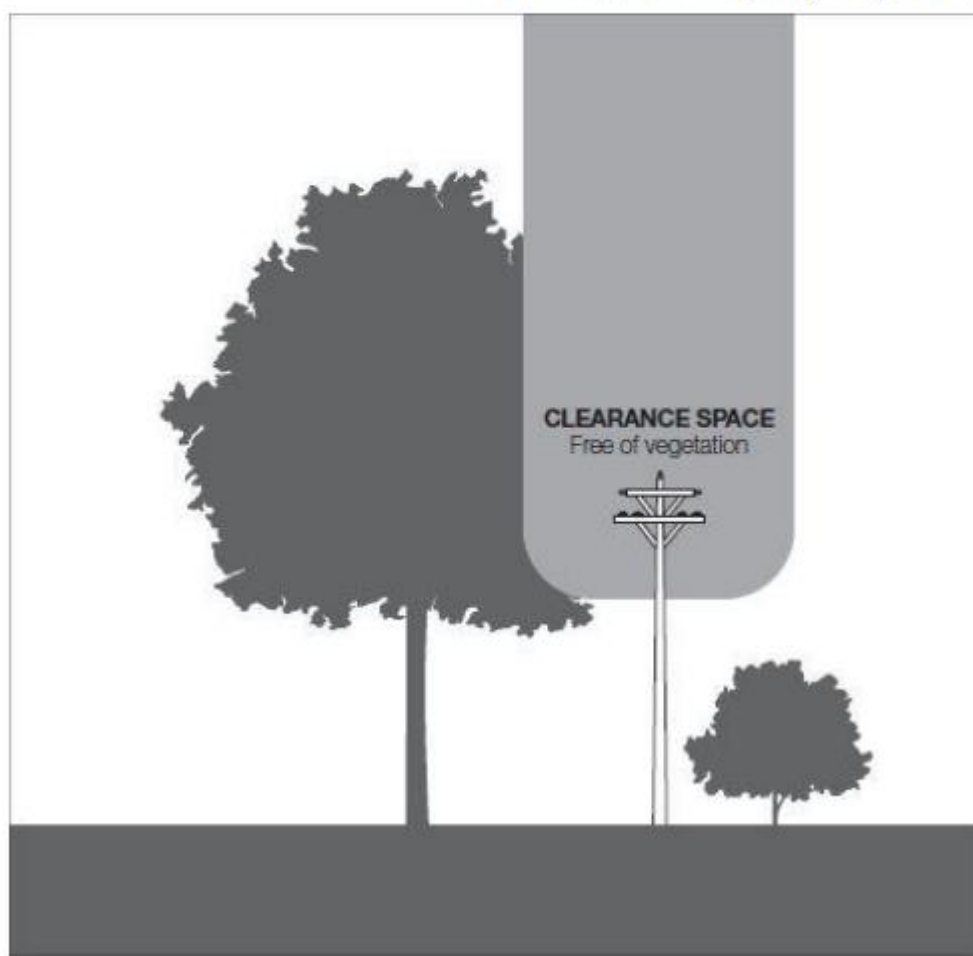
Figure 5—Uninsulated 66 000 volt electric line in a low bushfire risk area and uninsulated electric line in a hazardous bushfire risk area

Clauses 27, 28 and 29, Graphs 4, 5 and 6

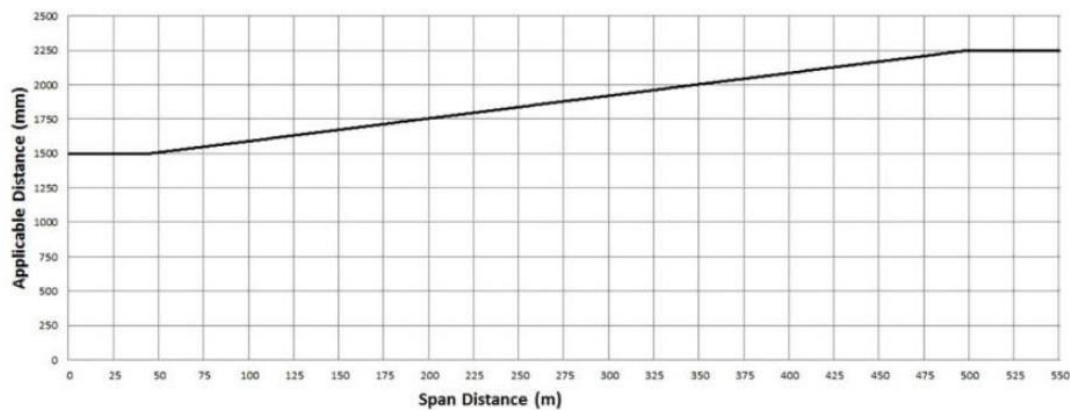
Figure C.1 – Applicable Distance by Span Length

Applicable Distance by Span Length, and
Minimum Distance Requirement Including Swag and Sway, In
High Bushfire Risk Areas.

- i. Sag and Sway is not included in the above figure,

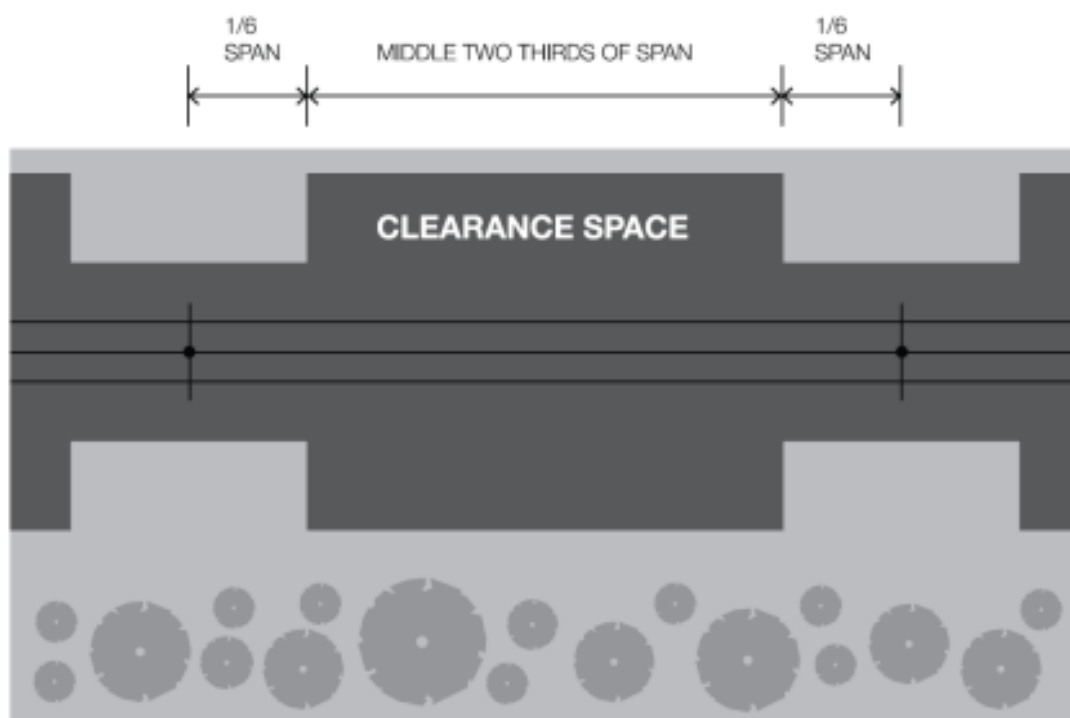
Figure 1—Plan view of electric lines in all areas

Clauses 24, 25, 26, 27, 28 and 29,
Graphs 1, 2, 3, 4, 5 and 6

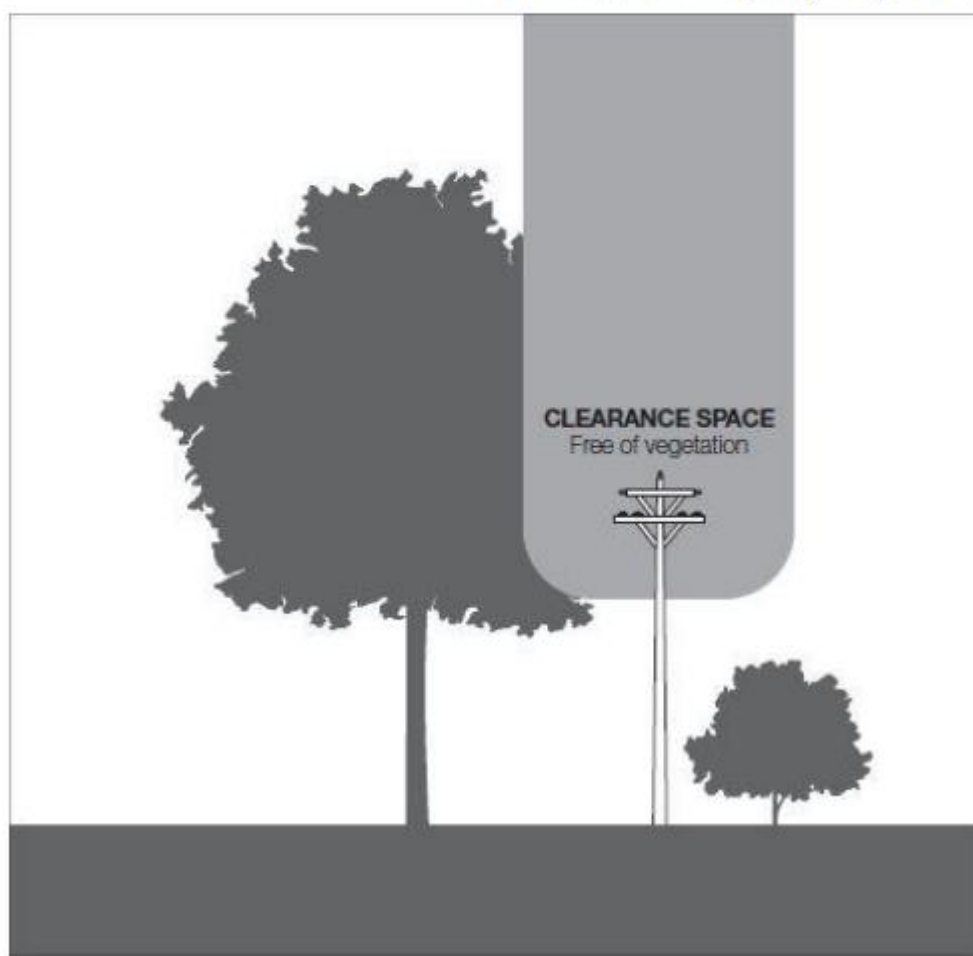
Figure 5—Uninsulated 66 000 volt electric line in a low bushfire risk area and uninsulated electric line in a hazardous bushfire risk area

Clauses 27, 28 and 29, Graphs 4, 5 and 6
