Appendix E1
Contamination -
Berth 101

Australian Industrial Energy
Port Kembla Gas Terminal
Contamination Assessment Report for Berth 101

November 2018

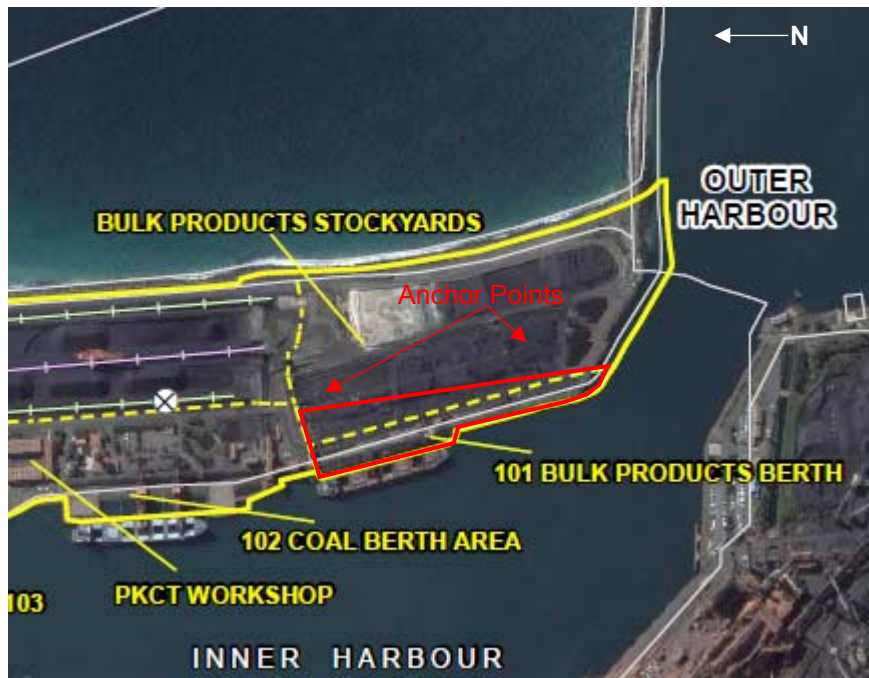
Figure A – Site definition (Cardno Forbes Rigby 2008, p. 152)

This report provides the results of the contamination assessment for Berth 101, which includes an area immediately east of the berth and six anchor points, as shown by the red outline in Figure A. The contamination assessment along the proposed pipeline route, the proposed dredge area in the waters off Berth 101 and the proposed Outer Harbour reclamation area have been reported separately.

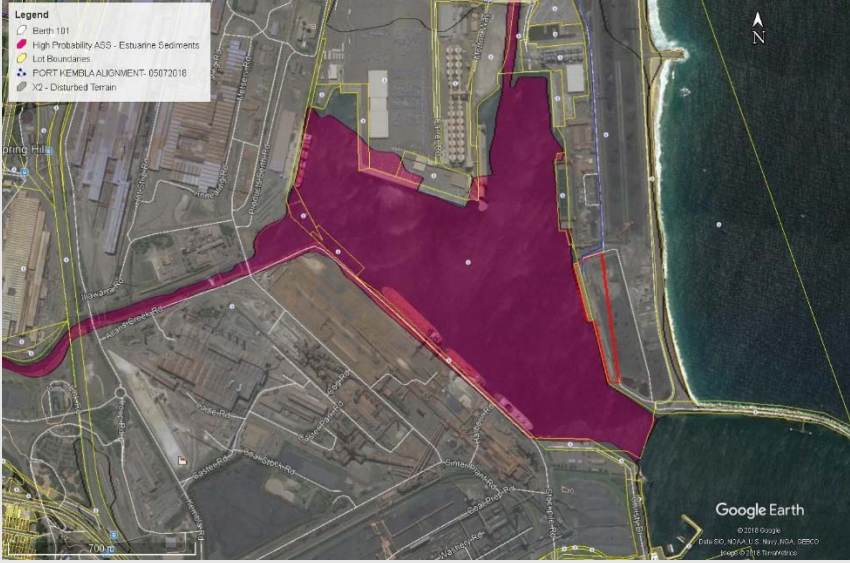
Site specific geology: (DP, 2014)	Refer to Table 5.
Acid Sulphate Soils:	<p>The ASS Risk Map indicates that the Berth (in red outline) is situated in an area mapped as disturbed terrain at an elevation >4 m (shown in grey shading). Estuarine sediments exist within the harbour and are mapped as high probability of ASS.</p>

<p>Figure E – ASS Risk Map</p>
Soil landscape:	Disturbed Terrain

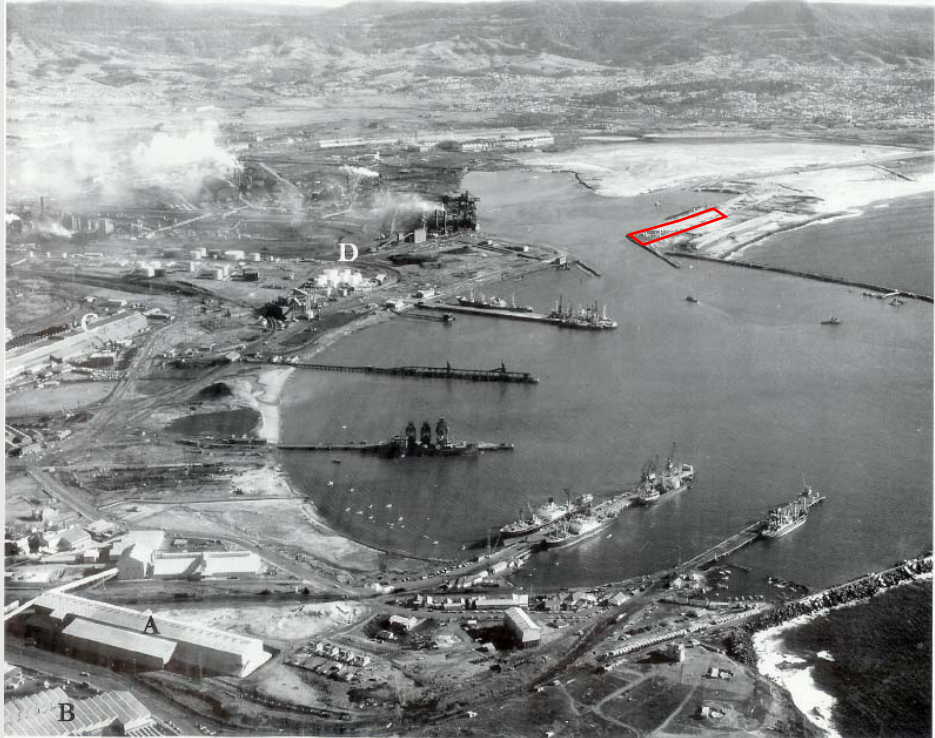
<p data-bbox="491 936 1254 969">Historical photograph circa 1962. Approx. Berth 101 area in red.</p>

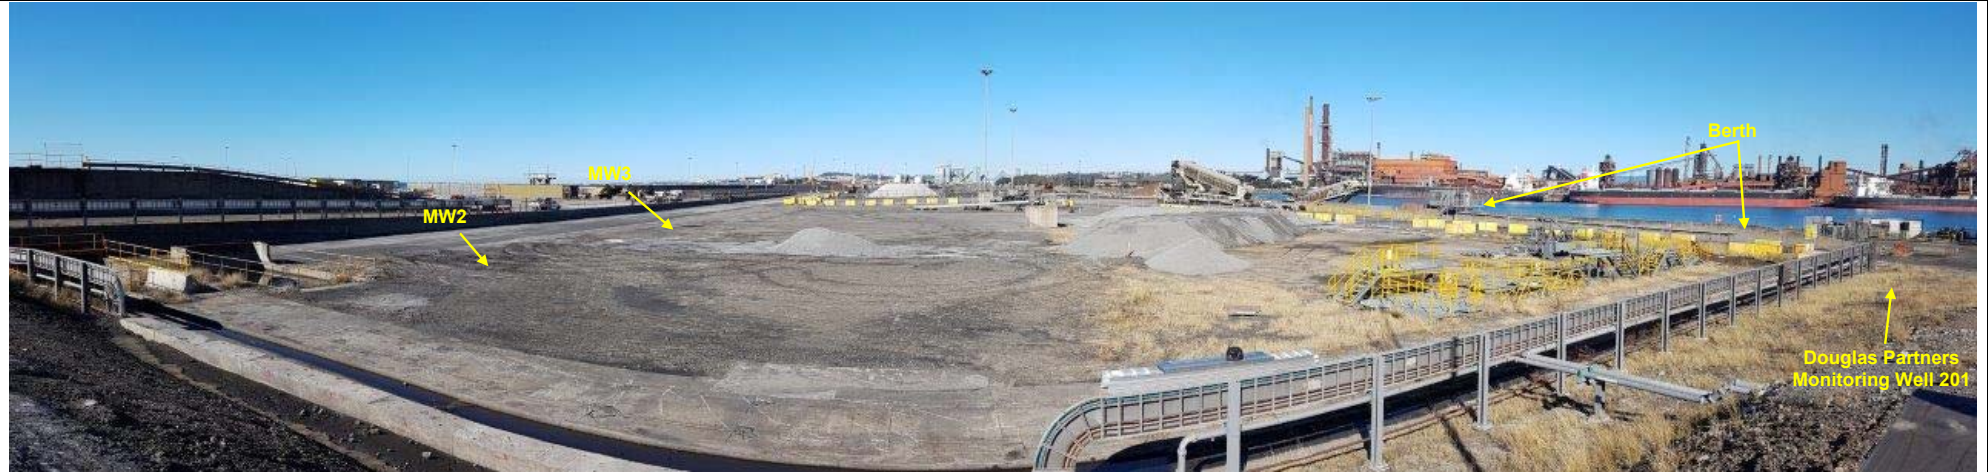
Two large stockpiles, approximately 700 m³ to 800 m³ of mixed sandy gravel material were observed in the south-western section of site, slag gravel, cobbles and boulders were seen mixed with this stockpiled material. Water was found to be largely captured by internal site drainage except in areas where the coal was stockpiled, and ponding was found to occur due to inadequate drainage in these areas. A partitioned pond was observed in the southern portion of Berth 101 and outside the proposed excavation area and anchor points.

Photograph 1: Panoramic view looking south towards the proposed northern anchor points and Berth 101 (right) (5/7/2018)

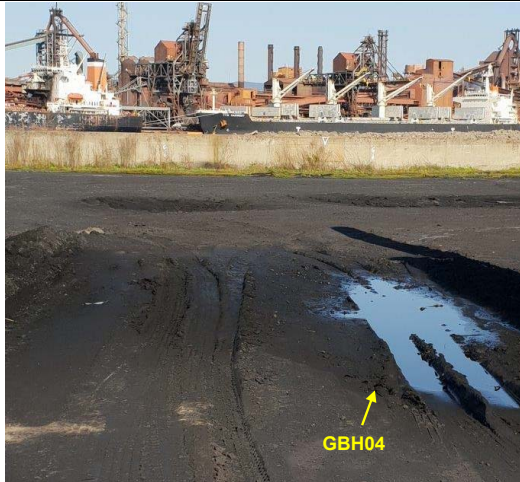
Photograph 2: Looking west towards the steelworks, GBH04 in the foreground (12/9/2018)

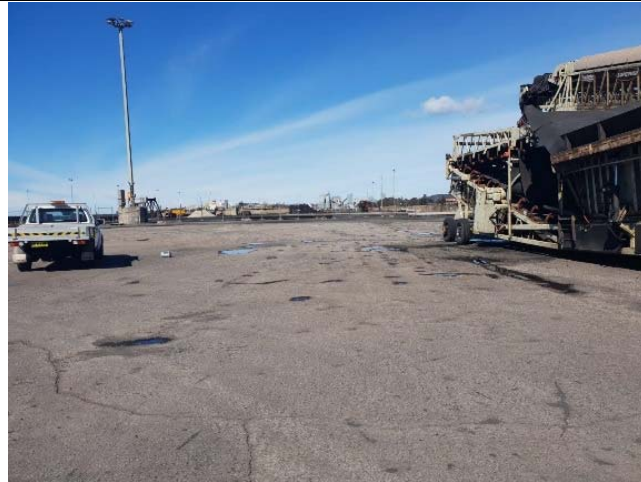
Photograph 3: Looking south towards the paved area of the site, near sample location GBH32 (13/8/2018)

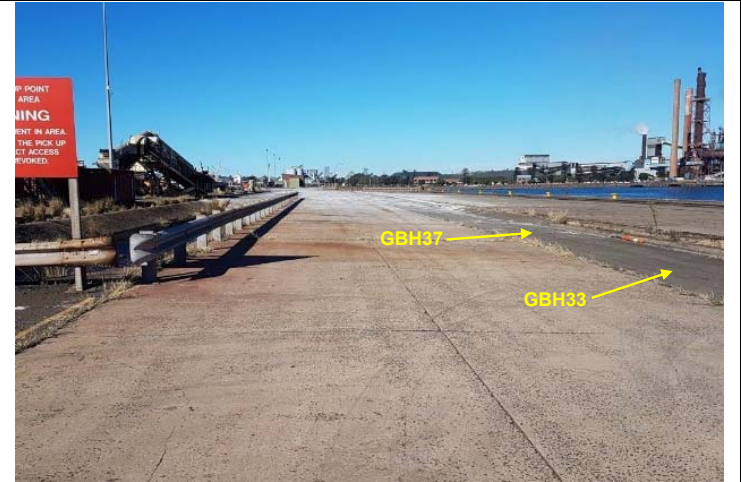
Photograph 4: Looking south at Berth 101 and proposed excavation area. GHD borehole locations GBH33 and GBH37 were drilled in the area shown (13/8/2018)
