Appendix E2
Contamination -
Gas pipeline

Australian Industrial Energy
Port Kembla Gas Terminal
Preliminary Site Investigation - Pipeline Alignment

November 2018

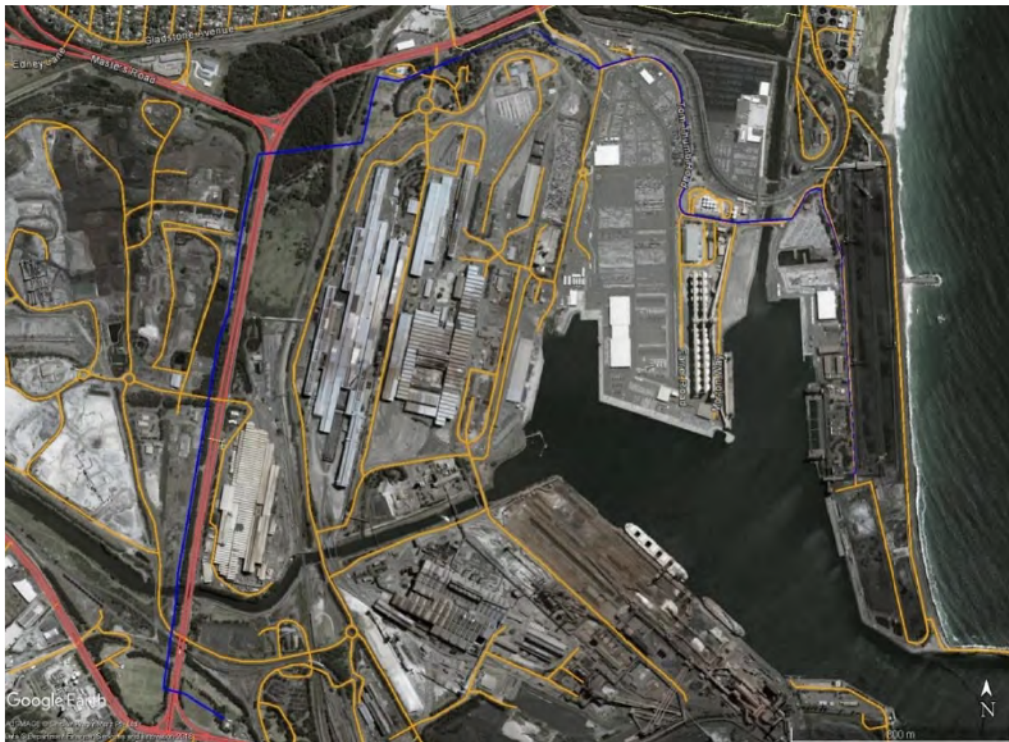
Figure A - Pipeline route (blue line) around Port Kembla district

The proposed pipeline will likely follow the route as shown in Figure A. The pipeline will pass through land currently occupied by PKCT, Bluescope and NSW Ports industrial facilities as well as crossing road and rail infrastructure and public parkland.

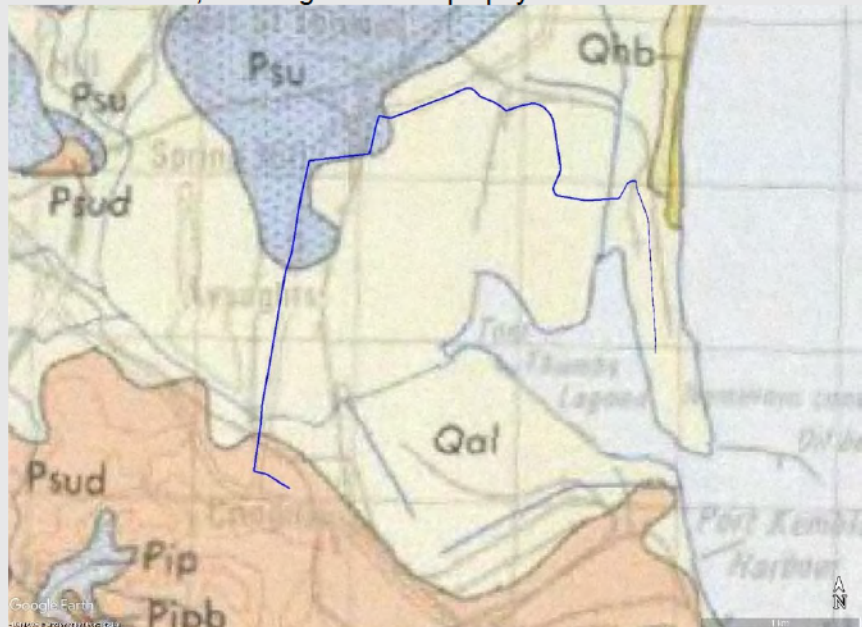
The 1:100,000 *Geological of the Wollongong-Port Hacking Sheets 9029, 9129* indicates that the site is underlain by three geological units (see Figure B). Most of the alignment is underlain by Quaternary sediments (Qal) described as quartz and lithic "fluvial" sand, silt and clay. The north western extent of the alignment is underlain by the Budgong Sandstone (Psu) of the Shoalhaven Group, described as red, brown and grey lithic sandstone. The area on the southern side of Allans Creek is underlain by the Dapto Latite Member (Psud) of the Shoalhaven Group, described as melanocratic, coarse-grained and porphyritic latite.

Figure B - Geology of Wollongong - Port Hacking 1:100,000 map extract showing pipeline alignment (blue line)

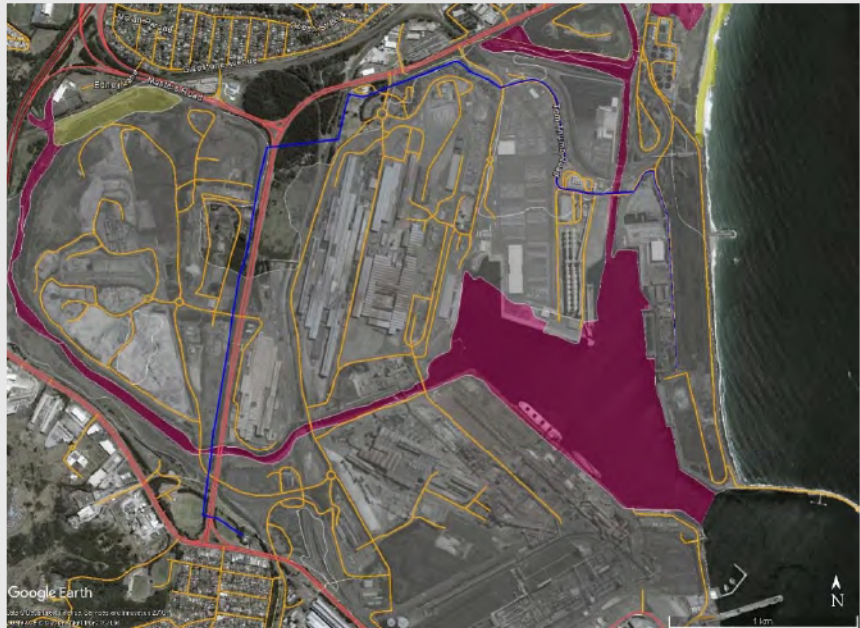
The *Wollongong 1:25,000 Acid Sulfate Soil Risk Map* indicates that the pipeline alignment is underlain by areas of Disturbed Terrain (grey) from 2 m to > 4 m thickness or areas of No Known Occurrence (no colour). Estuarine sediments (dark pink) exist within Allans Creek, Gurungaty Waterway and Inner Harbour and are mapped as having a high probability of occurrence of acid sulphate soils.

Figure C - Wollongong 1:25,000 Acid Sulfate Soil Risk Map extract showing pipeline alignment (blue line)

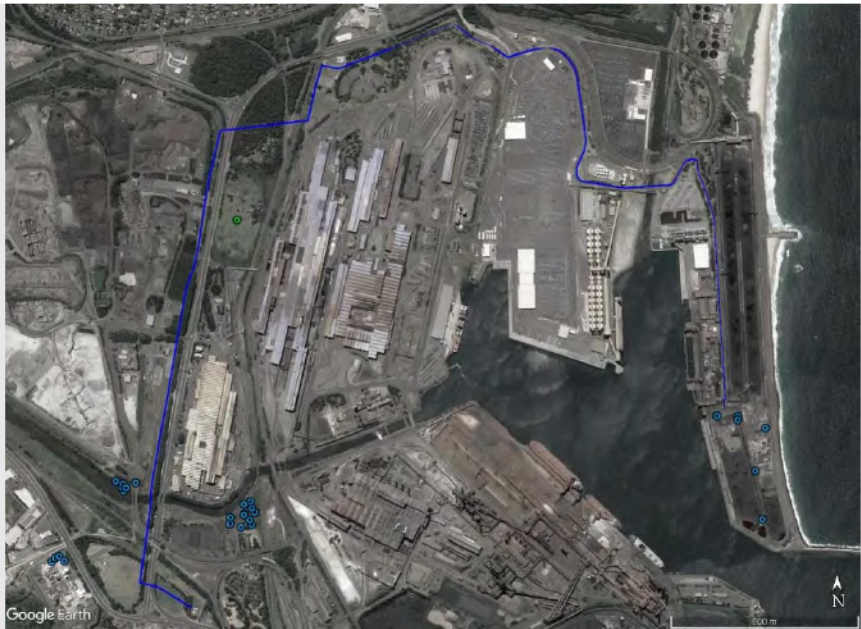
A search of publically registered groundwater bores within 500 m of the alignment returned 61 results, of these only a single bore (GW100678) contained standing water level information. This location is on the western extent of the pipeline alignment, approximately 150 m east of the alignment and had a standing water level of 8.2 m
Bores with reliable location data are shown in Figure D below.

Figure D - Public groundwater bore search results showing pipeline alignment (blue line)

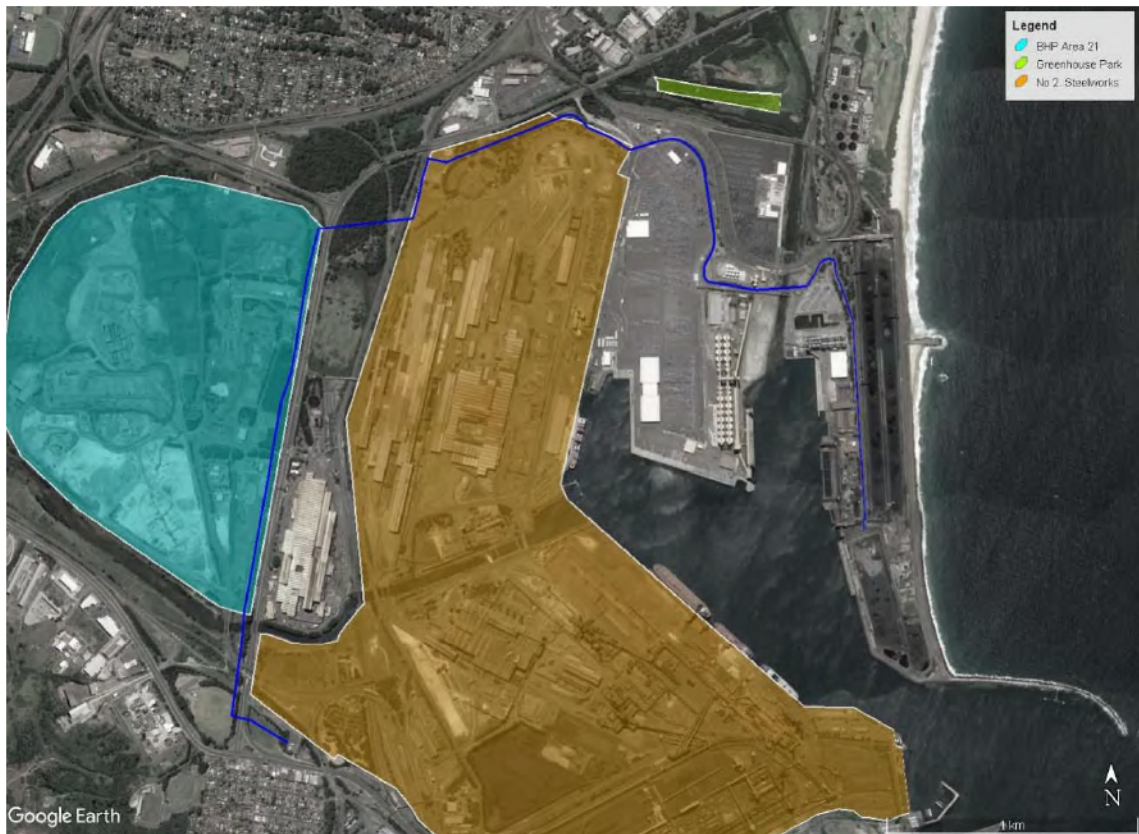
Figure E - NSW EPA Contaminated Sites Records of Notice within 500 m of the pipeline alignment
