Australian Industrial Energy  
Port Kembla Gas Terminal  
Pipeline PSI  
Berth 101, Port Kembla, NSW, 2505

Project No. 21-27477  
Revision No. -  
Date 05/11/2018

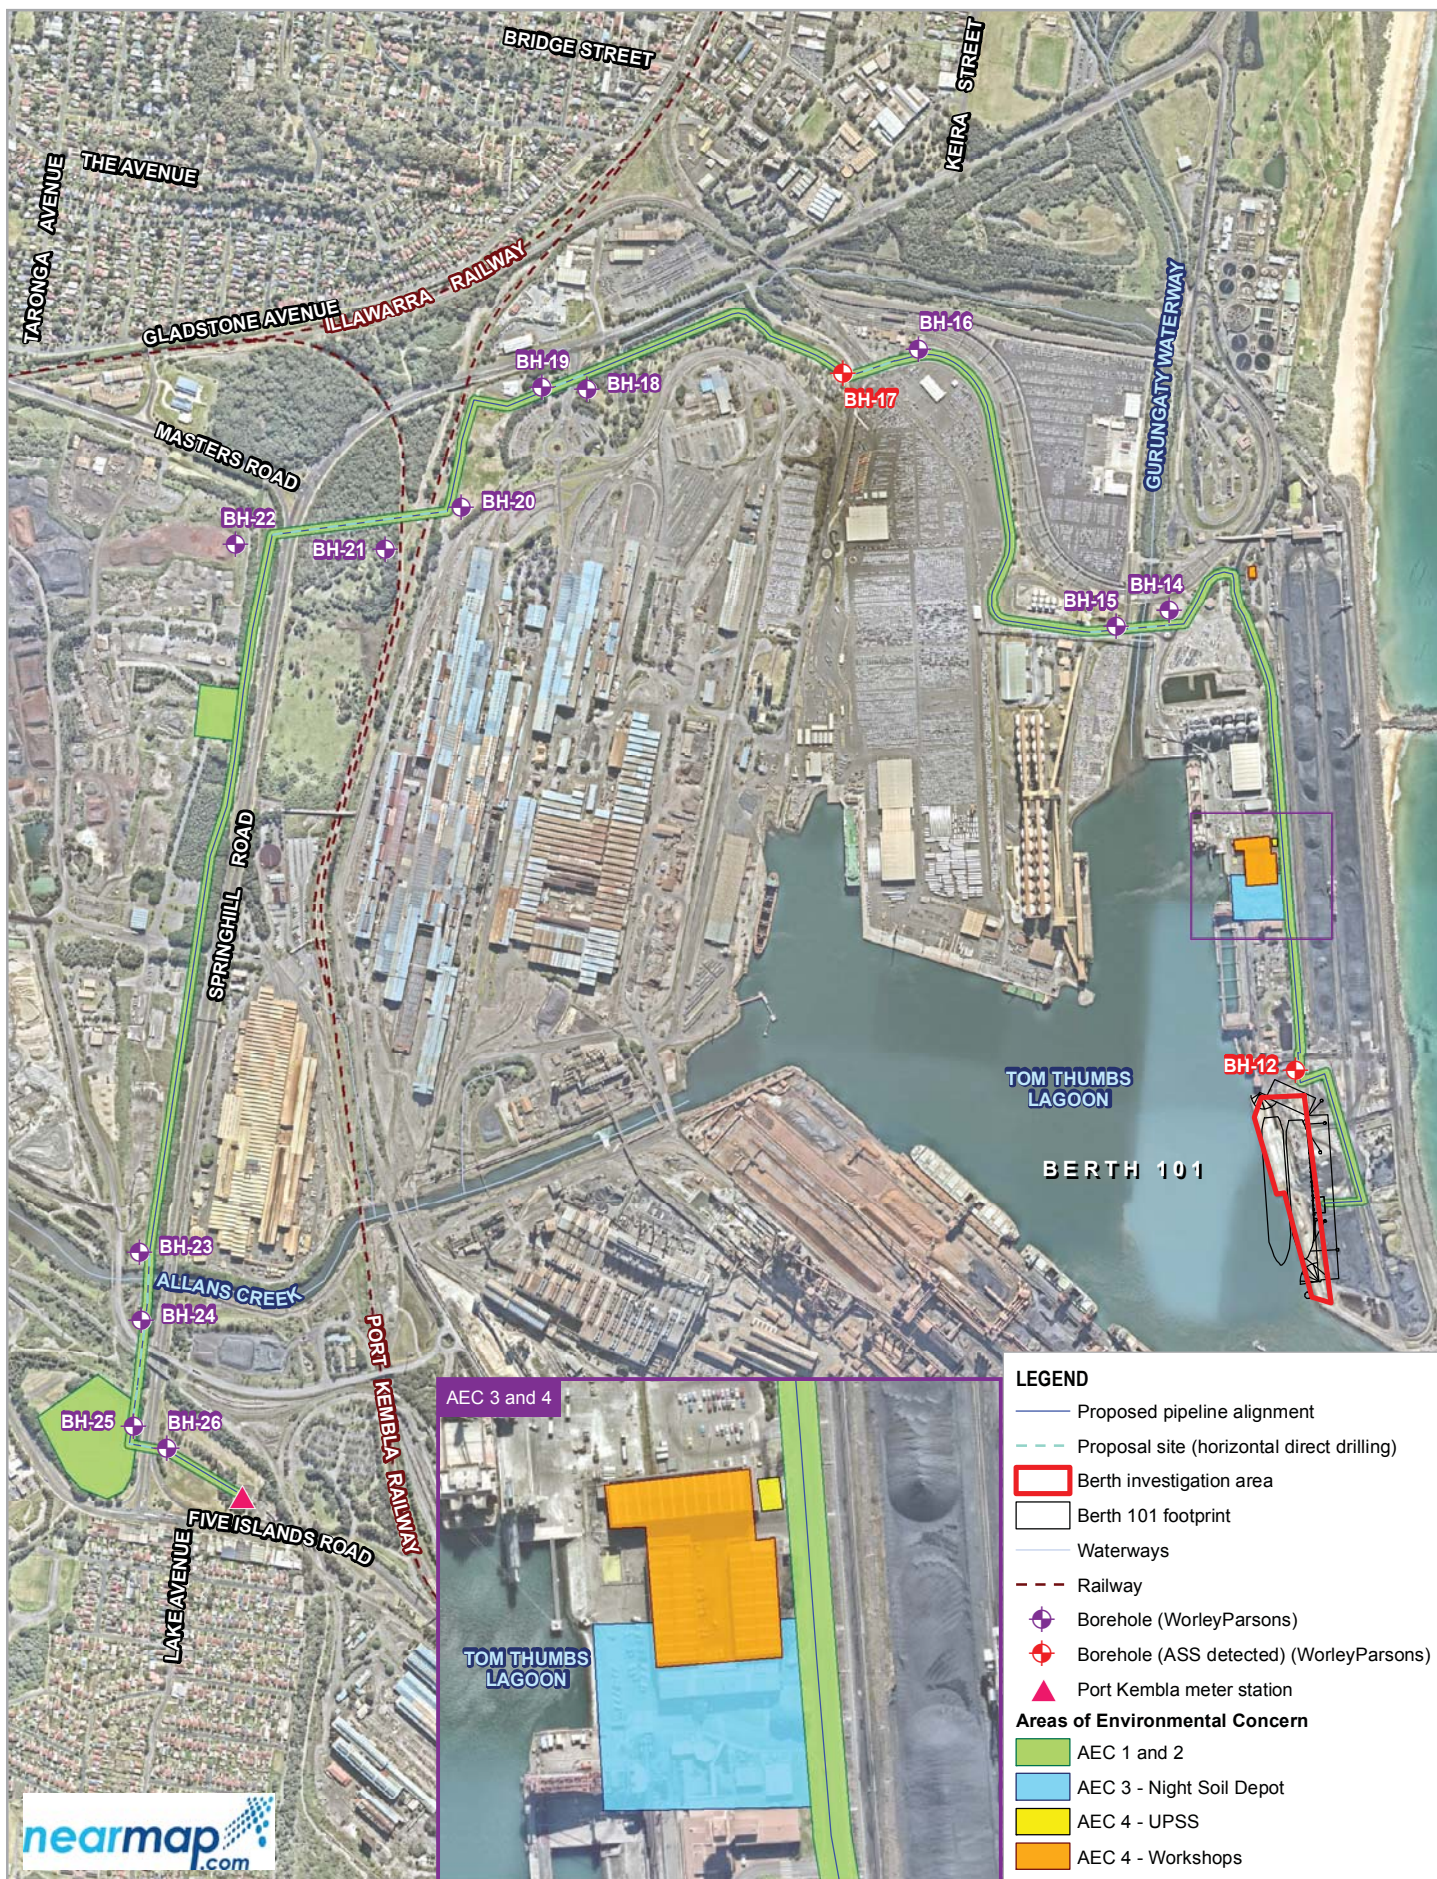
**FIGURE 11-1**

**AECs and Site Features**

Relevant site features identified in the site history searches and locations of previous investigations are shown on Figure 11-1.

- **Bluescope visitor carpark area** - The walkover was conducted in the area around the Bluescope visitor car park which was in the general vicinity of WorleyParsons geotechnical borehole BH-19 (refer to Figure 11-1 for location). The area immediate area around BH-19 was mainly lightly vegetated with grasses and light tree cover, the vegetation did not appear to be distressed. The area to the south-west of BH-19 was a visitor carpark for BlueScope, south south-east are the boom gates and entrance into BlueScope. There was a building west of BH-19 and paved car parking area located behind it. Drainage in this area is likely to infiltrate into the soil in unpaved areas, with runoff expected to get captured in existing stormwater drains.

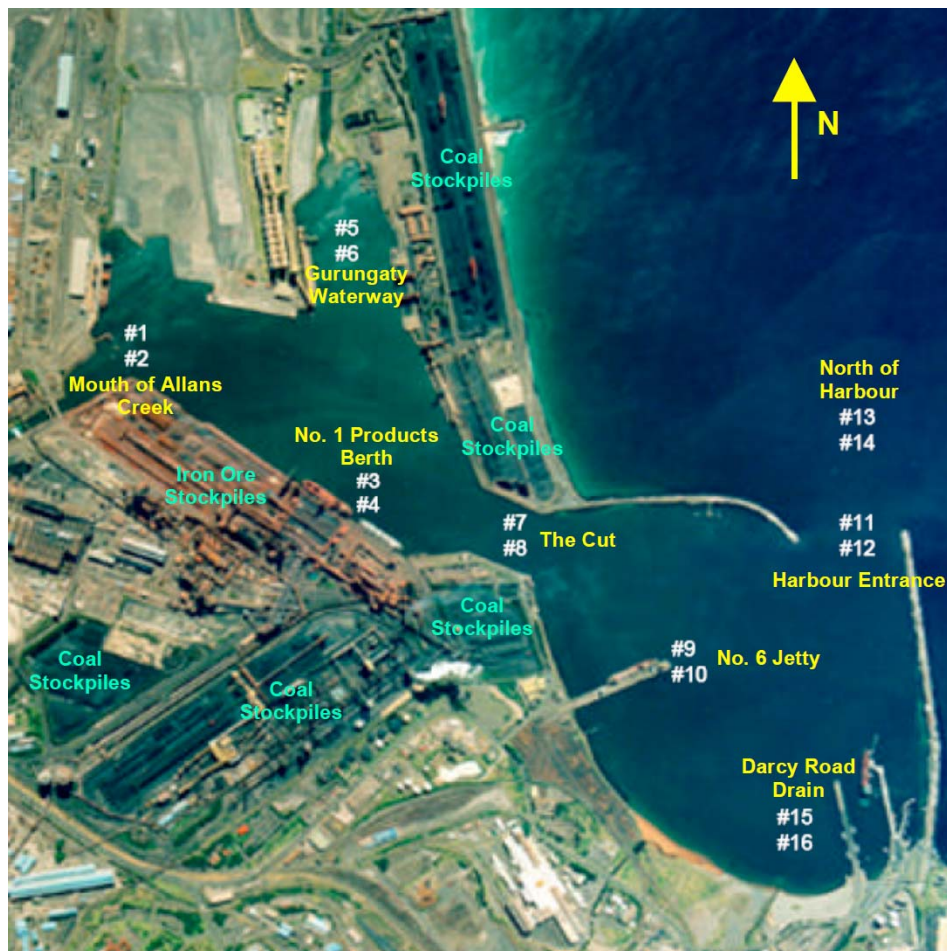
**Figure 12-2 Port Kembla monitoring locations**

The 2002-2005 monitoring program undertaken by the Port Kembla Environment Group is considered to be the most comprehensive study of ambient water quality conditions within the Port. The program aimed to establish benchmarks to determine trends and future improvements in water quality and assess whether contaminant concentrations exceed the ANZECC / ARMCANZ Guidelines (2000). The program identified monitoring locations within the Inner and Outer Harbours which have been subsequently adopted by a number of programs and are presented below in Figure 12-2.

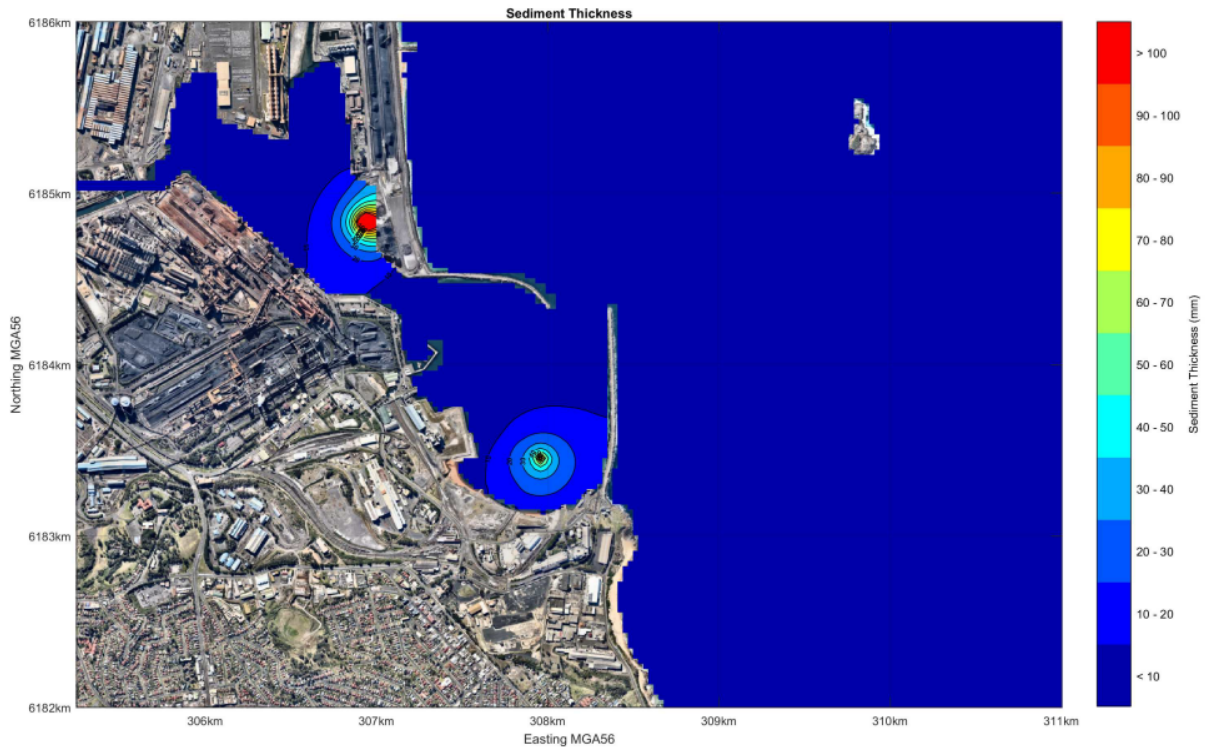
**Figure 12-6 Predicted sedimentation of fines post dredging and disposal (Cardno, 2018)**

Figure 12-6 presents the predicted sediment deposition thickness following the dredging and disposal of the mud layer. Sedimentation is predicted to occur in the vicinity of the dredging and disposal activities with no noticeable impacts to sedimentation rates outside of the port. Information regarding the potential impacts associated with the removal and placement of contaminated sediments is provided in Chapter 11.

It should be noted that the sedimentation expected to occur within the dredge area would be re-dredged where necessary to achieve the nominated design levels and tolerances. Similarly, the bulk of the predicted sedimentation within the Outer Harbour would occur within the footprint of the approved Outer Harbour Development and would ultimately be covered by the reclaimed material.

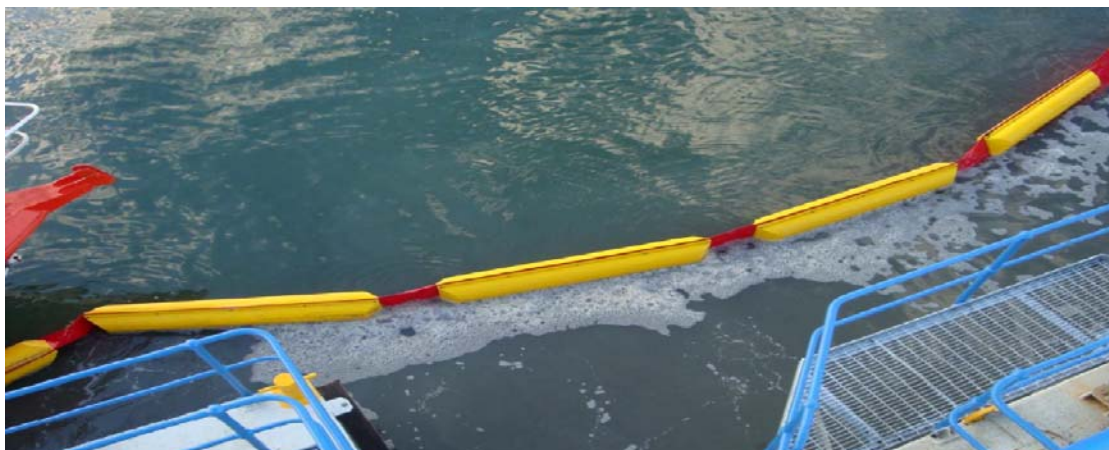
**Figure 12-7 Example of a silt curtain surrounding a dredging operation**

These potential impacts are expected to be minor in comparison to the proposed dredging and disposal works. Such activities would be undertaken in accordance with emergency spill plans and the objectives and development criteria outlined in the Port Kembla Development Code (NSW Ports 2016). Potential impacts to turbidity levels and sedimentation rates associated with these activities would also be mitigated through the use of silt curtains surrounding equipment and activities where there is a potential for impacts to water quality as shown in Figure 12-7 and discussed in Section 12.4.

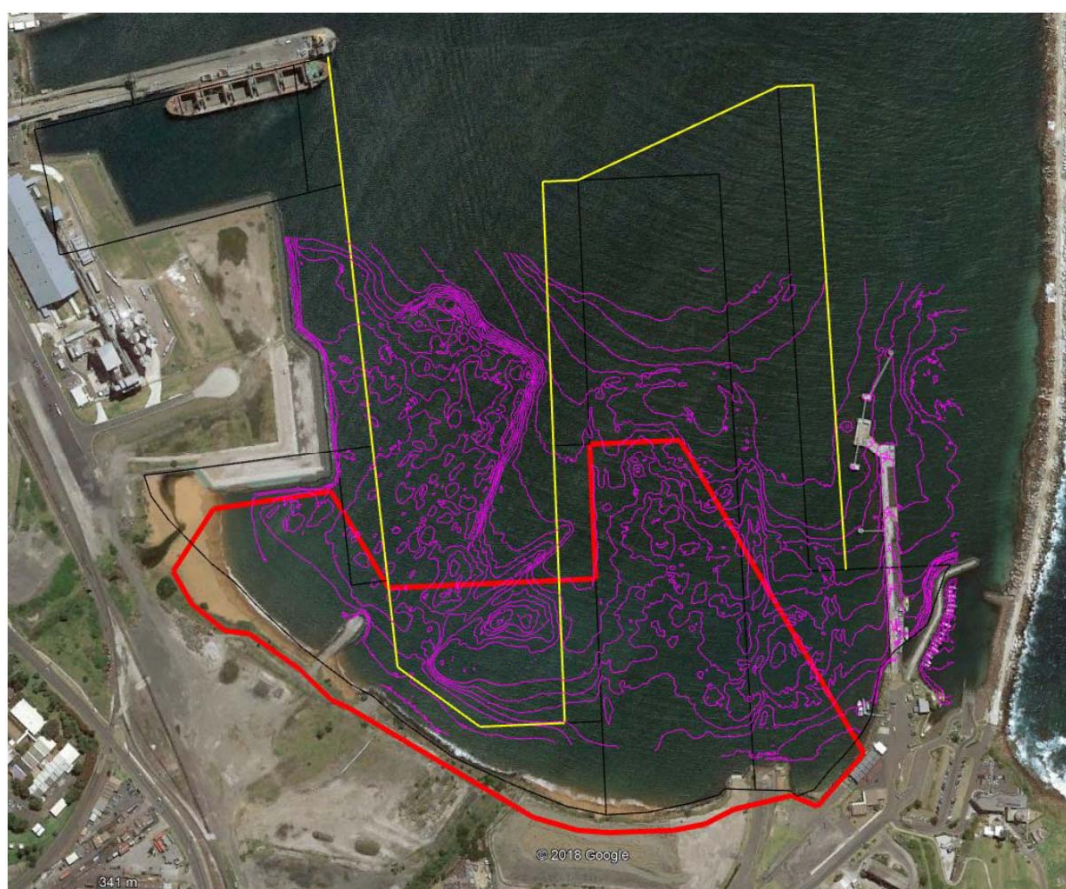
**Figure 12-11 Proposed Outer Harbour disposal footprint (Advisian, 2018)**

During recent discussions between AIE and NSW Ports, a disposal footprint has been agreed as shown in red in Figure 12-11. The previously approved reclamation footprint for the Outer Harbour Development included a longer western berth area as shown in yellow in Figure 12-11.

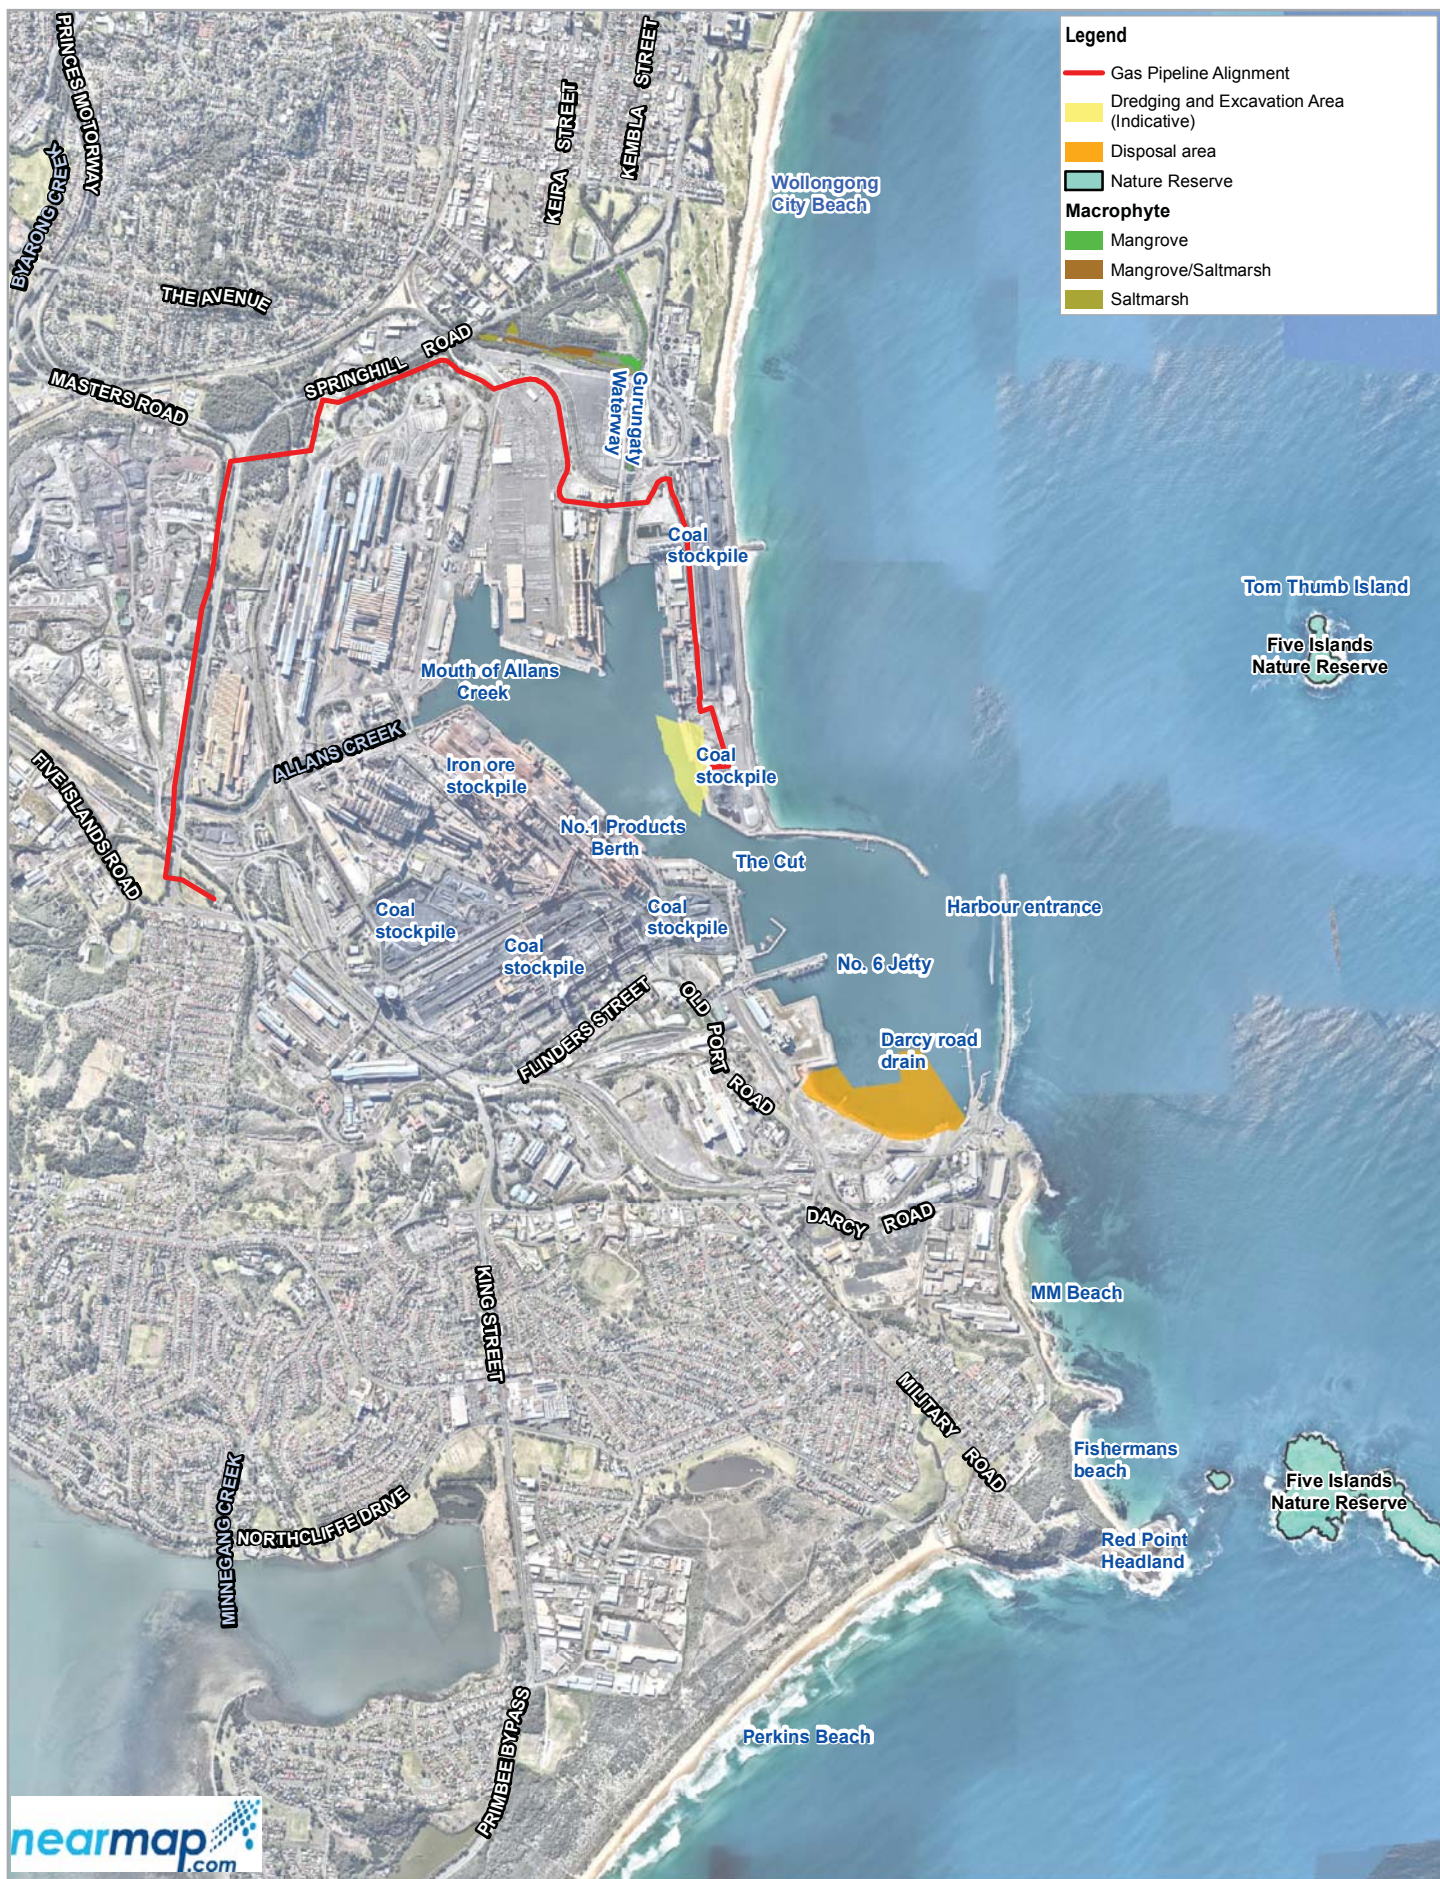
Land use in the immediate vicinity of Port Kembla contributes to the ambient marine water quality within the port. The creeks and waterways that drain industrial, coal and iron ore stockpile areas (Figure 13-3) include:

- Allans Creek, Gurungaty Waterway and No. 1 Products Berth within the Inner Harbour
- The Cut passage which connects the Inner and Outer Harbours
- Darcy Road Drain within the Outer Harbour
- In addition, the ambient marine water quality within Port Kembla is also subject to tidal influences from the Port Kembla entrance (Figure 13-3).

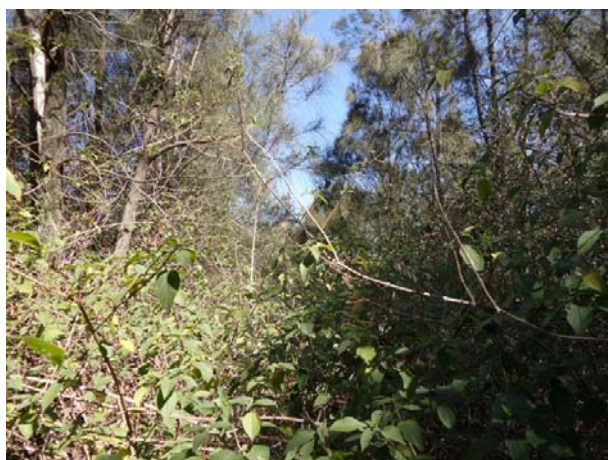
**Photograph 14-1 Woollybutt White Stringybark – Forest Red Gum grassy woodland on coastal lowlands**

Field surveys confirmed the presence of a single patch of native vegetation, comprising a small area of dense revegetation on modified/cleared lands at the approximate mid-point of the western pipeline alignment, within the project site. The vegetation is composed of a native canopy monoculture with a small number of native species regenerating in the understorey, amongst dense exotic species cover. The patch of native vegetation has been assigned to a PCT based on the classification of surrounding remnant vegetation (NPWS 2002), and likely substrates and landscape position in the area prior to their excavation and redevelopment (see Table 14-2). The vegetation zone at the project site is summarised in Table 14-2 and shown in Photograph 14-1

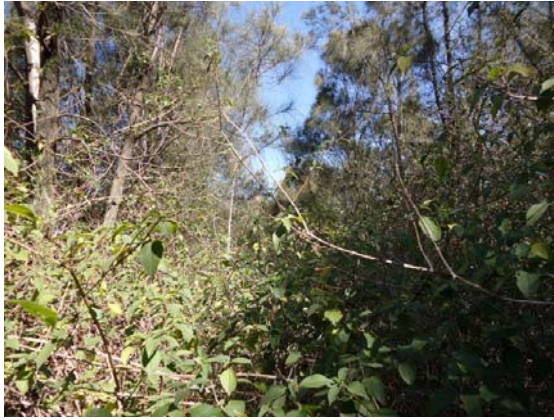
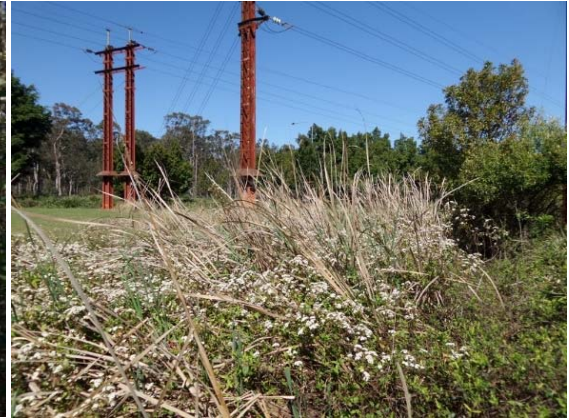
**Photograph 14-2 Left: Swamp oak revegetation Right: Typha wetland**

Habitats for fauna associated with native vegetation are limited in the study area due to the history of industrial development at the site. A small patch of planted native vegetation dominated by Swamp Oak is located west of Springhill Road. A small drain with emergent vegetation is also located adjacent to Springhill Road. Swamp Oak revegetation and Typha wetland within the study area are shown in Photograph 14-2 and described in Table 14-4.

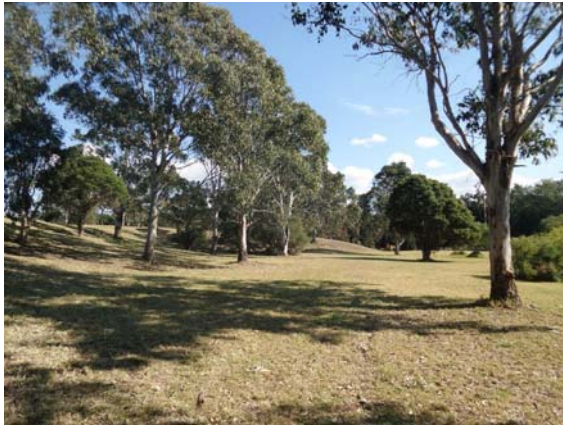
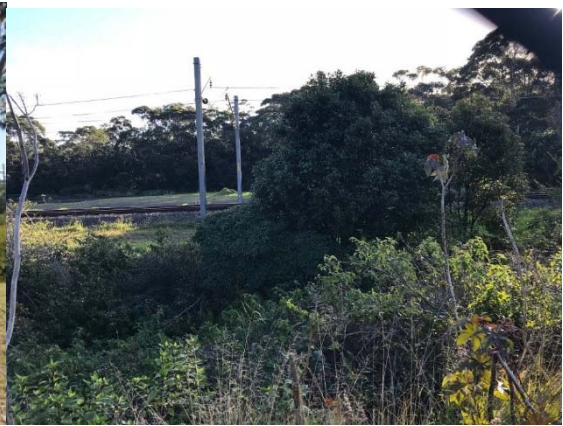
**Photograph 14-3 Left: planted trees and shrubs Right: exotic shrub**

Potential fauna habitats associated with non-native vegetation in the study area predominantly comprise areas of sediment ponds planted vegetation, mown lawns and areas of weeds as described in Table 14-5. Non-native vegetation and constructed habitat features within the study area are shown in Photograph 14-3 and Photograph 14-4.

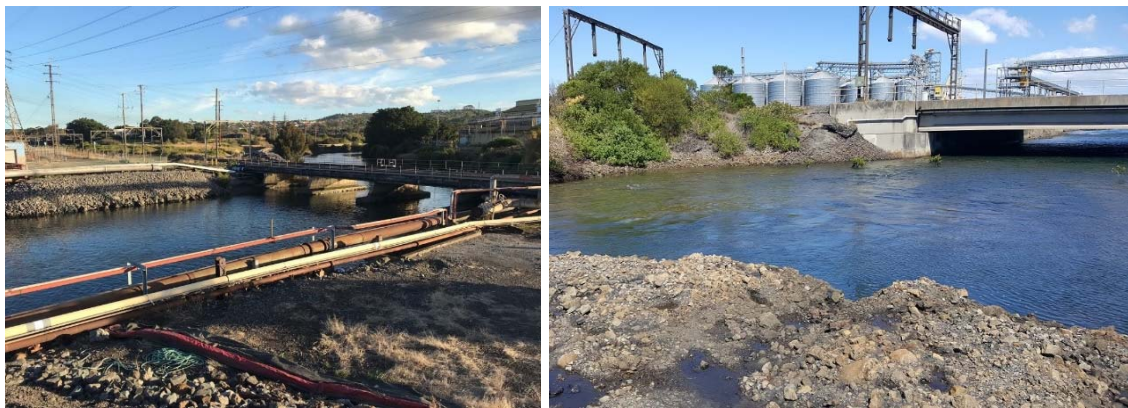
**Photograph 14-1 Left: Allans Creek within Bluescope Steel land Right: Gurungaty Waterway upstream of the project site**

Allans Creek and Gurungaty Waterway are highly disturbed aquatic habitats as shown in Photograph 14-1 and described in Table 14-7.
