Environmental Monitoring Summary Report

Port Kembla Gas Terminal

Infrastructure Approval **SSI-9471**
EPL Licence Number: **21529**

Reporting period: **1 August 2021 – 31 August 2021**

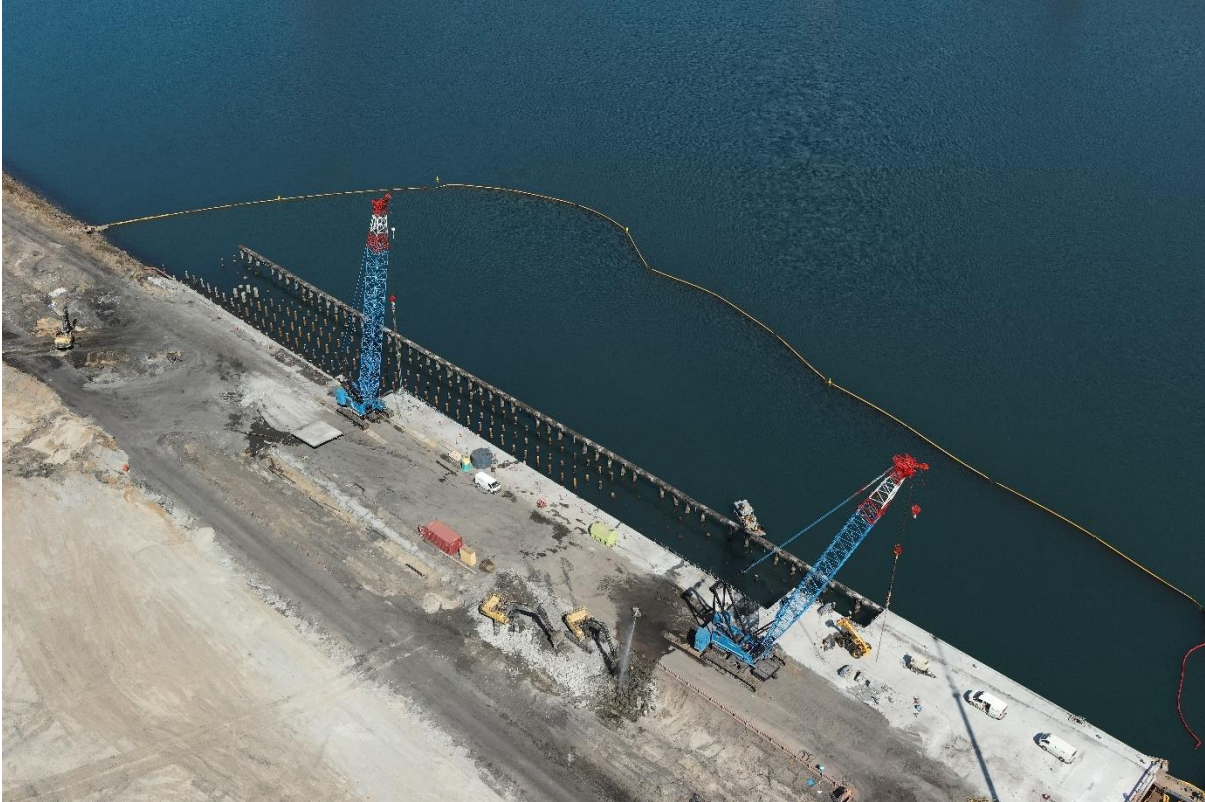
The drone footage provides a visual representation of the ecological health of Port Kembla and will indicate if there are any visual issues requiring investigation, such as sediment plumes, etc. No issues were noted in this month's survey. Select photos are provided in Appendix C from the August 2021 survey.

Photograph 1. View of MBD Site, showing berth 101 demolition in progress and silt curtain, facing west. Captured 31/08/2021.

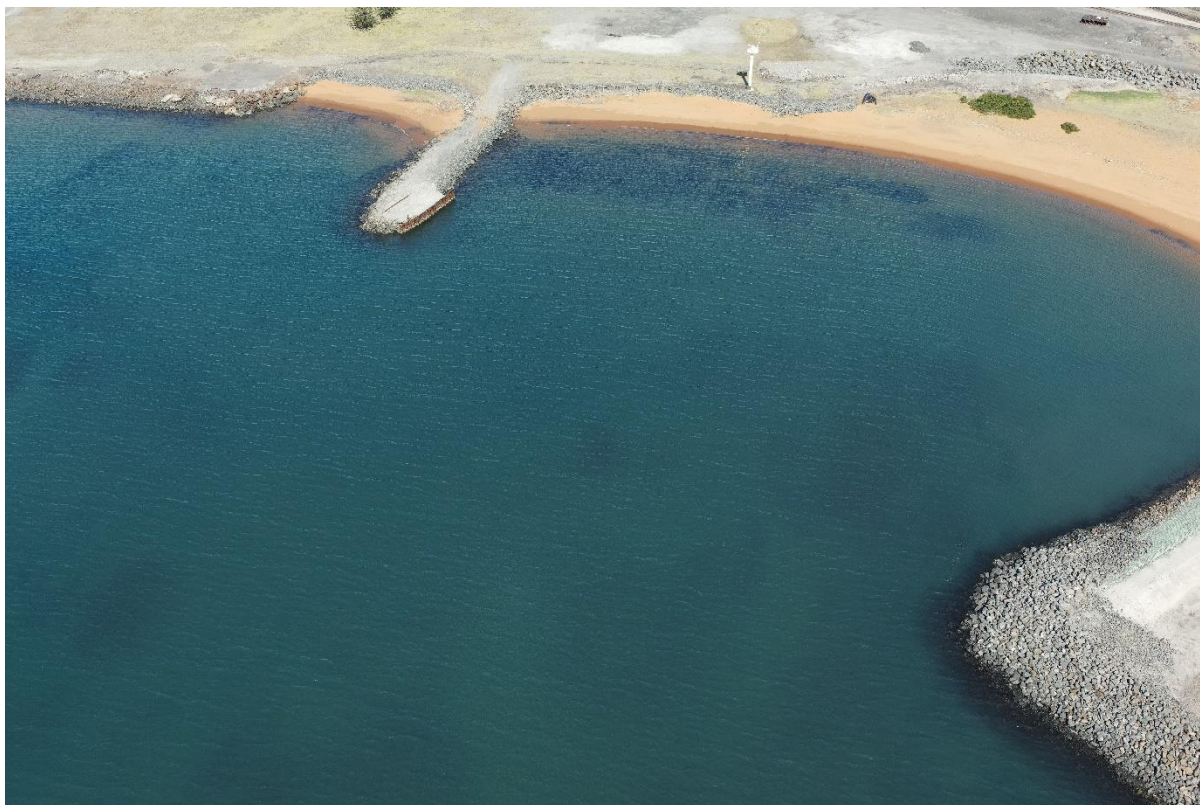
Photograph 3. View of outer harbour area prior to site setup. Captured 31/08/2021.
