Environmental Monitoring Summary Report

Port Kembla Gas Terminal

Reporting period: **1 September 2021 – 30 September 2021**

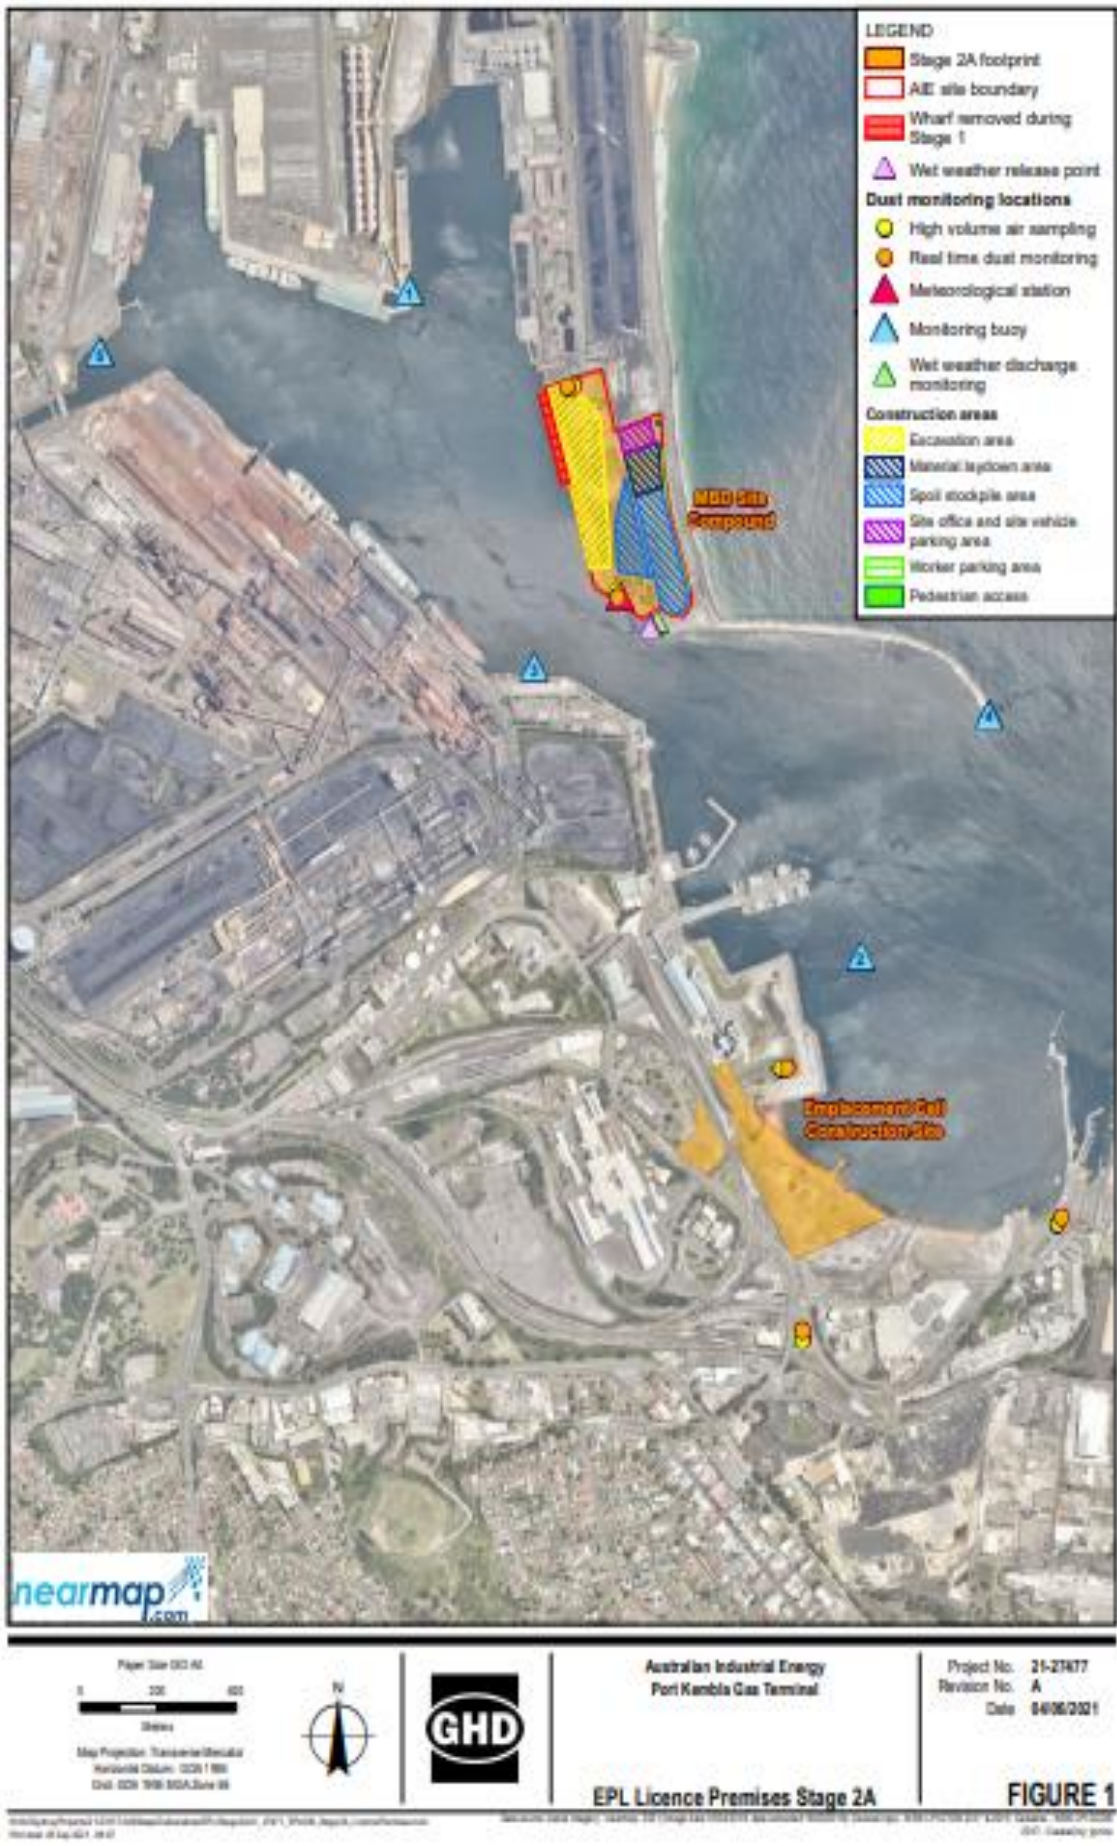
Appendix A – Monitoring Location Plan

Air quality monitoring equipment is installed to the north and south of the demolition area (Berth 101), and to the east, west and central portion of the Outer Harbour stockpile area.

AIE established and maintains a weather station for the project site located at the southern point of Berth 101 (EPL monitoring point 21) as shown in the Monitoring Location Plan in Appendix A. The monthly data obtained from the onsite weather station is provided below in Table 4-9.

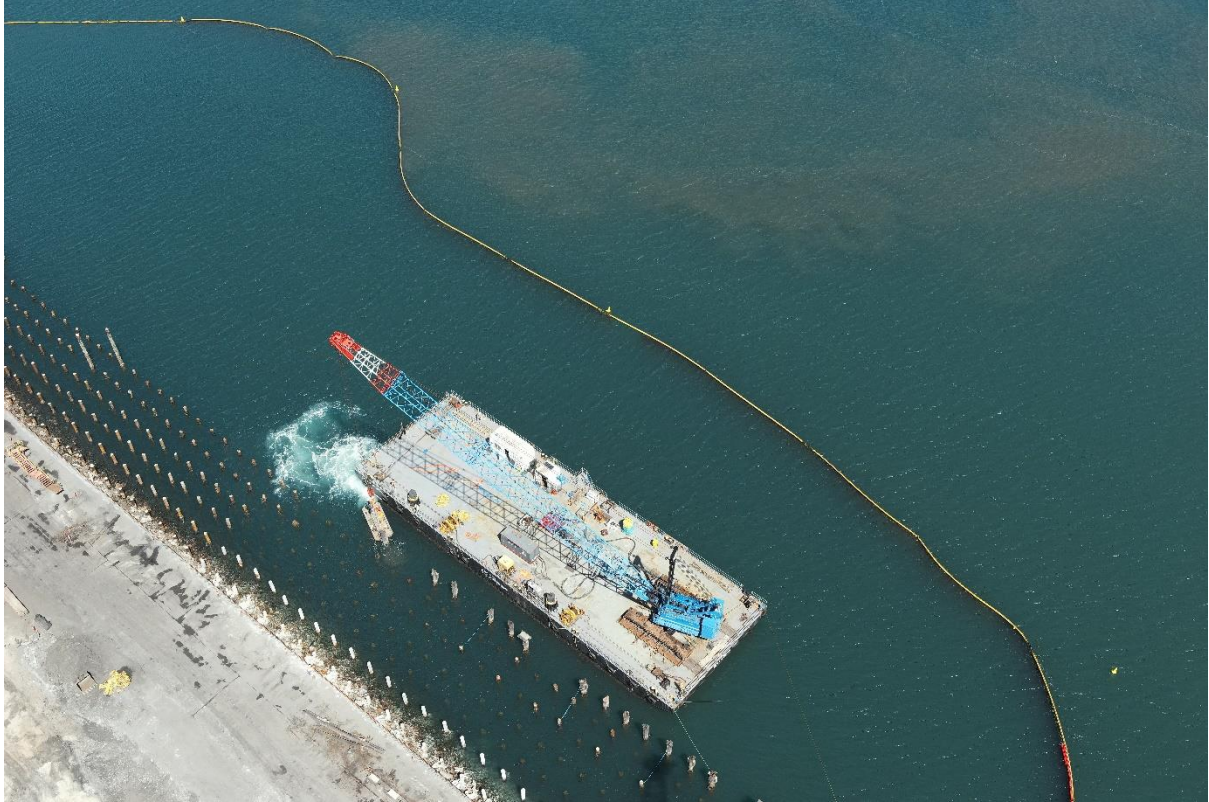
Photograph 1. View of pile removal barge and silt curtain at Berth 101. Visible sediment as a result of a recent ship movement. Facing west. Captured 22/09/2021.

The drone footage provides a visual representation of the ecological health of Port Kembla and will indicate if there are any visual issues requiring investigation, such as sediment plumes or excessive runoff. No issues were noted in this month's survey. Select photos are provided in Appendix C from the September 2021 survey.

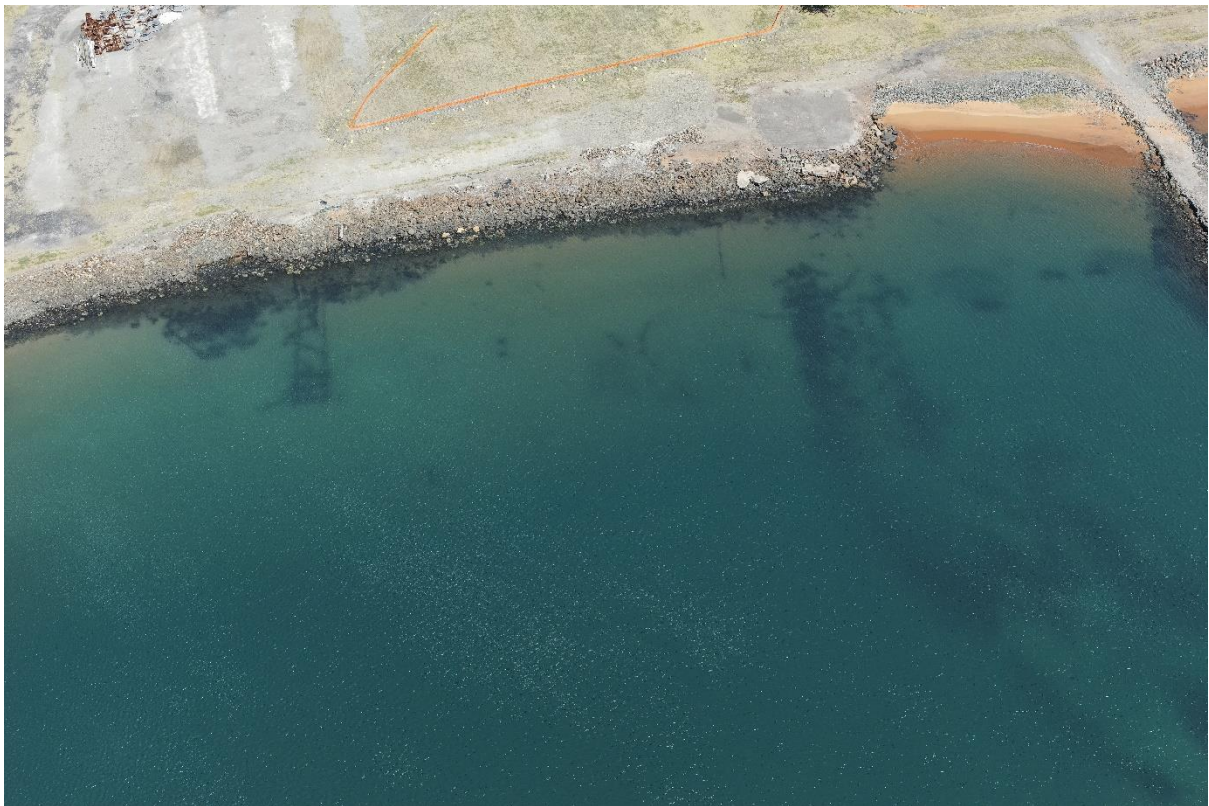
Photograph 2. View of sediment fence installed at the Outer Harbour site, facing west. Captured 22/09/2021
