# Sapphire Wind Farm

## Fourth Year Annual Report on the Implementation of the Bird and Bat Adaptive Management Plan

Prepared for Sapphire Wind Farm 1  
Operations Pty Ltd

March 2023  
Report No. 16045.4 (1.1)

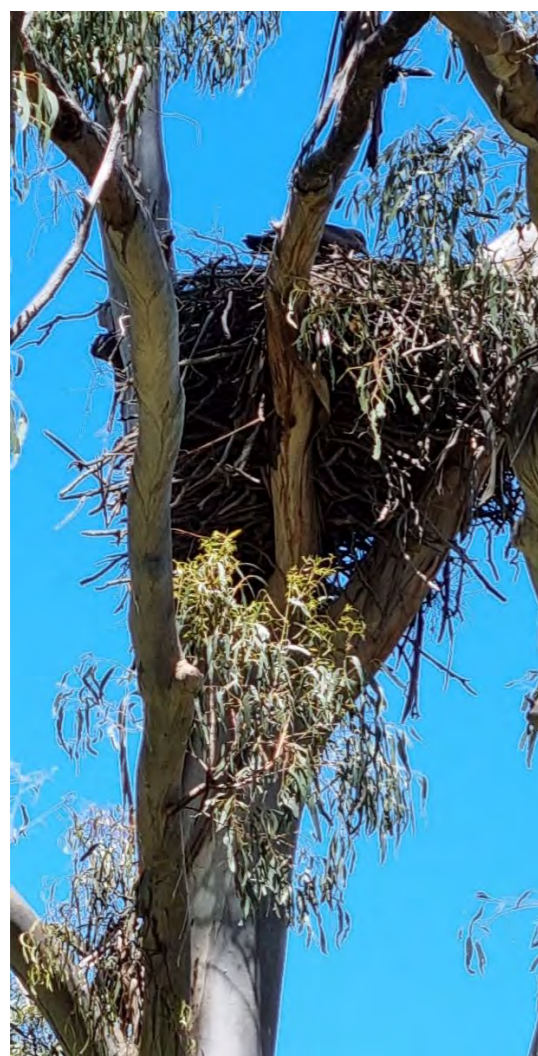
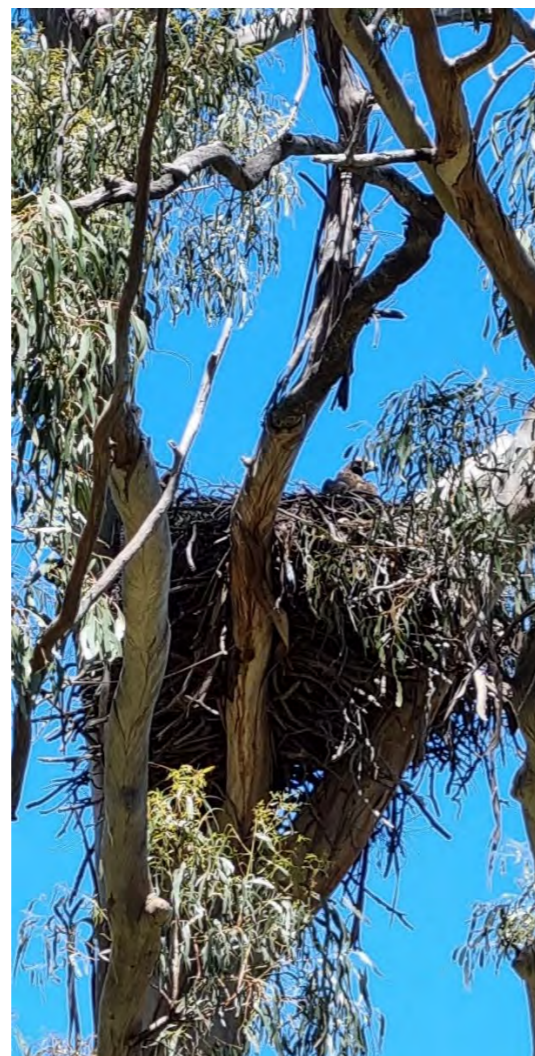
Figure 2: WTE active nest

A total of six WTE observations were recorded during the survey, with a group of four individuals being recorded in a single observation. Flight heights ranged from 20 meters above the ground to 200 meters. One WTE nest was found to be active with a juvenile present (Figure 2). Another raptor nest was discovered; however, it was empty.

Geographically, WTE observations were recorded mostly around the southern section of the wind farm, particularly around the woodland adjacent to turbines numbered 63 through 73. This is to be expected as the active WTE nest was also observed in this area.

The observation of one active WTE nest indicates at least one resident pair of WTE utilising the site. Observations of four adult individuals simultaneously may indicate a second resident pair on, or in, the vicinity of SWF. This, in addition to the recorded flight paths, indicates a regular and continued use of the site by WTE for breeding and general activity. The majority of WTE observations tended to occur around the southern area of SWF, particularly around turbines numbered 63 through to 73, this is likely to be related to nesting occurring in the adjacent woodlands.

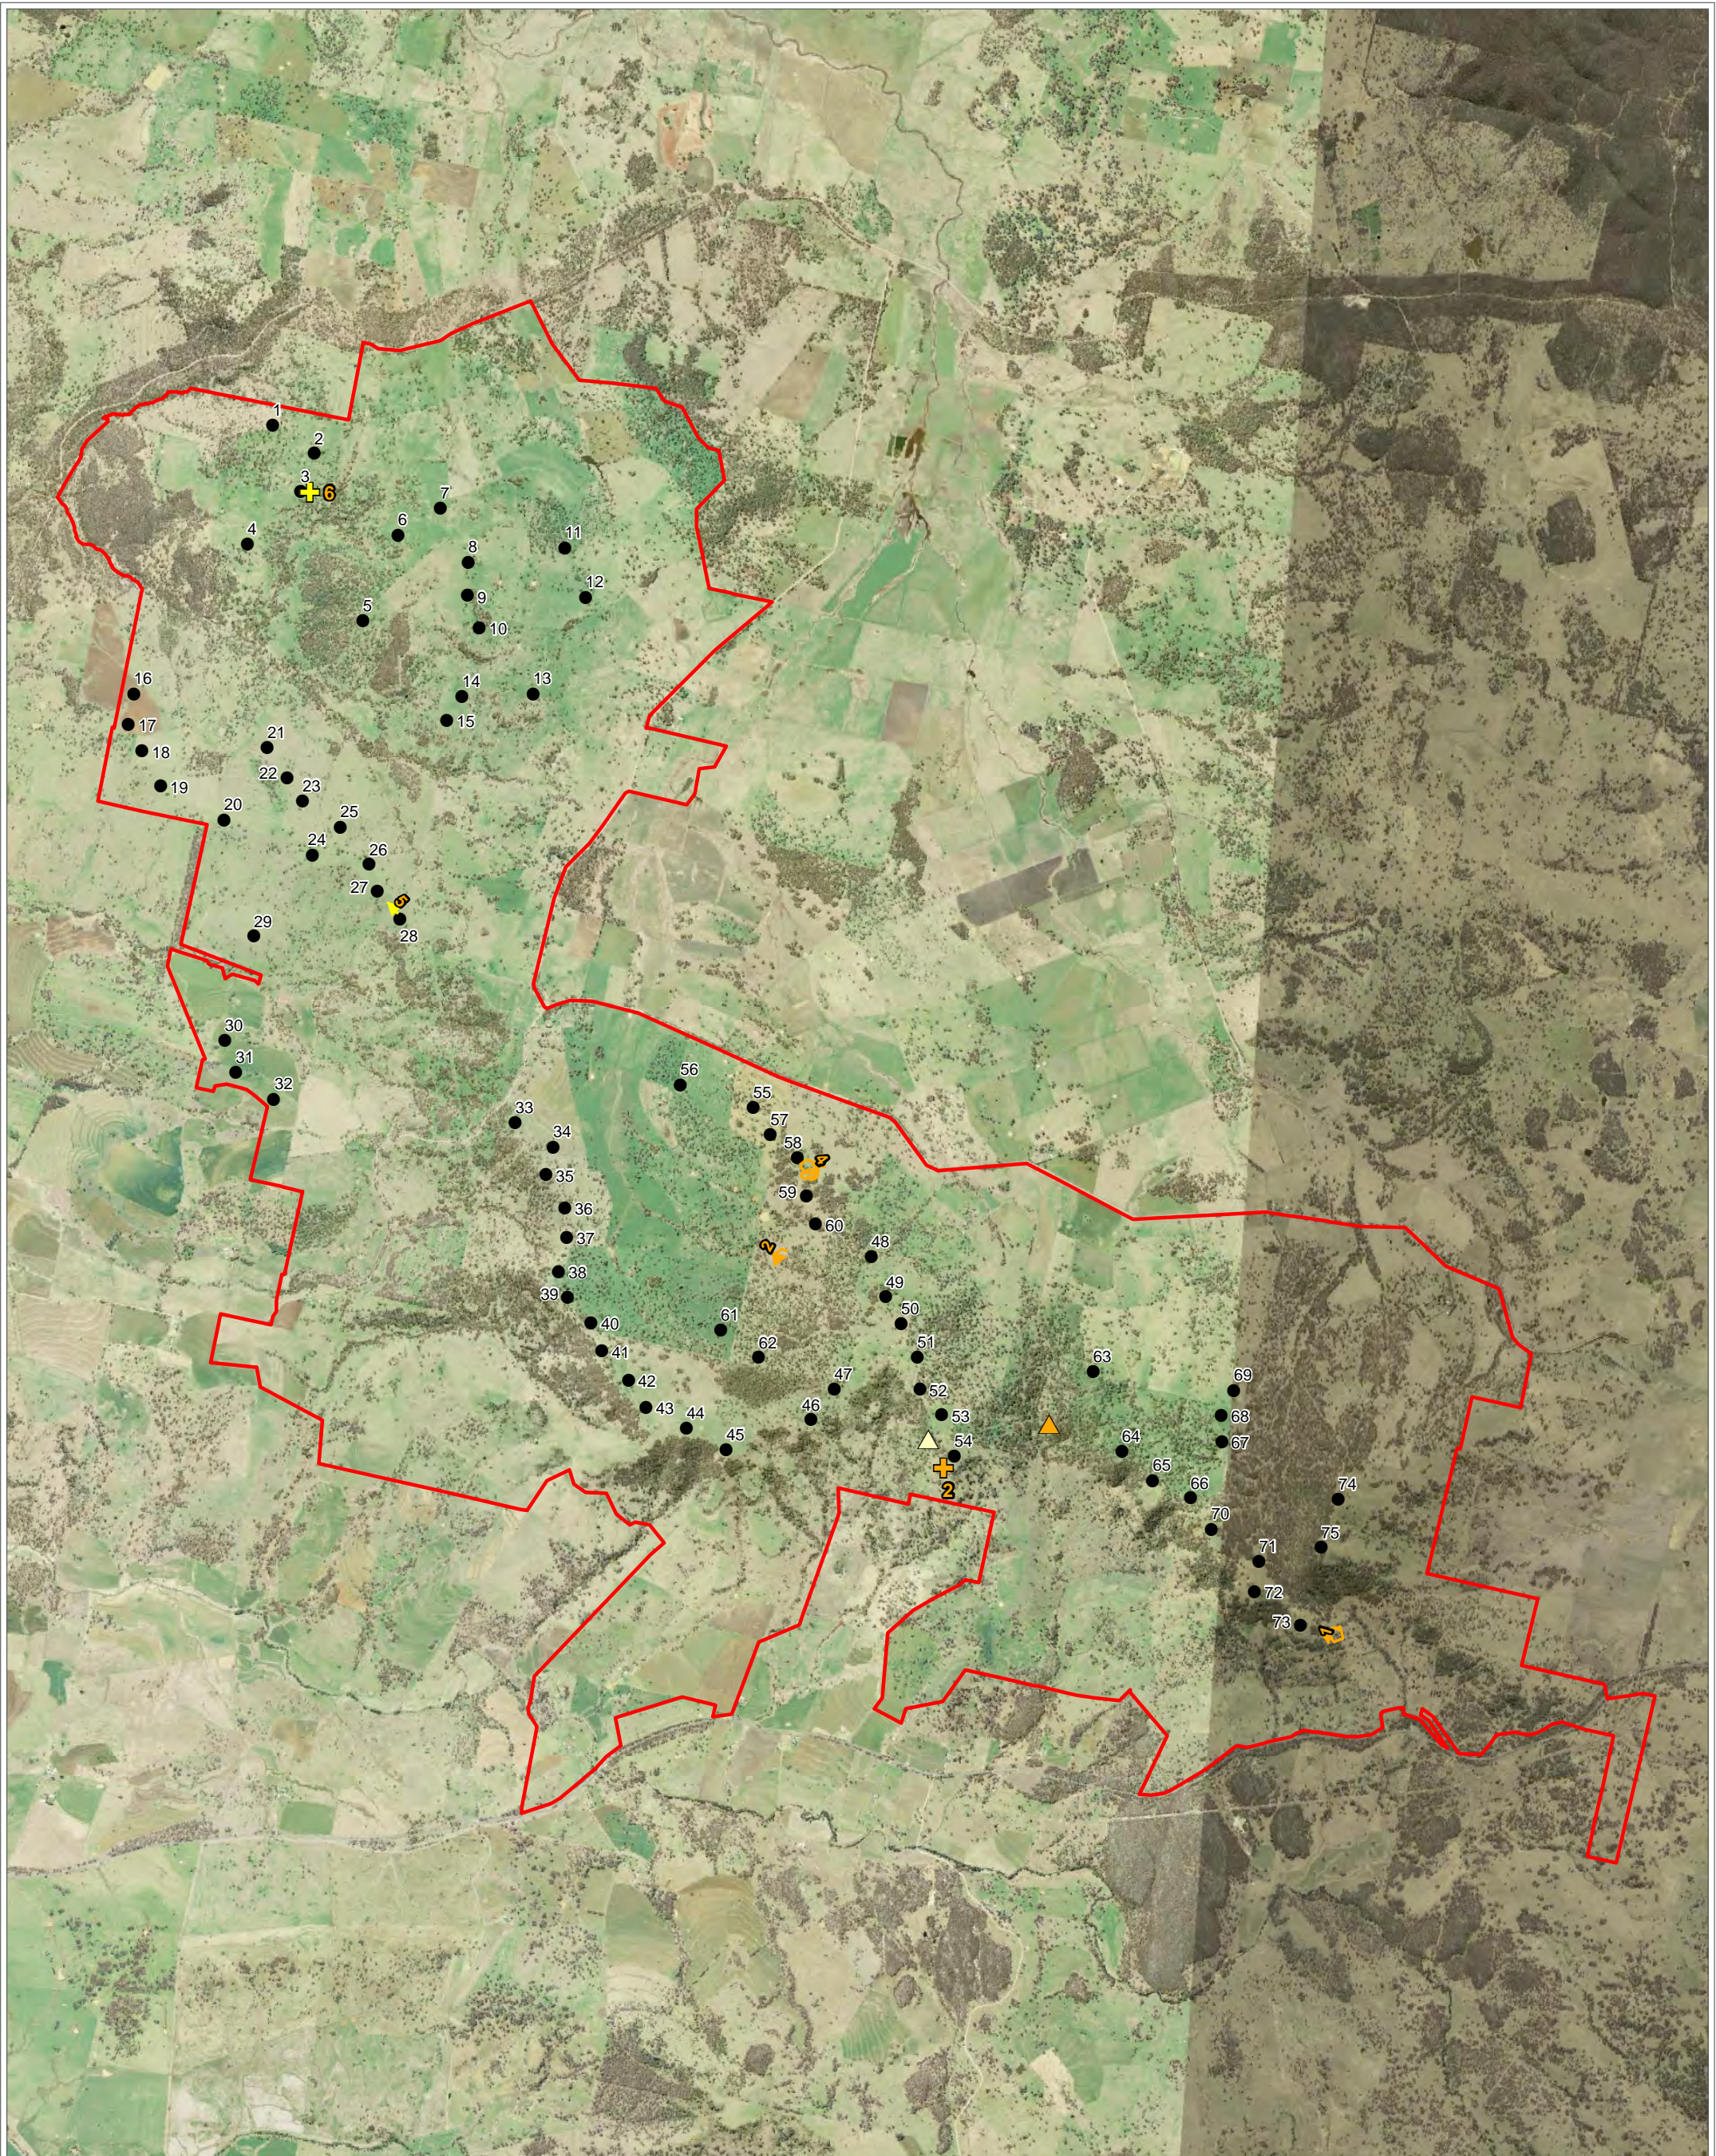
Figure 4: Wedge-tailed Eagle incidental observations

Two species of raptor were recorded flying at the wind farm during the carcass monitoring period, these were WTE and Nankeen Kestrel. Most incidental observations were WTE with a maximum number observed at one time being two individuals. Flight height ranged from 20 meters to 130 meters. Data collected for each raptor flight path is presented in Table 3 and presented Figure 4.
