Environmental Monitoring Summary Report

Port Kembla Gas Terminal

Infrastructure Approval **SSI-9471**
EPL Licence Number: **21529**

Reporting period: **1 August 2023 – 31 August 2023**

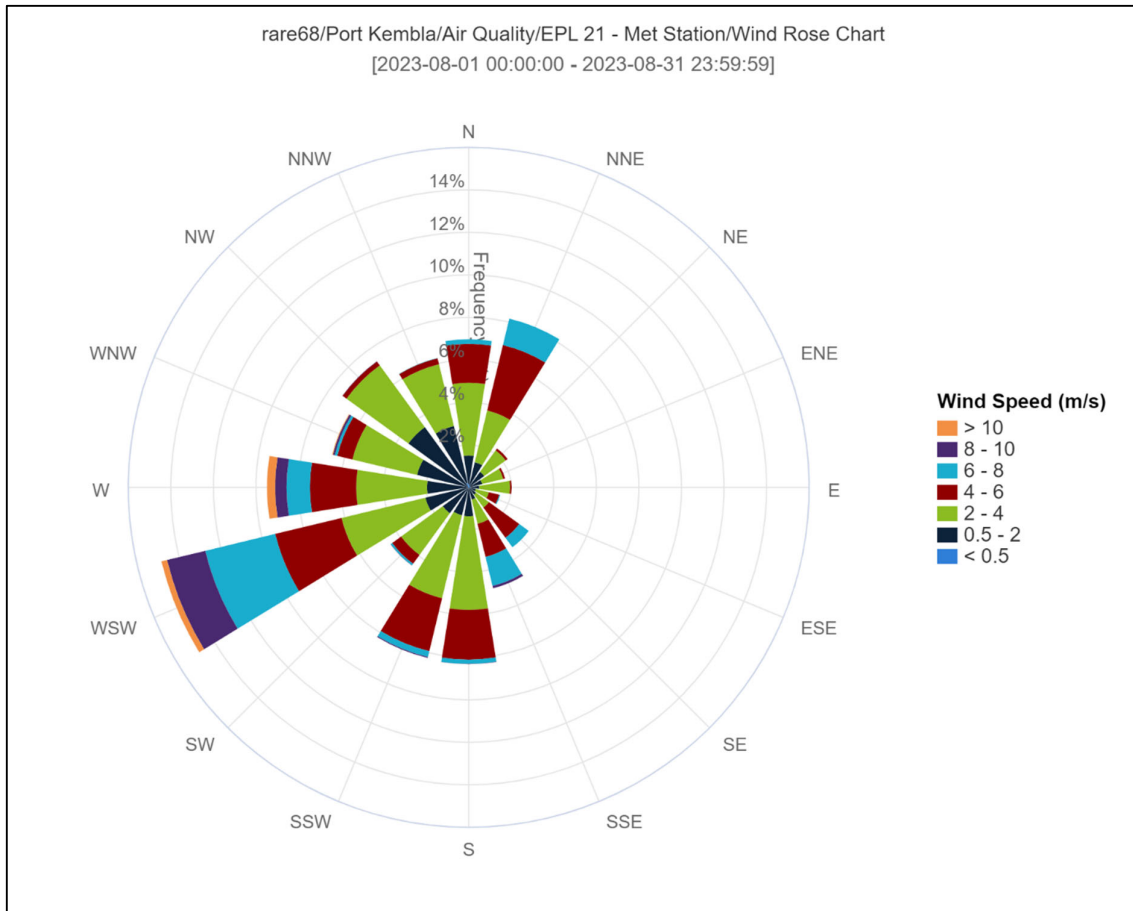
Figure 4-1 Wind Rose chart for the reporting period.

Parameter	Unit of measure	Monthly statistic	Result EPL 21
Wind velocity	m/s (15min average)	Average	3.47
		Minimum	0.10
		Maximum	11.53
Wind direction at 10m	Degrees (1 hour averaging period)	See Wind Rose chart (Figure 4-1)	
Rainfall (Hour)	mm/hr (1 hour averaging period)	Average	0.01
		Minimum	0.00
		Maximum	0.70
Rainfall (Daily)	mm/day	Average	2.10
		Minimum	0.00
		Maximum	24.80
Rainfall (Month)	mm/month	Total	65.20
Temperature	Degrees Celsius	Average	15.40
		Minimum	10.60
		Maximum	24.00
Humidity	%	Average	70.89
		Minimum	33.70
		Maximum	99.50

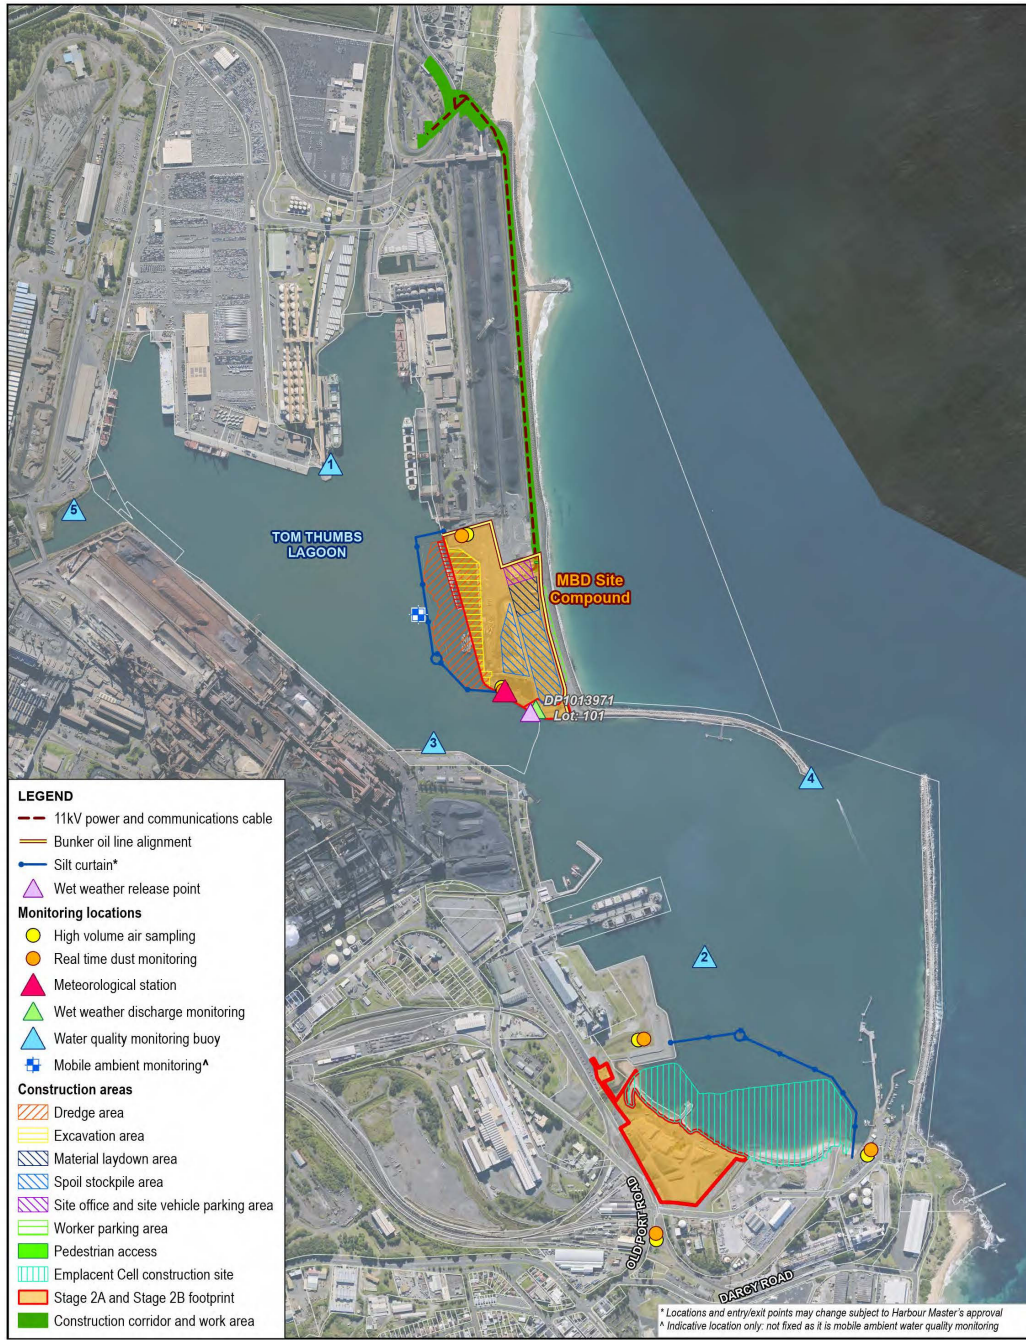
FIGURE 1

* Locations and entry/exit points may change subject to Harbour Master's approval
 ^ Indicative location only: not fixed as it is mobile ambient water quality monitoring

Premise Plan

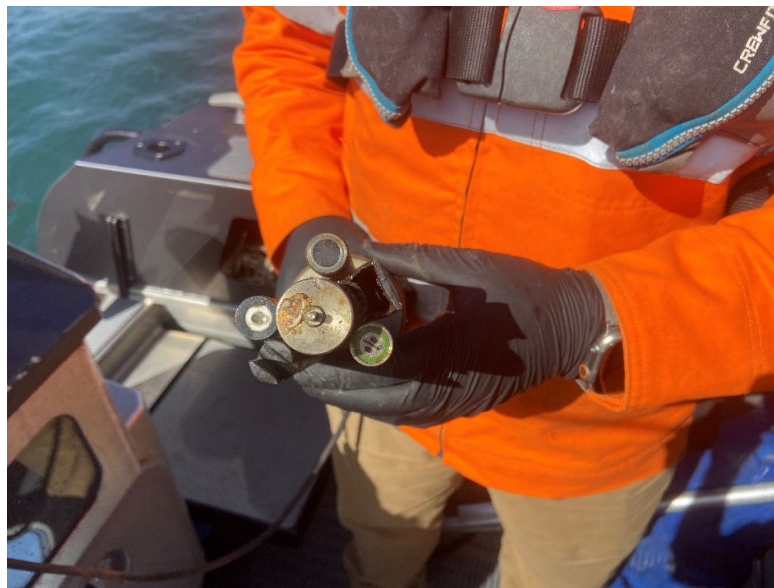
Date	Max. Background Buoy Value (Turbidity NTU)	Max. Receiver Buoy Value (Turbidity (NTU))	Action Taken & Investigation Outcomes
	Performance Criteria	35 + BG	
August 18 th 2023	WQM4 / EPL 18: 2.92 WQM5 / EPL 19: 125.10	WQM1 / EPL 1: 106.03 WQM3 / EPL 17: 59.44	A chart showing turbidity readings for the day of the recorded exceedance is provided below. The exceedances were one-off peak readings all coinciding with the weekly cleaning of the probes. Throughout the day there were consistent low-level readings observed at all buoys indicating this exceedance was most likely related to this cleaning. No dredging operations were occurring at the time.

Sensors of EPL 1 removed from the water for cleaning. Photograph taken 11:20 am on the 18th August 2023.

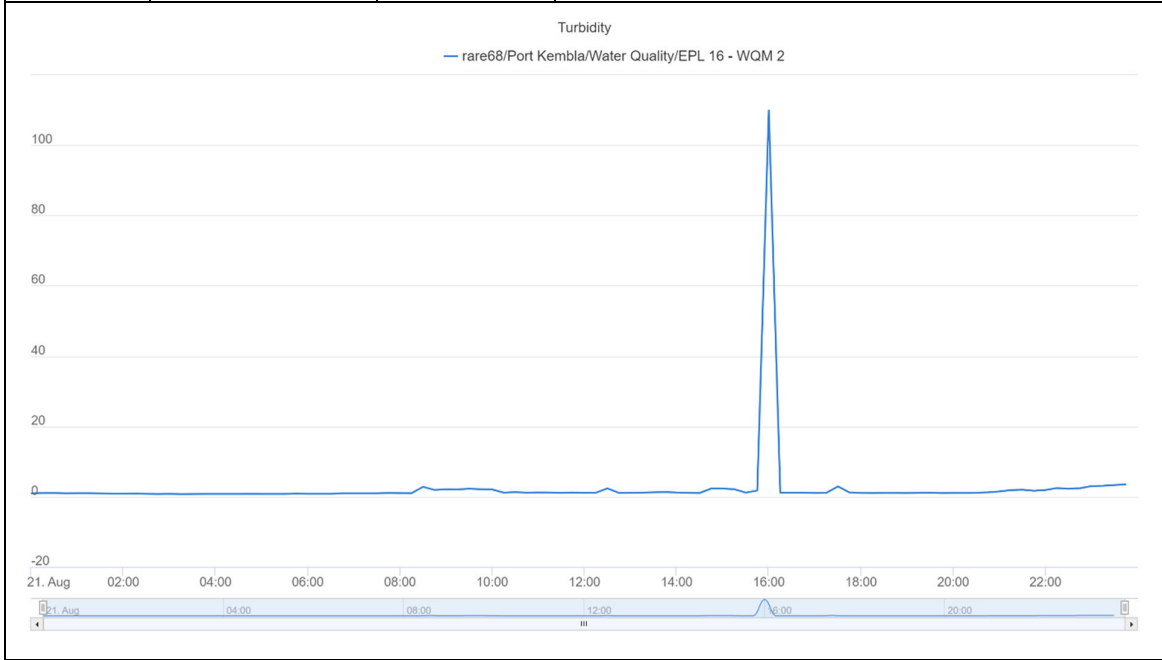
Date	Max. Background Buoy Value (Turbidity NTU)	Max. Receiver Buoy Value (Turbidity (NTU))	Action Taken & Investigation Outcomes
	<i>Performance Criteria</i>	<i>35 + BG</i>	
August 21 st 2023	WQM4 / EPL 18: 3.85 WQM5 / EPL 19: 5.69	WQM1 / EPL 1: 4.8 WQM2 / EPL 16: 110.14	A chart showing turbidity readings for the day of the recorded exceedance is provided below. The exceedance was a one-off peak reading. Throughout the day there were consistent low-level readings observed at both the other impact and background buoys indicating this exceedance was most likely related to biofouling over the sensor. No dredging operations were occurring at the time.
