# Environmental Monitoring Summary Report

## *Port Kembla Gas Terminal*

Infrastructure Approval     **SSI-9471**  
EPL Licence Number:       **21529**

Reporting period:           **1 November 2021 – 30 November 2021**

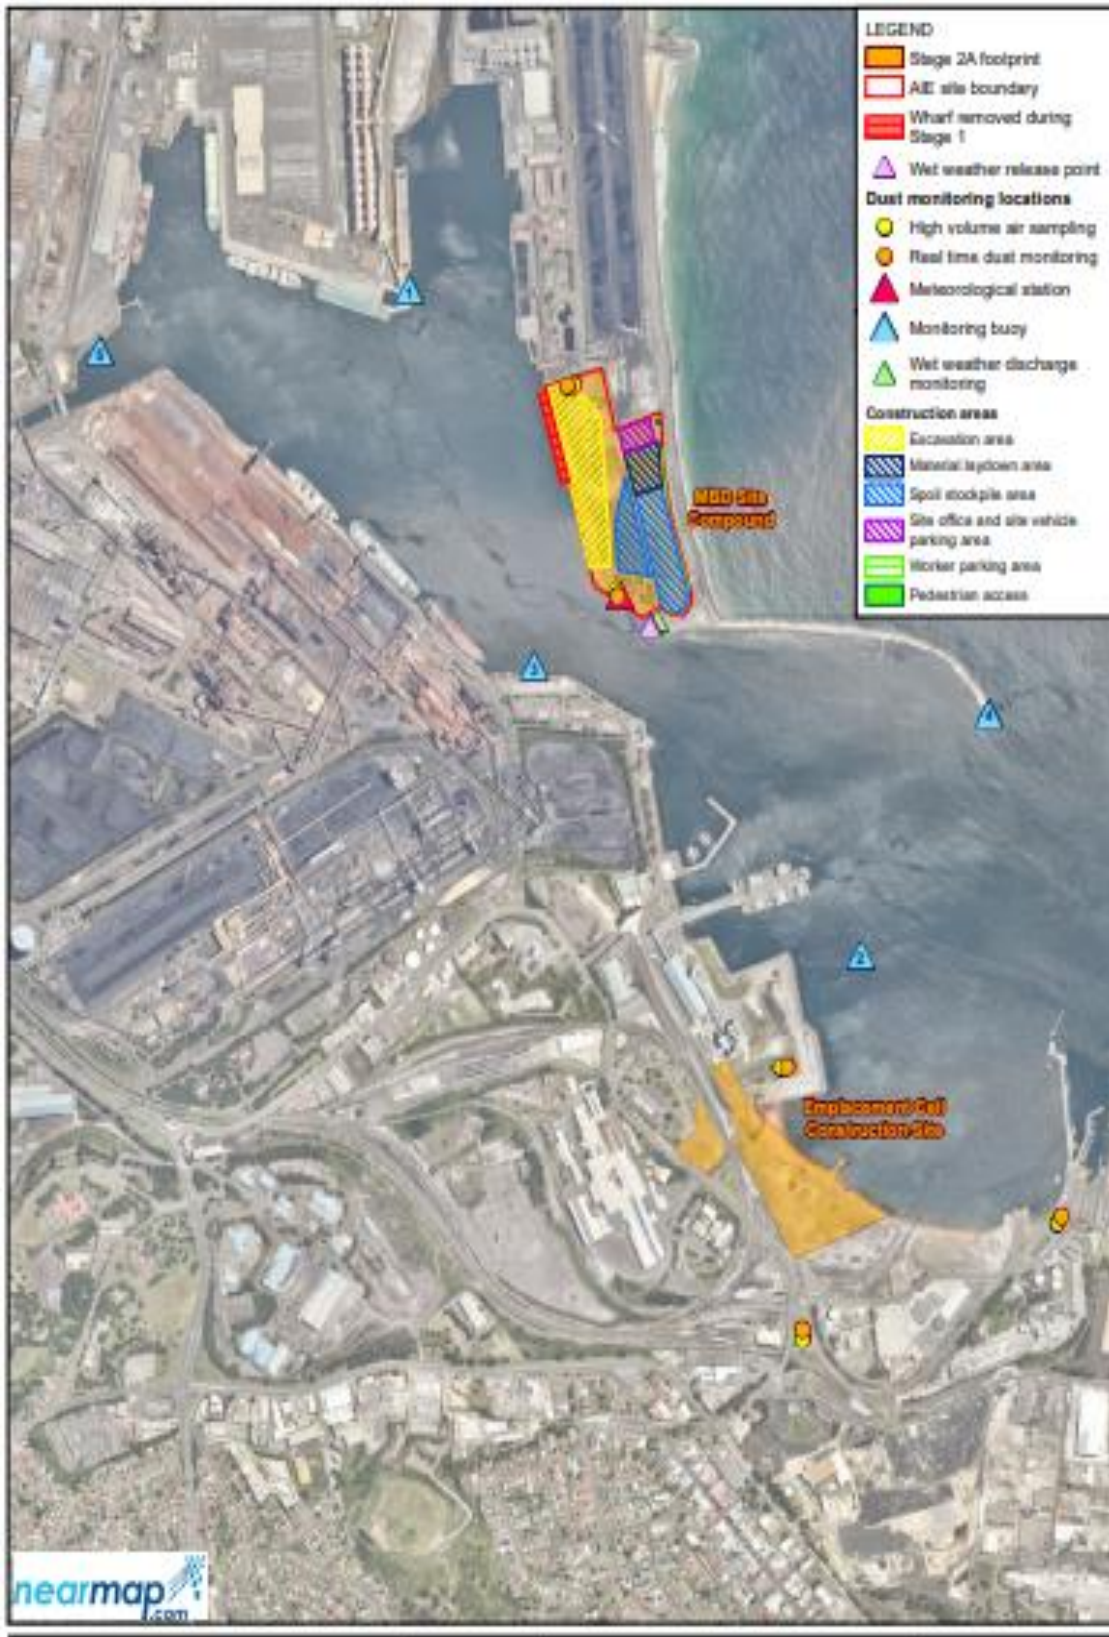
**FIGURE 1**

EPL Licence Premises Stage 2A

AIE established and maintains a weather station for the project site located at the southern point of Berth 101 (EPL monitoring point 21) as shown in the Monitoring Location Plan in Appendix A. The monthly data obtained from the onsite weather station is provided below in Table 4-9.

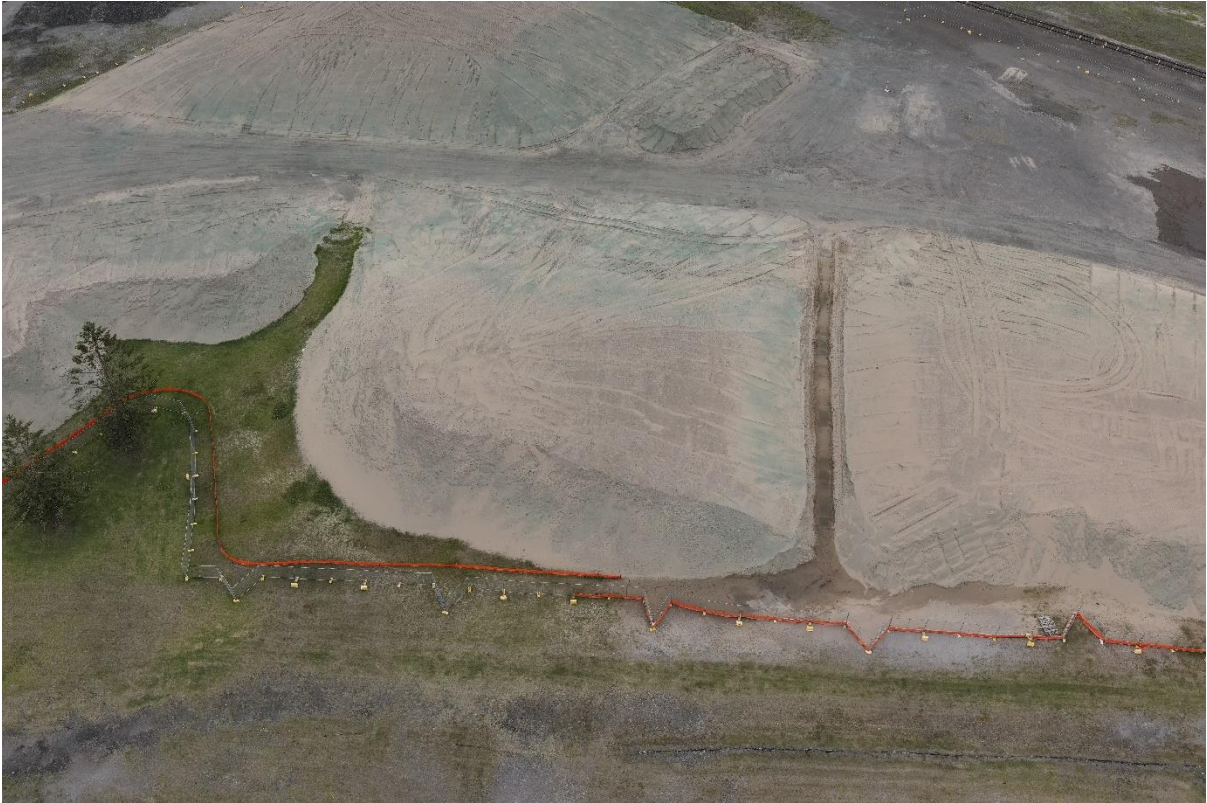
Photograph 1: View of Outer Harbour stockpiles following polymer application and sediment controls.

The drone footage provides a visual representation of the ecological health of Port Kembla and will indicate if there are any visual issues requiring investigation, such as sediment plumes or excessive runoff. No issues were noted in this month's survey. Select photos are provided in Appendix C from the November 2021 survey.

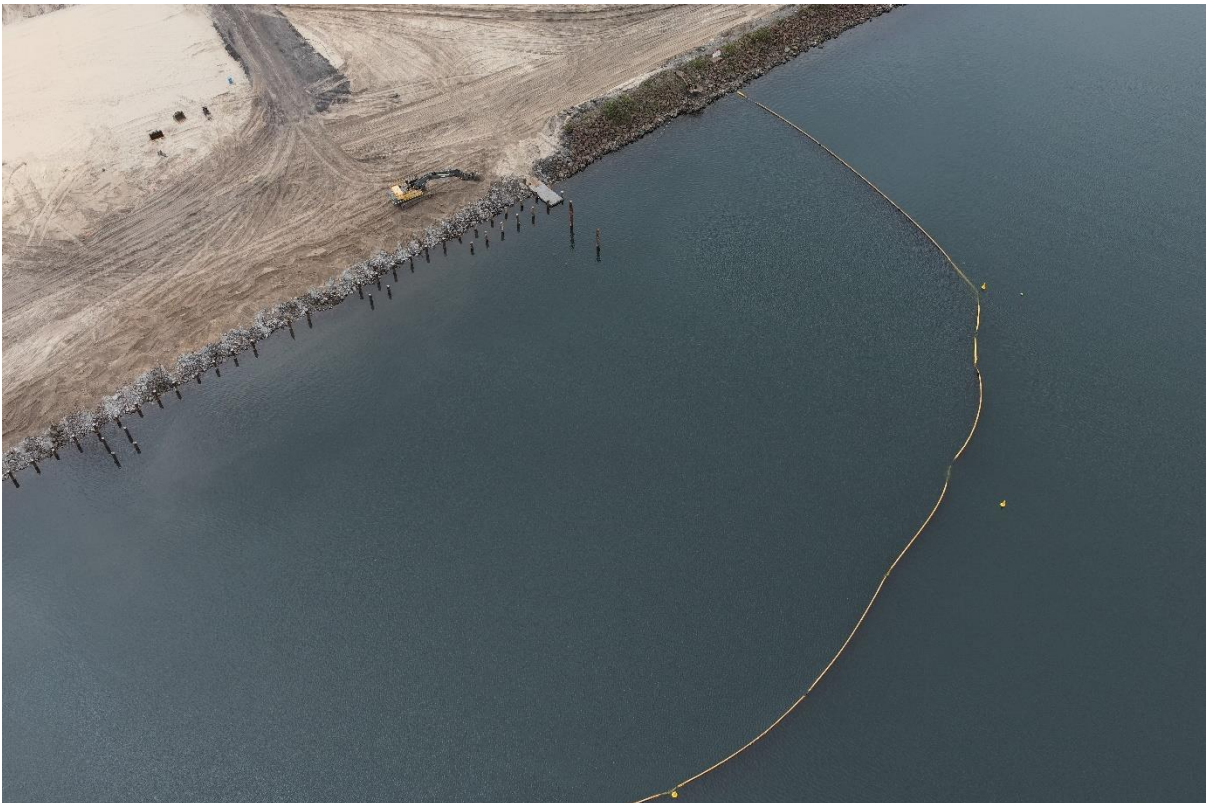
Photograph 2: View of removed wharf apron and remaining wharf piles at Berth 101.
